LEAVITT REPORT

2215 S. Harrison - Anytown, UT.

CLIENT'S NAME: Bob & Melanie Homebuyers.
 DATE OF INSPECTION: 03/09/2001.
 TIME OF INSPECTION: 08:45 AM.
 INSPECTION #: 30901A.
 CLIENT'S AGENT: Robert Salesman - Wardley GMAC.

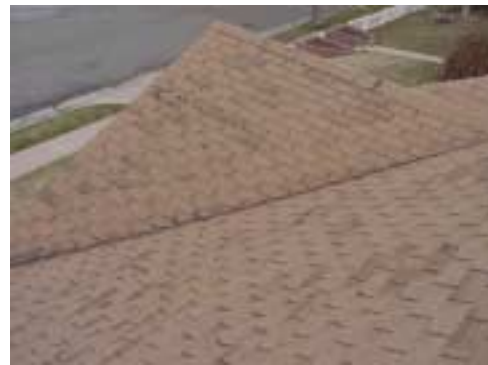
ROOFING CONDITION: This roofing material is being used beyond it's typical projected lifespan. Consideration should be given to upgrading the roof covering.

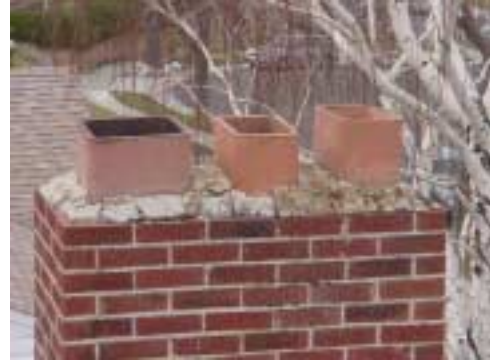
A cement chimney cap is installed.
There is significant deterioration to the chimney cap = Recommend repair by a brick mason specialist.

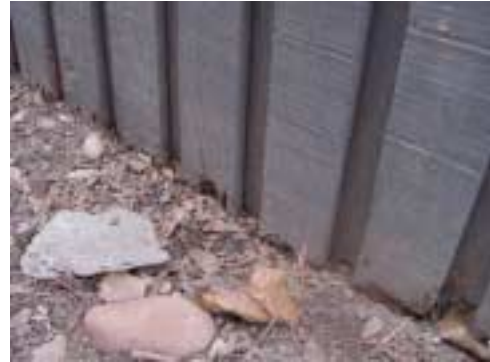
There is direct earth to wood contact around the perimeter of the structure. Both moisture and termite damage was observed on the lower edges = Recommend lowering the earth and possible treatment by a licensed Pest Control Operator.

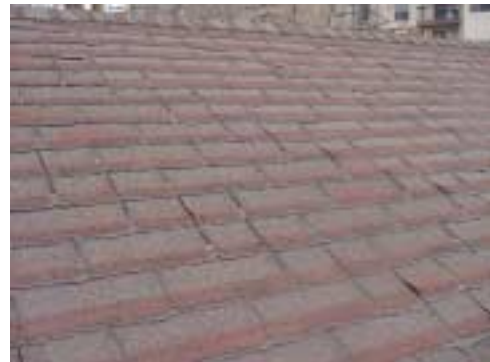
Two car.
Detached.
The roof is in Poor condition = Reshingle.

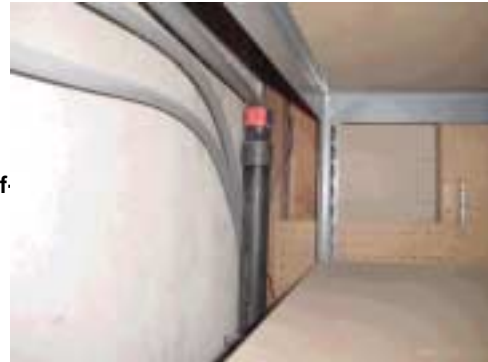
WASHER DRAIN: Did Not Test. The testing of the washing machine drain is beyond the scope of this inspection. The drain for the unit and the floor was an afterthought and there were no provisions for a vent to extend through the roof. Instead, they put in a local self-closing vent. Typically these are not allowed in this installation by the City officials.

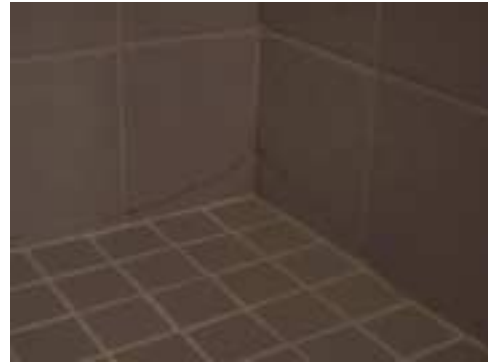
- TUB/SHOWER SURROUND:** There are 2 tiles cracked in the corner.
- SHOWER ENCLOSURE:** General condition is Good.
- TUB/SHOWER PLUMBING:** Appears serviceable.
- VANITY:** General condition is Good.
- COUNTERTOPS:** General condition is Good.
- SINK:** General condition is Good.
- FAUCET:** General condition is Good.
- TOILET:** General condition is Good.

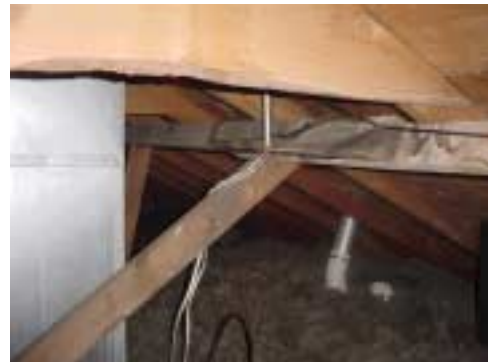
LEAK EVIDENCE: There is evidence of water entry around the Evaporative Cooler base.

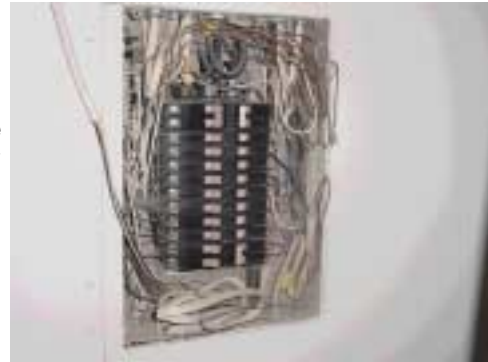
The dead cover is not currently installed. Accessing the panel was difficult due to the placement of the shelves. Inside the panel there was some confusion as to the need to place the grounds on the grounding buss bar and the white neutrals on the neutral buss bar. They are incorrectly intermixed = Recommend further evaluation/repair. There are also several Romex lines that enter the panel, but are not hooked up. It is unknown what they go to. There is another Romex line that enters the panel over the front instead of through one of the entry holes. It is good to see that the panel has been upgraded, but a licensed Electrician is needed to resolve the incorrect and unsafe wiring in this panel.

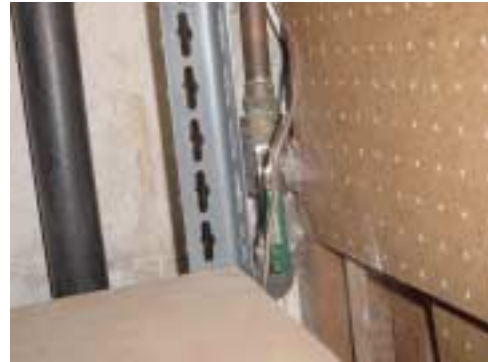
There is a rod ground under the main panel. There is also a main water line ground, but it was not connected since the upgrade of the Plumbing system = Hazard = Recommend secure reinstallation of this main house ground.
