# LEAVITT REPORT

**2828 West 680 North - Provo, UT.**

CLIENT'S NAME: Debra Biser.  
DATE OF INSPECTION: 03/22/2001.  
TIME OF INSPECTION: 03:00 PM.  
INSPECTION #: 32201B.  
CLIENT'S AGENT: No Agent Representation.

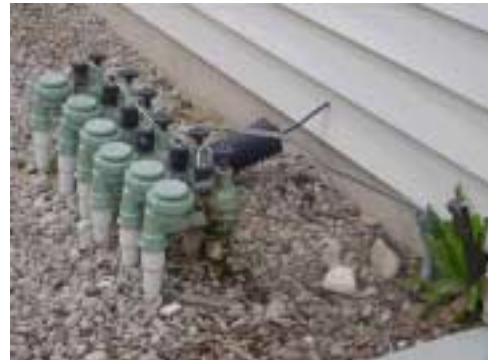
Yes: Automatic sprinklers were identified. Did Not Test = The evaluation of sprinkler systems is beyond the scope of this evaluation. It is recommended that information about the sprinkler system, stations, care and maintenance be obtained from the Seller.  
2 of the east side electric valves are leaking = Repair. There is also a Romex electrical wire near these valves that is not connected to anything.

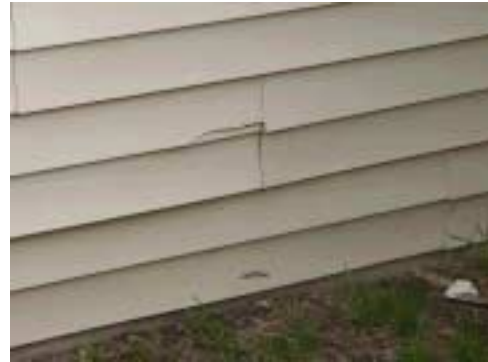
There are 2 damaged sections on the lower west middle.

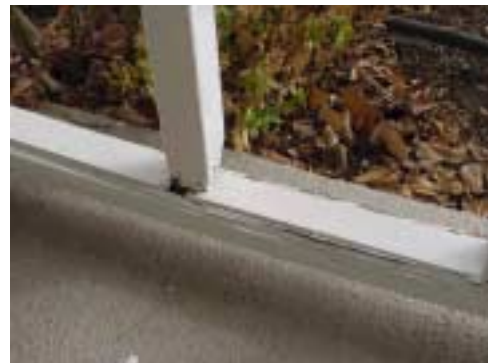
The railing is at ground level, so the wider spacing is okay. There is rot on the lower edge of the railing = Repair.

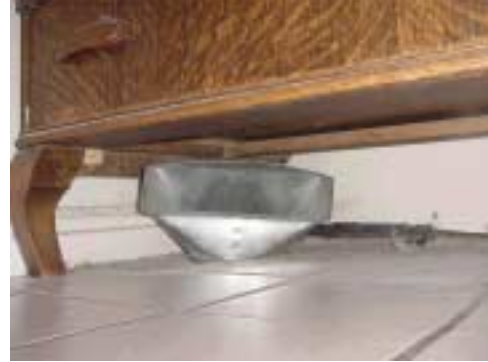
**LOCATION:** Upstairs, Master.  
**WALL FINISH:** Paint condition is Intact.  
**FLOORING:** Good condition.  
**WINDOWS:** Dual pane window(s) condition is Good.  
**DOOR:** Acceptable.  
**LIGHTING:** Room lighting appears adequate.  
**OUTLETS:** Functioning as designed.  
**GFI OUTLETS:** GFI outlet is installed and working as designed.  
**HEATING DEVICE:** The duct has no grill cover installed.

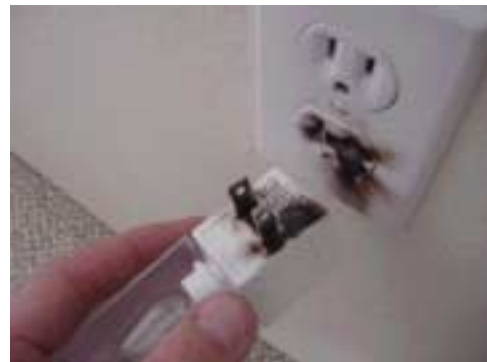
**TYPE:** Carpet - Good.  
**RISER/TREAD RATIO:** Good.  
**HEAD CLEARANCE:** Good.  
**RAILINGS STURDY:** The top newel post is loosely mounted = Resecure.  
**BALUSTRADE SPACING:** Good.  
**REMARKS:** There is an outlet that is scorched on the stairway. It is still functioning.

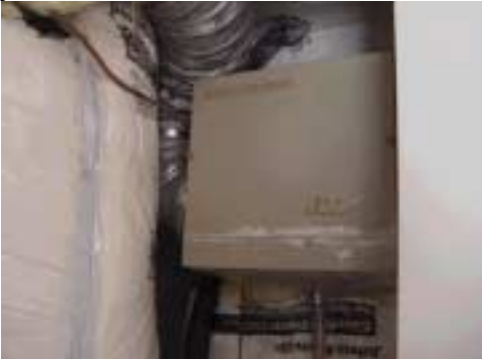
**BLOWER MOTOR:** Appears to operate smoothly.  
**FILTER TYPE:** This system utilizes a standard efficiency air filter.  
**HUMIDIFIER:** A humidifier is installed, but was not tested. Humidifiers require seasonal maintenance to work properly. The unit has previously overflowed and regular maintenance is always needed with these systems.
