LEAVITT REPORT

Michael D. Leavitt - Certified Home Inspector

1530 South 1000 East - Anytown, UT.

CLIENT'S NAME: John & Judy Jones.
 DATE OF INSPECTION: 01/27/2001.
 TIME OF INSPECTION: 02:00 PM.
 INSPECTION #: 32701B.
 CLIENT'S AGENT: Top Producer - Century 21

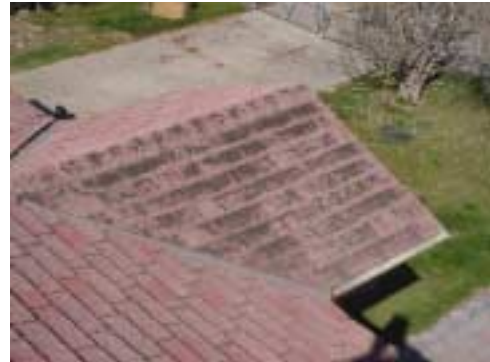
ROOFING CONDITION: The roof is in need of replacement. There are 3 different eras of roofing applied. The wet side is inadequately installed for the low pitch. The other areas are just plain worn out.

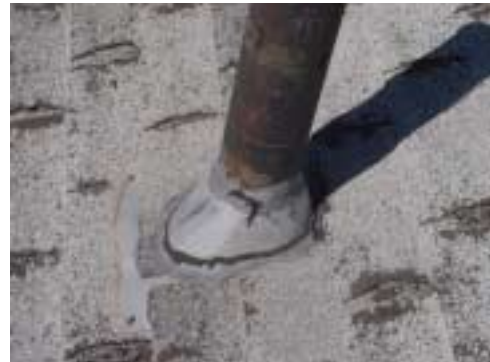
ROOFING MATERIAL: Composition Shingles.
ROOF PENETRATIONS: The roof jacks are in need of recaulking to prevent water penetration into the attic. This maintenance is normal and should be performed about every 3 to 5 years.

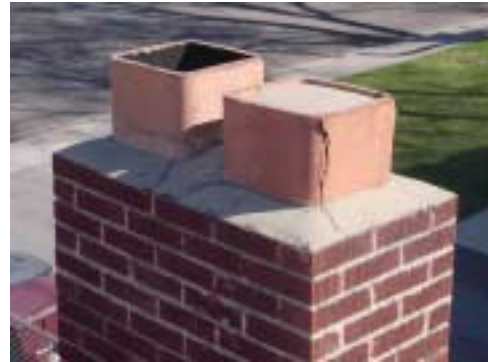
A cement chimney cap is installed.
Cracks were noted in the chimney cap
= Repair is recommended to prevent
the spalling of the masonry below.

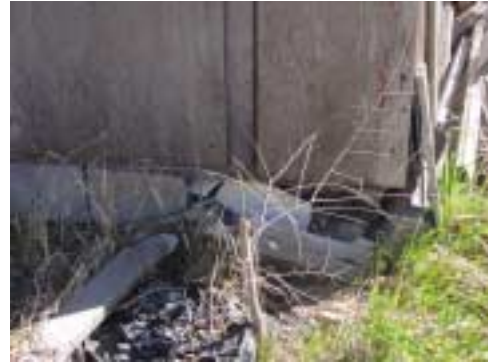
he NW portion of the home is an added on deteriorated sub par type of structure. There has been major long term water leakage which has ruined ceiling drywall coverage and has stained and warped the roof framing. Consideration should be given to removing this portion of the structure and reroofing over the laundry area to ensure that there are no more leaks. The foundation under this section is deteriorated wood and amateur installed cinder blocks.

Roof replacement is recommended. The NW shed addition should be removed. Cosmetic and window upgrades were already planned for and discussed on site.

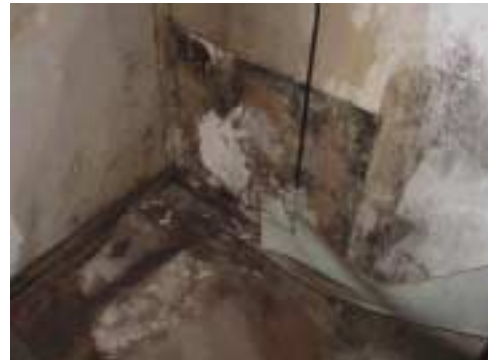
The wiring at the NW room is unsafe = Abort. The photo shows the dangling outlet box. There is a heavy moisture content in the room and severe deterioration to the ceiling, walls and wood type floor.

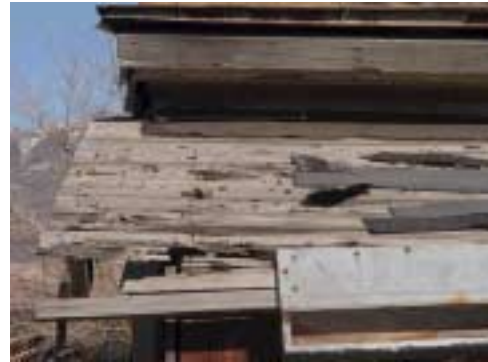
Here is a photo of the NW portion of the shed roof.

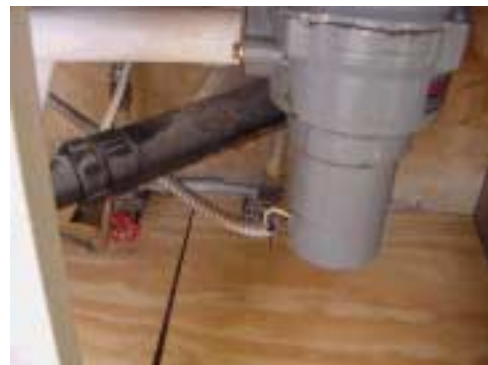
- DISHWASHER:** Did Not Test. The upper cabinet securing screws are not installed = Potential Hazard = This improperly allows for movement of the unit and possible tumbling if a child climbs on the opened door.
- DISPOSAL INSTALLATION:** The disposal electrical hook-up is inadequate or amateur in quality = Recommend upgrading to an approved disposal electrical hook-up. The sink drain also flows uphill with this disposal installation and it is recommended that repairs be made.

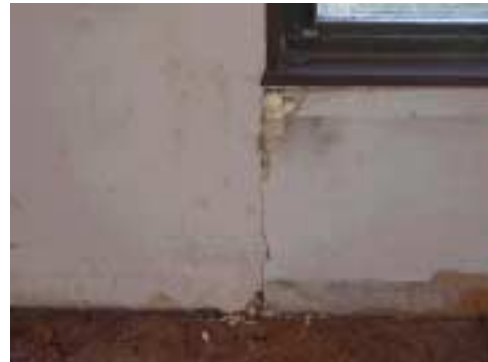
WALL FINISH: There are large cracks below each corner of the large window = Repair.

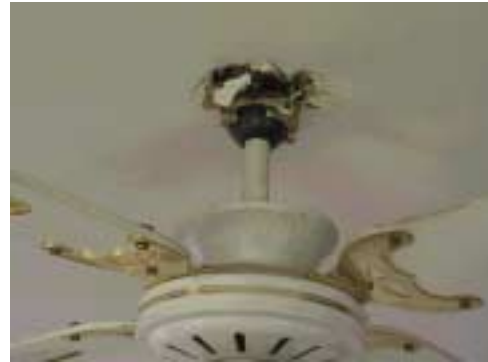
The fan light did not respond to the switch. The wiring splices are not inside a junction box = Repair/replace.

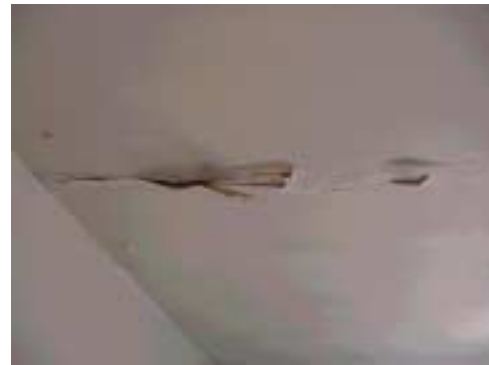
LOCATION: Main Floor, Northwest.
CONDITION: The components of this bedroom are both Durable and Serviceable with the exception of the following item(s) listed below.
SMOKE DETECTOR: None.
WALL FINISH: There is a 36" leak damage area on the western ceiling.

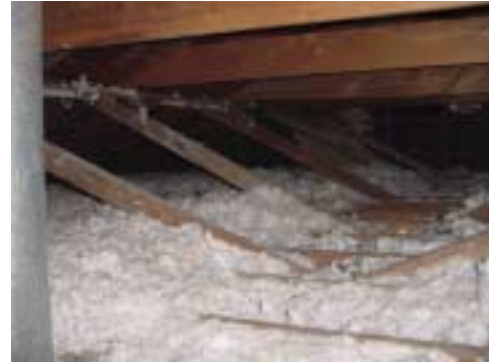
STRONG BACKS: Yes.
VAULTED CEILING: None.
CEILING JOIST SAGGING: No.
ROOF SHEATHING: Solid 1" sheathing.
ATTIC FLOOR: None.
ATTIC VENTILATION: Adequate.
ATTIC INSULATION: Type: Blown-in Fiberglass. Total Thickness: 10"-12".

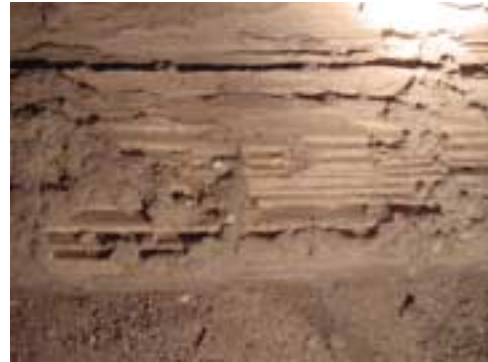
NOTE: I did observe some termite infestation on the scrap wood laying directly on the earth of the crawl space. This wood should be removed so that there is no direct to earth contact.

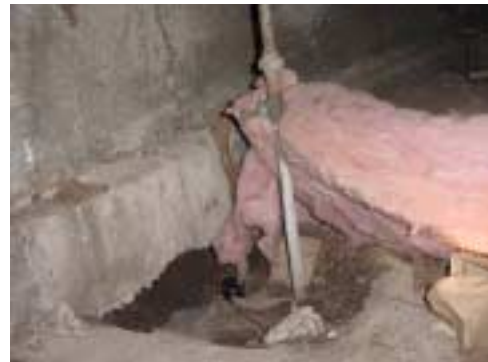
SHUT-OFF LOCATION: The main interior water shut-off location is inside the front foundation wall. The shut off valve is old and has no handle = Recommend adding a working shut off valve and pressure regulator.

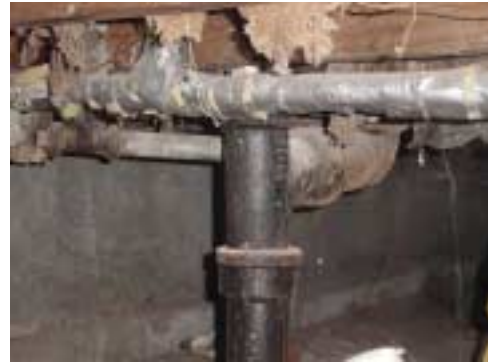
Galvanized & Iron Waste Lines. Note:
Waste lines which are not visible are
not part of these conclusions.

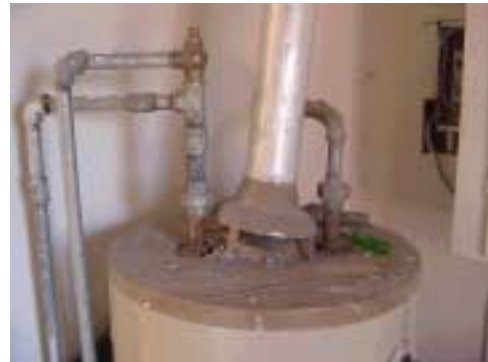
The combustion air is provided by the home's interior. No exterior or attic ventilation air source is provided. The exhaust flue needs upgrading.

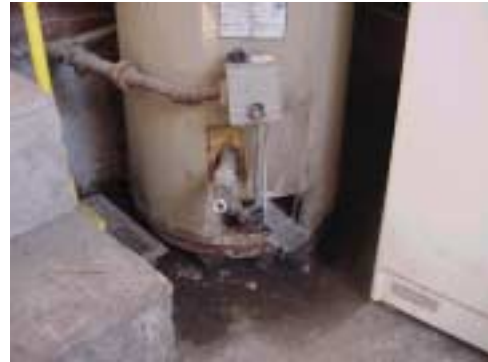
There is evidence of back drafting out of the lower inspection covers in the form of charred surface paint above the covers = This could be a sign of a collapsed exhaust flue within the middle of the unit = Recommend further evaluation/repair by a licensed Heating contractor or Plumber for safety.

RECOMMENDATION: Recommend further evaluation/repair by a licensed Plumber.

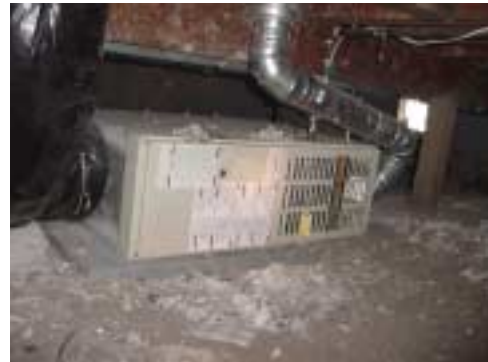
HEATING AREA: Whole house.
VISUAL CONDITION: The heater is the bright spot of the home. It was upgraded in 1995 and cycled as designed during the inspection. There are needed exhaust flue repairs.

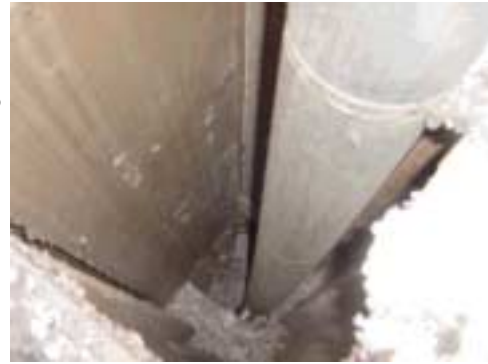
The exhaust flue does not have the recommended firestopping at the crawl space or the attic = Add for safety. The foundation was cut on the north side to ease the installation, but it should be covered with 1/4" mesh and never completely sealed off.

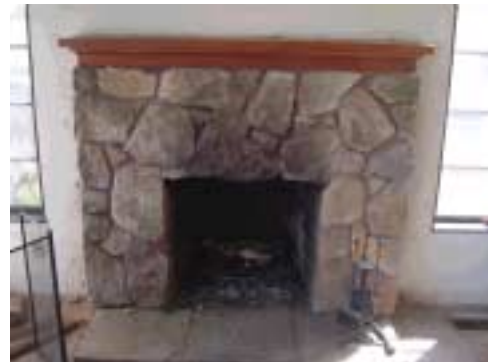
LOCATION: Living Room.
TYPE OF UNIT: Fireplace with damper. Noted evidence of smoke.

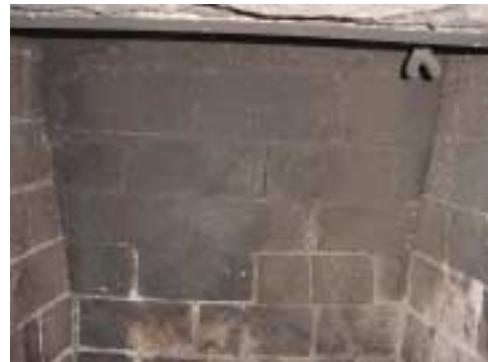
TYPE OF FUEL: The unit is wood burning.
FIREBOX CONDITION: The firebox opening does not conform to the standard 2 to 3 ratio. This means that if the opening was 36" wide the height should not exceed 24" As a result of the odd sized opening the fireplace may allow smoke to enter the room. Evidence of smoke was observed. There is damage to the rear wall firebrick = Recommend repair.

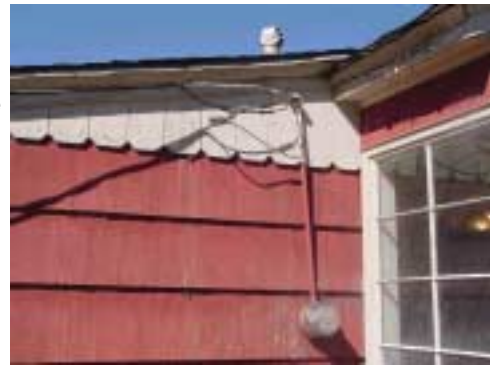
Overhead clearance of the service drop is Poor = Recommend repair. The height clearance of the power drop is only 7 feet off the ground instead of the recommended 10'. There is also no weatherhead and mast on the system = Recommend upgrade and repair.

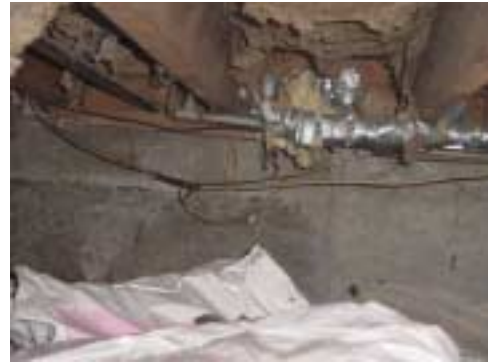
There are splices made without junction boxes in the crawl space.

This system is older and repairs are needed by a licensed Electrician. Consideration should be given to upgrading the panel and the breaker box for safety.
