LEAVITT REPORT

Michael D. Leavitt - Certified Home Inspector

894 South 101 West - Anytown, UT.

CLIENT'S NAME:	Johnny Homebuyer
CLIENT'S E-MAIL:	JHomebuyer@yahoo.com.
DATE OF INSPECTION:	02/29/2001.
TIME OF INSPECTION:	01:00 PM.
INSPECTION #:	22301B.
CLIENT'S AGENT:	Top Producer - Re/Max Central.
AGENT'S E-MAIL:	TP@juno.com.

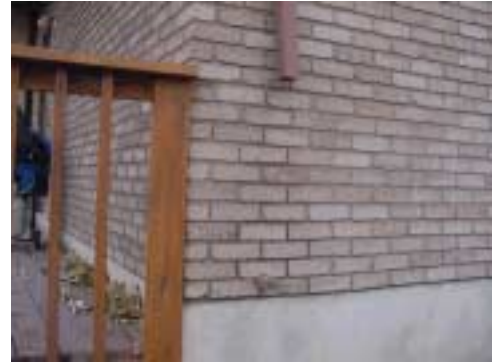
ROOF DRAINAGE: The SW downspout is partially missing = Replace the missing piece.

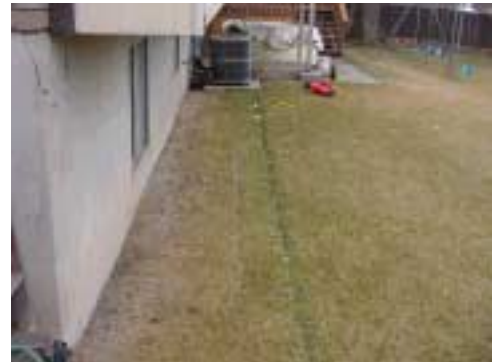
FOUNDATION DRAINAGE: The grade on the front and rear is level at best. The general guideline is for the grading to drop 6" in the first 10' away from the foundation. This promotes water saturation away from the foundation.

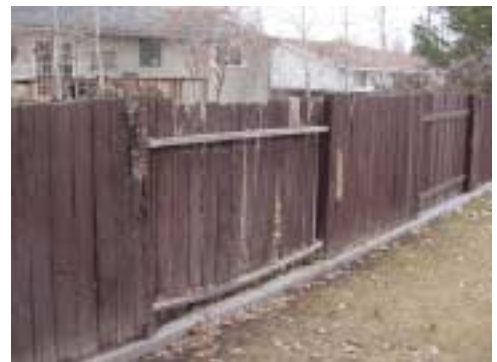
REAR YARD FENCE: The fence has some sections that have been upgraded and some that are nearing the end of their lifespan = Anticipate maintenance repairs.

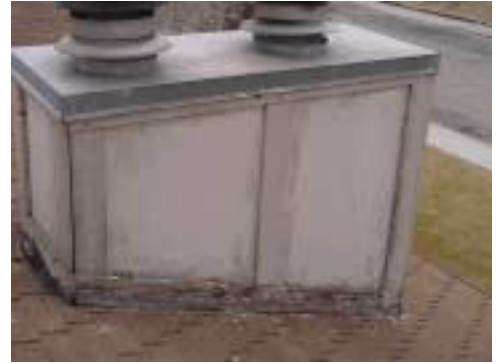
SIDING CONDITION: Some of the siding shows some deterioration due to lack of regular painting maintenance and caulking.

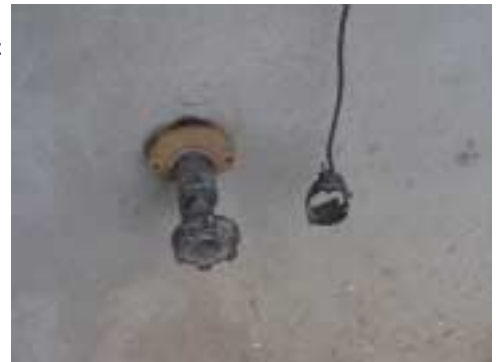
BRICK CONDITION: Good.
MOLDINGS & TRIM CONDITION: Fair.
TRIM PAINT CONDITION: Peeling/flaking.
EAVES/OVERHANGS CONDITION: Good.
WINDOWS CONDITION: Good.
SCREEN CONDITIONS: Did Not Evaluate.
CAULKING CONDITION: Caulking condition is Fair.
WEATHERSTRIPPING CONDITION: General condition is Fair.
HOSE BIBS: Hose bibs were turned on and off again. The rear hose bib has a phone system ground that is designed to be connected to the copper piping, but it has been removed.

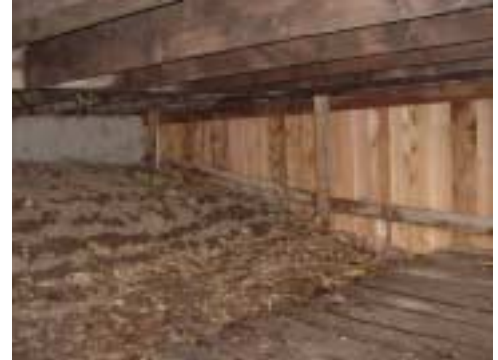
Wood - General condition is Good to Fair. The support post have direct earth to wood contact which will moderately increase their deterioration rate.

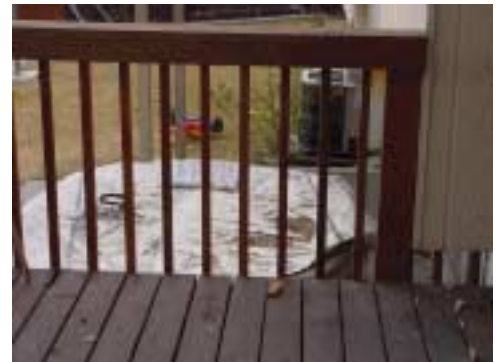
The spacing of the balusters exceeds the recommended modern 4" guidelines = Potential hazard for infants = Consideration should be given to modifying the spacing of the balusters for safety.

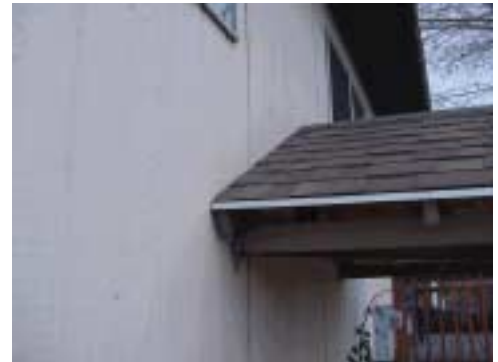
The lower basement entry has an added little roof covering. It has no flashing installed at the house joint and this will promote water deterioration. Water has been entering and the 2x framing is stained as a result. The cover is a great idea = Add sealant or flashing to prevent moisture damage.

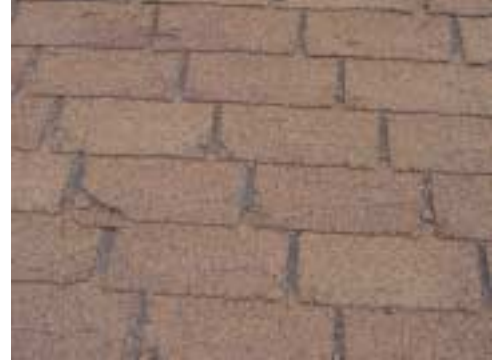
This roof cover has lived a full life and it is now time to replace it to prevent any interior water damage. This roof covering does not meet the general FHA/HUD 2 years of remaining life guideline.

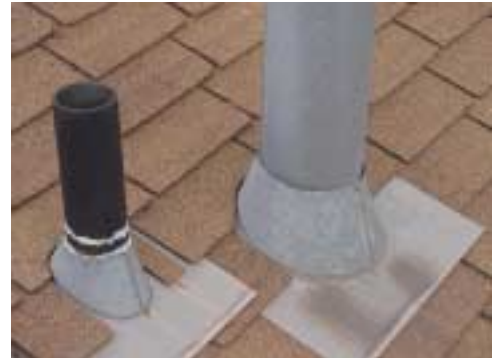
Plumbing vents were noted. The roof jacks are in need of recaulking to prevent water penetration into the attic. This maintenance is normal and should be performed about every 3 to 5 years.

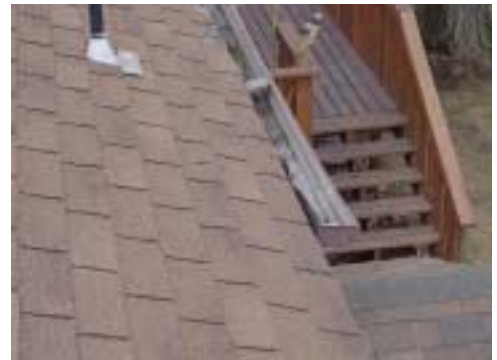
The rear gutter is not securely tucked under the drip edge flashing at the northern end = Repair.

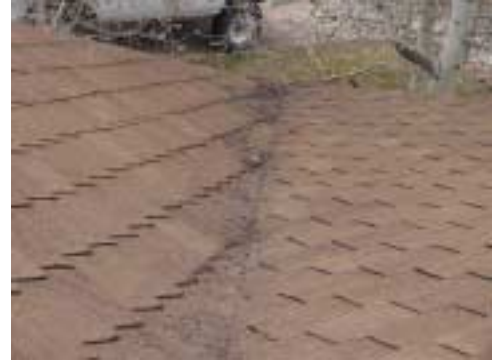
The shingles are old, dried out, missing granules, and the valleys are very deteriorated = Replace the roof to prevent interior moisture damage.

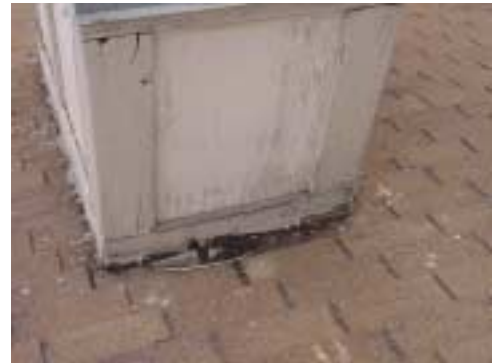
From the attic there is leak evidence from the chimney system. The sided flue chase has not been well maintained = Recommend repair to the chase system.

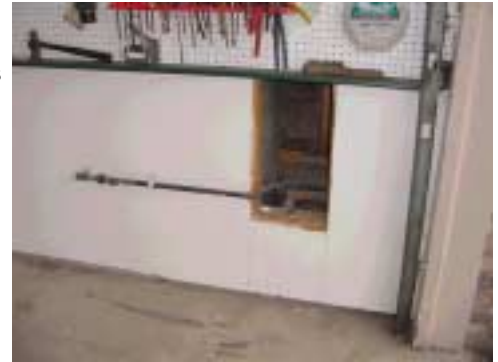
There has been a hole cut in the firewall to run the gas line for the fireplace insert = Repair for safety. The attic access also needs a fire rated cover.

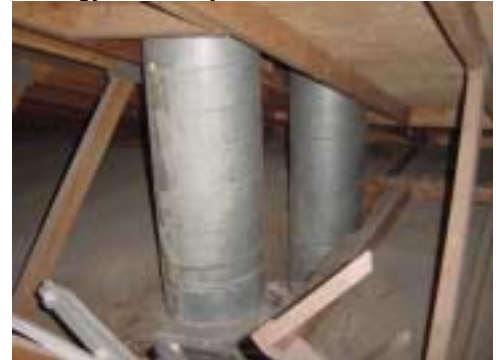
METHOD OF INSPECTION:	Entered inside and inspected all of the accessible areas.
ATTIC ACCESS:	Attic access is located in the hallway. Attic access is also located in the Garage.
STRUCTURE:	Visual condition is Good.
TRUSS SYSTEM:	Yes.
RAFTERS VISIBLY SAGGING:	No.
VAULTED CEILING:	None.
CEILING JOIST SAGGING:	No.
ROOF SHEATHING:	Plywood sheathing.
ATTIC FLOOR:	None.
ATTIC VENTILATION:	Adequate.
ATTIC INSULATION:	Type: Blown-in Cellulose. Total Thickness: 4"-6". Increasing this insulation depth to modern R-38 standards will increase the overall energy efficiency of the home.
LEAK EVIDENCE:	There is moisture entry evidence from the chimney chase system = Recommend repair to prevent interior moisture damage.

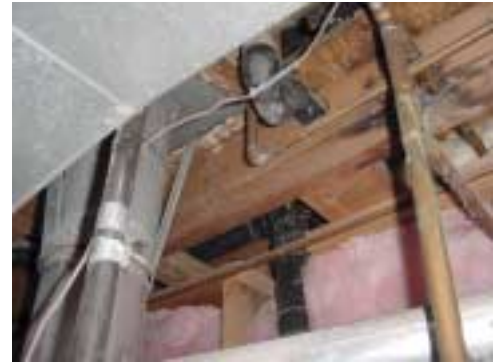
There has been leaks from the main floor plumbing fixtures over the years. I did not observe any current leaking = Monitor in the future and repair as needed.

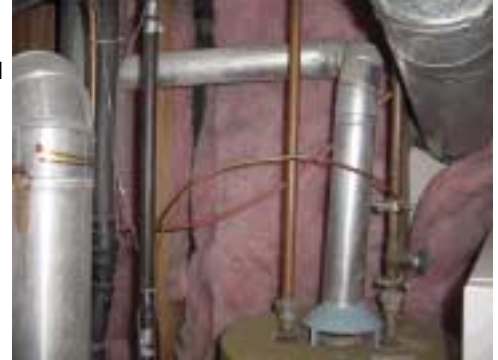
The combustion air is provided by the home's interior. No exterior or attic ventilation air source is provided. Horizontal or negative fall on the exhaust vent line = Hazard = Recommend repair to prevent a backflow of the exhaust gases.

Repairs are needed = Recommend further evaluation/repair by a licensed Plumber.

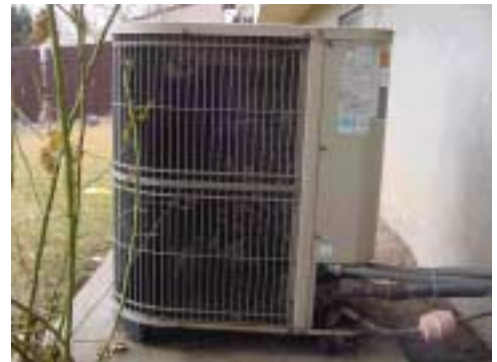
The condenser unit cooling fins are currently dirty. Part of the regular maintenance is to hose off these fins to keep them clean and unobstructed. This will improve the overall efficiency of the unit.
