LEAVITT REPORT

Michael D. Leavitt - Certified Home Inspector

302 East 180 South - Anytown, UT.

CLIENT'S NAME: Harvey Homebuyer
 DATE OF INSPECTION: 2-07-2001.
 TIME OF INSPECTION: 2 PM.
 INSPECTION #: 22701B.
 CLIENT'S AGENT: Top Producer - Prudential

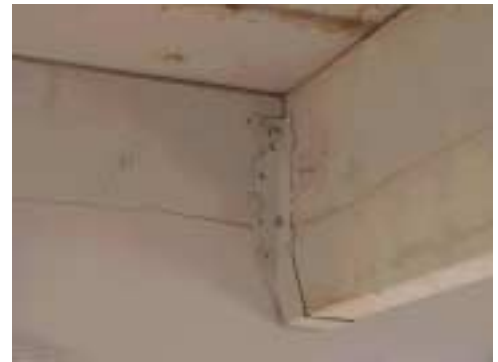
TYPE: The entry deck needs major painting maintenance. The joist hangars are severely under nailed. Along the west side. The east side hangars were not viewable.

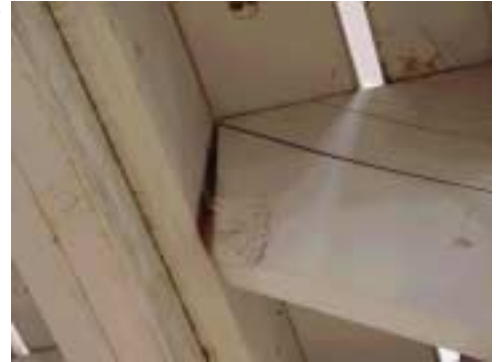
The large stairs are separating from the upper deck = Resecure to prevent collapse.

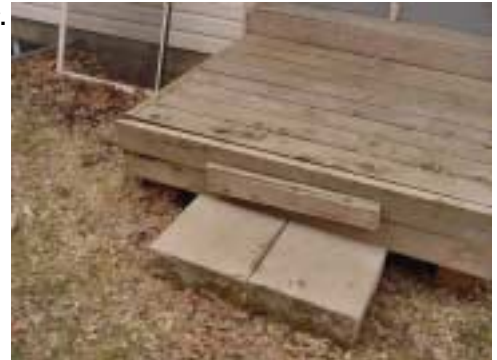
The rear landing is in need of structural repair.

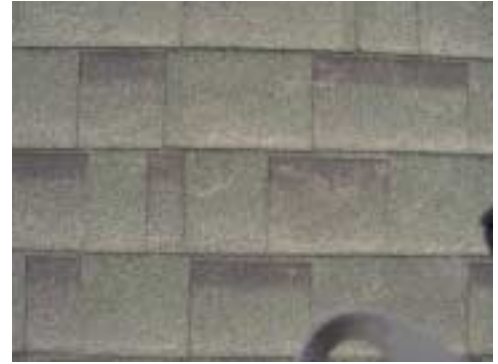
The roof was installed with too large of a reveal. This voids the manufacturer's warranty and decreases the life of the shingle. It is unknown how well this roofing material will now perform.

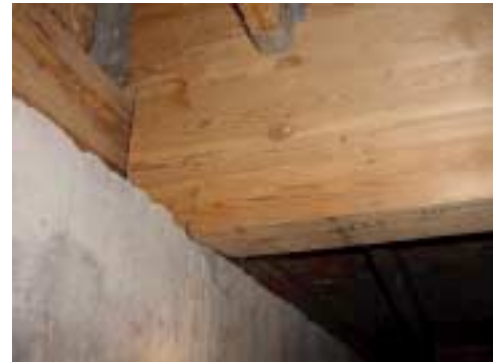
GENERAL CONDITION: The garage needs structural repairs. The large beam is not adequately supported at the north end. Part of the beam is resting on the base plates, part on the foundation and part has no support. The lowest portion of the beam at the northern end has a hairline splitting crack. The addition of a 4x6 support column is recommended.

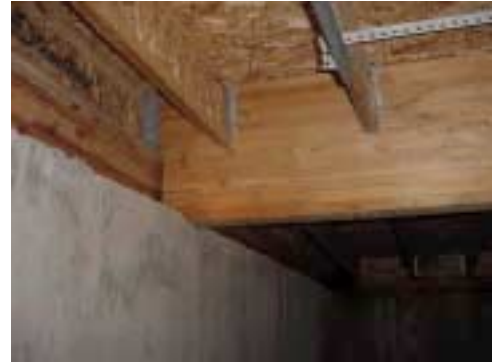
The overhead floor joists for the flat roof deck are severely under nailed. The joist hangars are designed to have a certain sized nail in each exposed hole in the hangar. This is not the case = Recommend repair.

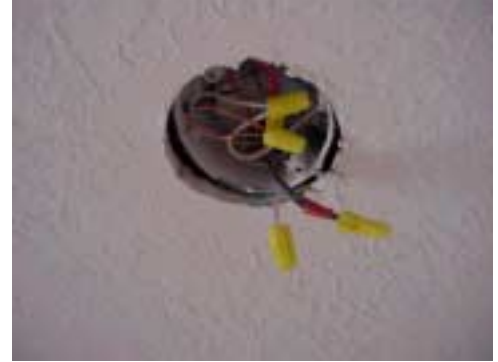
LOCATION: Basement, West, Middle.
CONDITION: The components of this room are both Durable and Serviceable with the exception of the following item(s) listed below.
WALL FINISH: The baseboards, crown and door trims are in poor condition. The window trims are also incomplete. It looks like they were finishing this room off as a kitchenette.
WINDOWS: The finish trim is incomplete.
LIGHTING: Repairs are needed to the wiring. It was interesting to find the unsafe condition of an unprotected traveler wire running through the above ceiling area from fixture to fixture. 1 fixture is dangling and two fixtures are missing. The exhaust fan terminates in the service room instead of to the exterior.

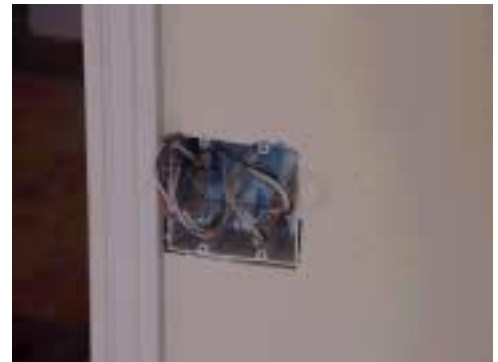
LIGHTING SWITCH: There are open switch boxes on the wall.

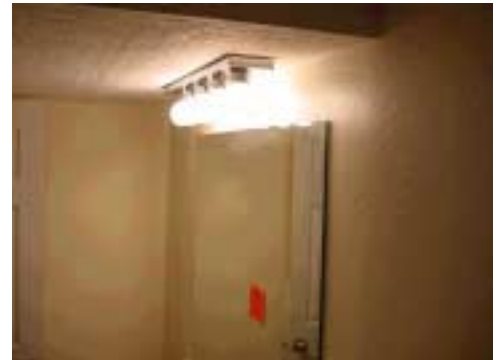
LOCATION: Basement.
WALL FINISH: Paint condition is Intact.
FLOORING: The tile floor is unlevel and the SW corner of the toilet is not supported as a result.
DOOR: General condition is Good.
LIGHTING: The lighting fixture is mounted from the ceiling instead of from the wall.

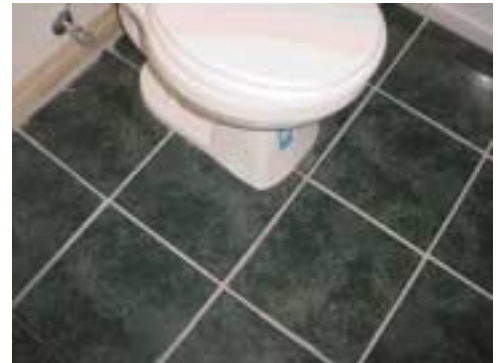
The toilet flushed as designed. The base does not fully rest on the floor.

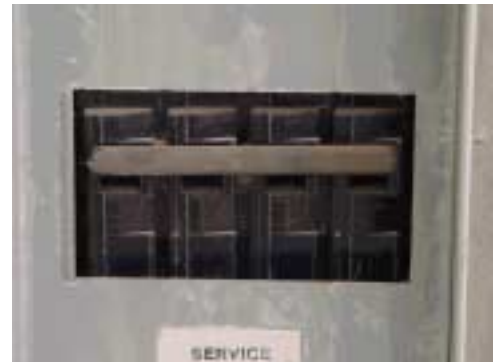
ELECTRICAL SERVICE: Underground System.
SYSTEM TYPE: Circuit Breakers.
MAIN PANEL LOCATION: North exterior.
MAIN DISCONNECT SIZE: 150 amps. The main breaker is not fitting squarely inside the panel = Recommend repositioning by a licensed Electrician.

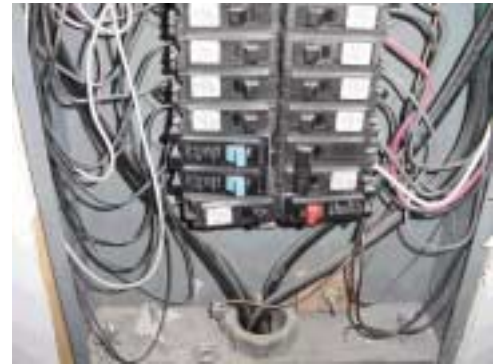
22 - The bottom 4 breakers are not the same breakers as designed for this panel. They do not fit correctly and their installation is a fire hazard = Recommend immediate repair. There is 1 double lugged breaker in the lower right that needs repair. There is one breaker that is shut down. Also inside the panel were two wires that are not currently connected to anything, but were in the past. The Electrician should figure this out as he finishes off the other incomplete things in the basement.
