LEAVITT REPORT

1095 E. Mountain View - Anytown, UT.

CLIENT'S NAME:	Jason & Debbie Homebuyer.
CLIENT'S E-MAIL:	JDHomebuyer@attglobal.net.
DATE OF INSPECTION:	03/07/2001.
TIME OF INSPECTION:	01:00 PM.
INSPECTION #:	30701B.
CLIENT'S AGENT:	Susie Homefinder - Re/Max.

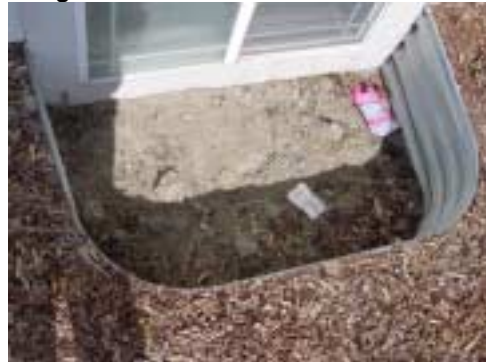
The window wells have not yet been filled with gravel, The typical installation of the window wells includes the removal of 14-18" of earth below the window sill and then filling the well with gravel. This allows water to collect and soak in to the earth without over filling and flooding the basement.

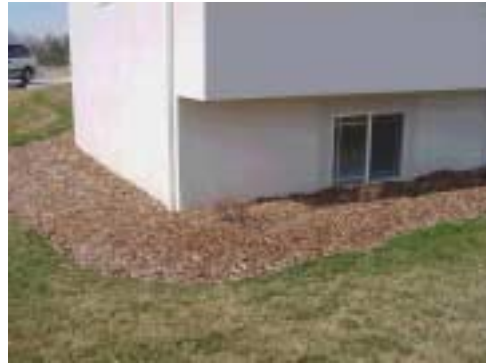
The grading is pretty good except for the SE area where the grading is above the stucco = Clear the earth from the stucco while maintaining the positive grade.

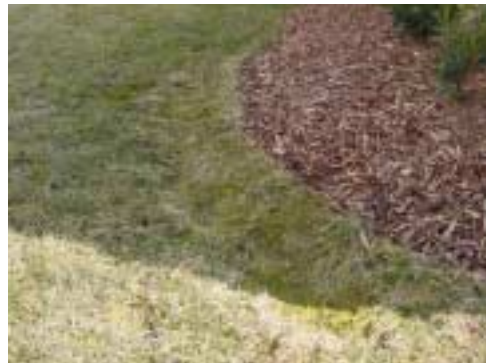
There is moss on the north side of the garage in the grass = This indicates constant moisture = Ask the owners about the condition and possible resolutions.

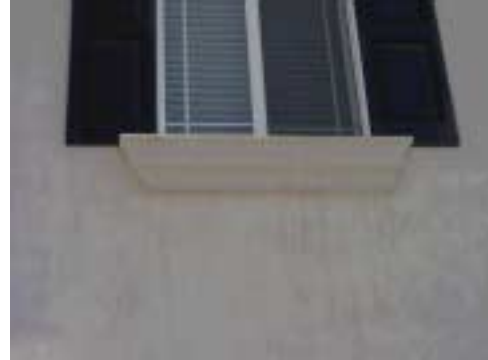
PAINT/STAIN CONDITION: Good.
STUCCO CONDITION: The stucco used on the home is a traditional portland cement based stucco and not the modern synthetic EIFS type stucco. There are drip stains off the 2 west side window ledges. There is a small ding on the lower edge of the SW window box.

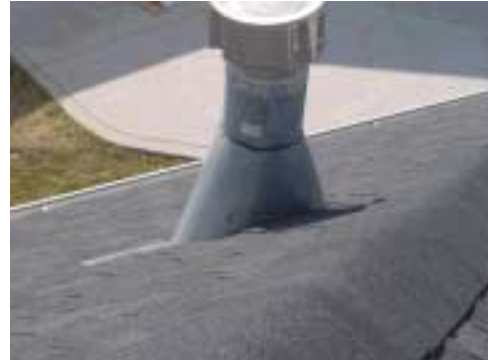
ROOFING CONDITION:	Good.
RIDGES:	Good.
INSPECTION METHOD:	Walked upon the rooftop.
ROOF PITCH (slope):	10:12.
ROOFING LAYERS:	One.
ESTIMATED AGE:	This appears to be the original roof covering.
DESIGNED LIFESPAN:	The statistical life average of this roofing product is 15-18 years.
ROOFING MATERIAL:	Composition Shingles.
ROOF PENETRATIONS:	Plumbing vents were noted. The exhaust flue(s) are in need of recaulking to prevent water penetration into the attic. This maintenance is normal and should be performed about every 3 years.

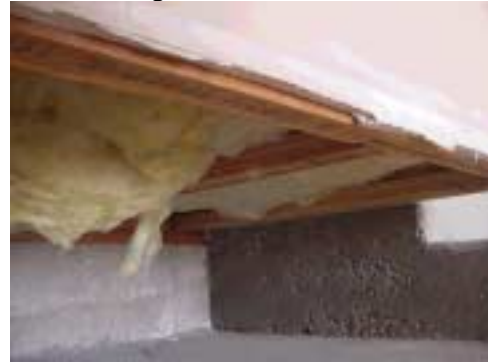
GENERAL CONDITION: Good.
TYPE: Two car.
LOCATION: Attached.
ROOF CONDITION: Same as house - Refer to ROOFING section.
FLOOR CONDITION: Concrete: General condition is Good. Normal settling cracks were noted.
FIRE WALL CONDITION: The under side of each east wall bump out is open stud cavities with insulation batts. To satisfy current firewall guidelines, these areas also need fire rated drywall, mud, and taping.

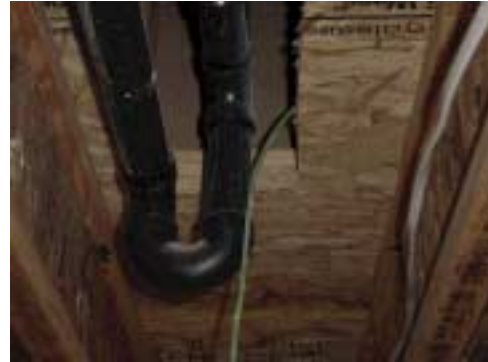
Exhaust fan is operational.
There are a separate tub and shower stall installed. There is a jetted tub installed. There have been many reports of unhealthy germ growth in the jets, pump, and lines. I was unable to test for this. It is recommended that you contact a jetted tub manufacturer for guidance on cleaning and maintaining the jetted tub system. There is no access panel or door provided to the tub plumbing and spa motor. I was unable to verify if there is the recommended bonding installed

for the jetted tub = Potential Hazard = Recommend verification by a licensed Electrician. By the looks of the dangling green wire in the basement the bonding connection was never completed.

110/120V BREAKERS: 21.
 220/240V BREAKERS: 2
 PANEL CONDITIONS: The panel is very neat and organized.
 SYSTEM TYPE & VOLTAGE: 3 Wire System using both 110/220 volts.
 WIRING TYPE: Romex.
 MAIN 110V BRANCH WIRING: Copper Branch Wiring - While viewing the 110 volt branch wiring inside the panel(s) there was NO evidence of any 110 volt aluminum branch wiring. Only copper 110 volt branch wiring was observed.
 MAIN 220/240V BRANCH WIRING: Copper and Aluminum was found = Normal.
 HOUSE GROUND CONNECTION: Water Pipe.
 GFI OUTLETS: Yes - This home is equipped with the recommended GFCI protection.
 OUTLET TESTING: All of the accessible open outlets were tested.
 VISIBLE WIRING HAZARDS: The jetted tub bonding wire should be completed.

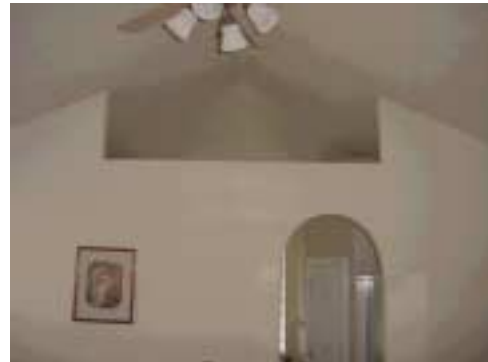
General condition is Good.
The bathing area is opened to the bedroom.

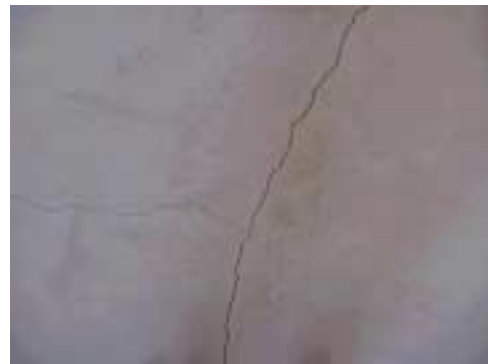
BASEMENT: Unfinished condition.
 SLAB CONDITION: Settling cracks were seen = Monitor for any further movement and fill as needed before covering with floor coverings..

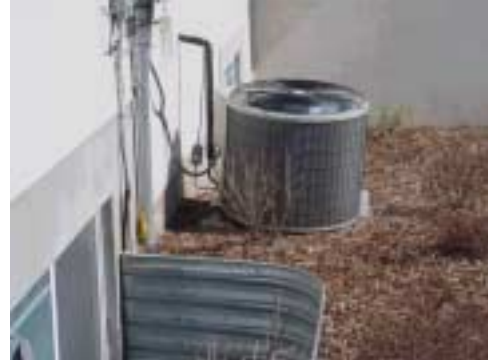
DID NOT TEST: We are unable to evaluate the working condition of A/C units when the ambient air temperature is below 65 degrees.
LOCATION: South.
CONDENSER UNIT: The compressor unit sits unlevel. It is recommended that the unit be re-leveled to help prolong the units lifespan. The unit is hanging on the copper lines.
