LISTING INSPECTION REPORT

892 East 350 South - Kamas, UT

CLIENT'S NAME:	Ray & Patricia Dufour
DATE OF INSPECTION:	03/18/2024
START TIME:	9:00 AM
INSPECTION #:	31824A
INSPECTOR:	Michael D. Leavitt - Certified Inspector
CLIENT'S AGENT:	Drew Armstrong & Matthew Flinders - Armstrong Flinders & Associates

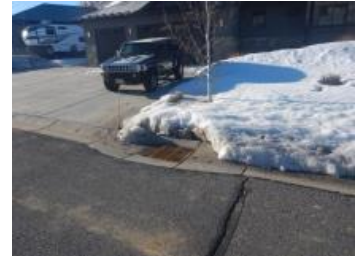
DRIVEWAY:

The driveway is in overall good condition. There is some surface spalling in the parking areas. This is typically due to road salts falling off of cars after driving in winter conditions.

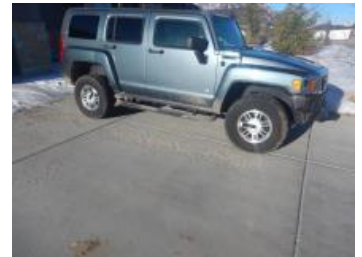
DRIVEWAY HEATING:

Some radiant lines were initially installed in the parking strip areas, but the lines leak at an unknown location and the boiler station for the driveway has been shut down. Check with a boiler specialist if you desire a heated driveway. In its current state, the leak would have to be found and cut into the concrete to repair. My recommendation would be to also add a small separate boiler in the garage that would be dedicated to the exterior driveway only.

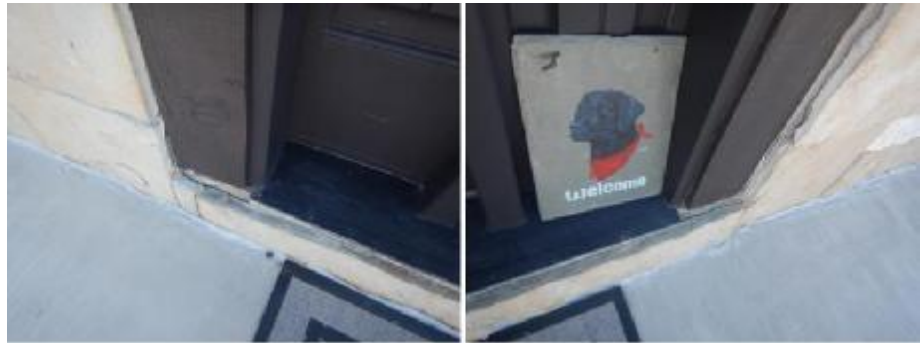
GAP:

The gap along the lower entry needs fresh caulking.

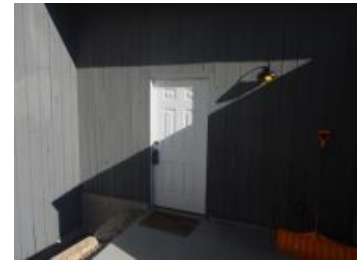
DOOR WATER:

There are some signs of water entry through the exterior rear garage door. Keep the threshold well caulked and the weatherstrippings and lower door seal refreshed as needed.

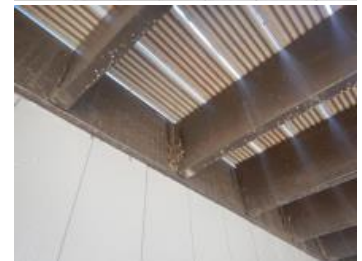
Some of the air nail gun nails did not fully seat.

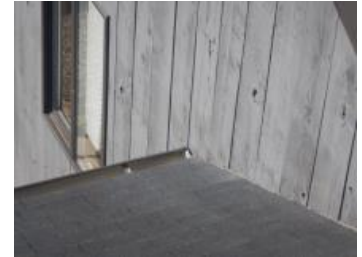
I did not find a kickout flashing at this rear garage roof to wall connection, but I viewed no ill effects or leaking.

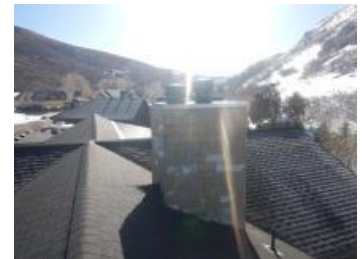
The stone clad chimney currently needs stone repair.

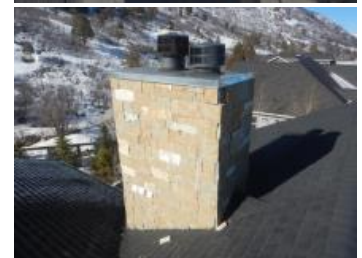
Yes. There are three stones that need to be reinstalled. There is one missing on the east, north, and another on the west side. All three stones are laying on the roof.

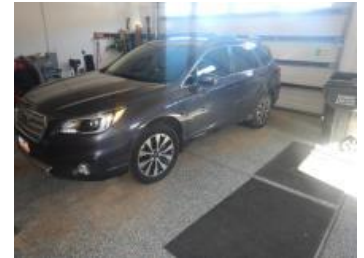
Concrete: Good. The added floor covering is worn in the primary parking area.

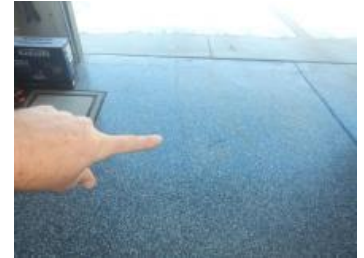
I viewed on long north to south slab crack = Monitor.

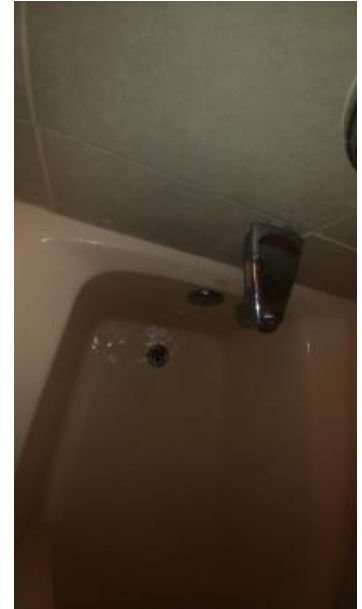
The addition of caulking sealant should be added to the surround/tub spout joint to prevent water penetration. There is no permanent drain stop installed.

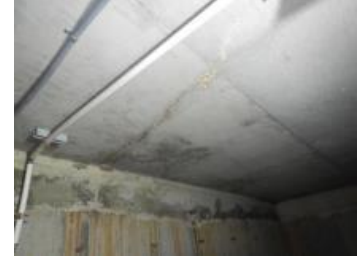
On my first visit I identified ceiling cracking and water entry signs. Since that time, the front porch was recapped and the side walls sealed. I found no fresh water entry signs during my visit.

I have recommended that the owner provide the work invoice so that if there are future issues, then you know who to contact.

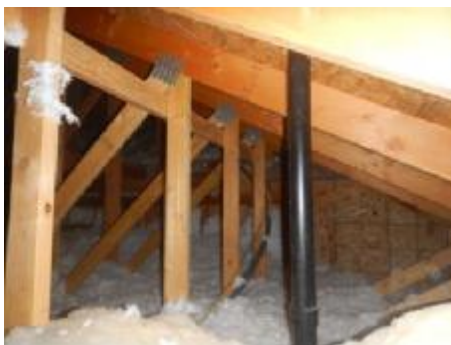
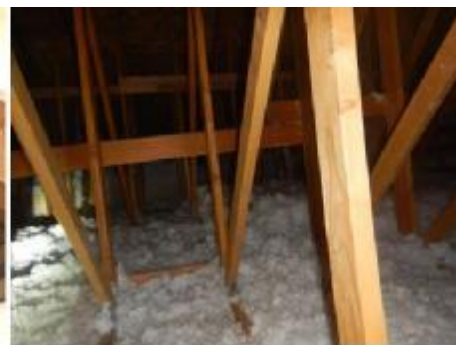
This insulation has been heavily trodden through = Consider adding a fresh topical blown-in layer over the existing insulation.

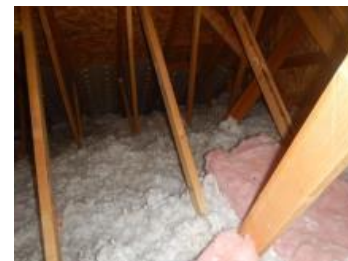
This insulation has also been trodden through = Consider adding a fresh topical blown-in layer over the existing insulation.

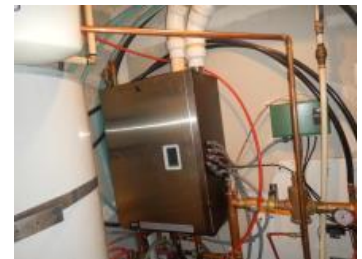
SYSTEM CONDITION: This home is heated by an on-demand boiler system with 4 separate zone pumps.

BASEMENT: I only found two of the bathrooms with active heating. The rest of the basement did not respond to the thermostat.

DRIVEWAY: This zone is shut down due to reported leaks in the heating piping. The exact location is unknown.

REPAIR: **REPAIRS ARE NEEDED** = I recommend that a boiler specialist be called upon to evaluate and repair this partially working system.

Have this system professionally serviced and repaired as needed.

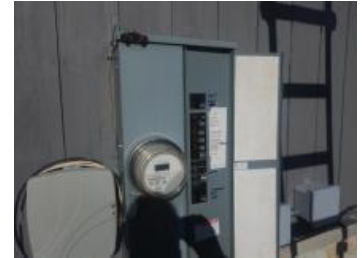
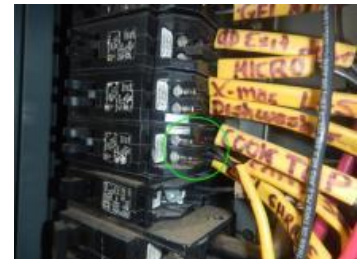
REPAIRS ARE NEEDED = The installer for the added electric heat strips ran out of room because he needed two 220 volt breakers that required four slots. His solution was to double up two of the 110 volt circuits to free up some breaker room. This ends up with unsafe double lugging on the breakers. The breakers are designed for securing one wire only. **SOLUTION** - If the two wires feed circuits that both won't overload the breaker, then you can twist them together with a third wire pigtail and then run the pigtail to the breaker. However, if the loads are too much for the single breaker, then another solution will need to be devised. They may be able to trade out the single breakers for double slim pancake breakers. There are options, but this one they chose is currently not deemed safe. I recommend that the installer be called upon to right their wrong. This repair work should be done by a licensed electrician familiar with calculating circuit loads.
