4-PLEX INSPECTION REPORT

222, 224, 226, & 228 North 250 East - Orem, UT

CLIENT'S NAME:	Eduardo Silva
DATE OF INSPECTION:	05/08/2024
START TIME:	9:00 AM
INSPECTION #:	50824A
INSPECTOR:	Michael D. Leavitt - Master Inspector
CLIENT'S AGENT:	Kim Brown - Bill Brown Realty, Inc

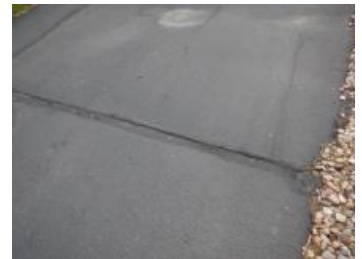
The asphalt has cracked and been filled and re-coated.

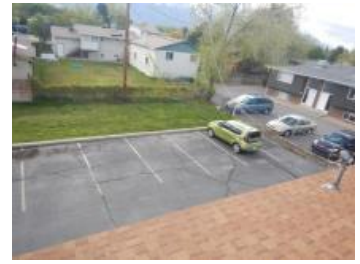
The parking spaces are marked. The paint is worn but obvious.

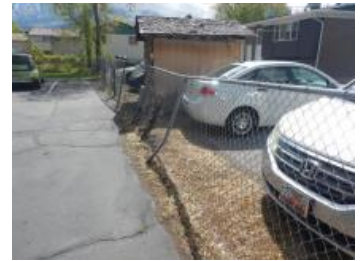
Your SE corner and the fence has been damaged by large moving trucks trying to navigate your smaller driveway.

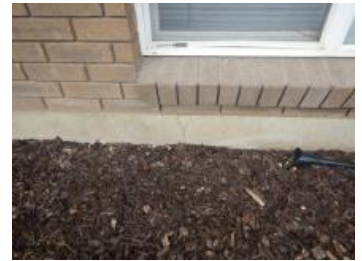
Hairline curing cracks were observed = Monitor for movement and repair as needed. I found no major signs of shifting and/or movement.

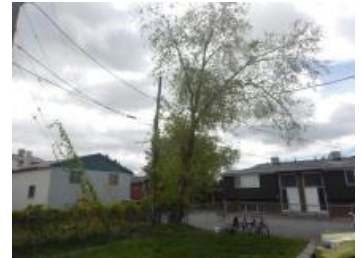
The large SE corner tree is old and offers no benefits to this building. Falling branches will damage neighboring parked cars.

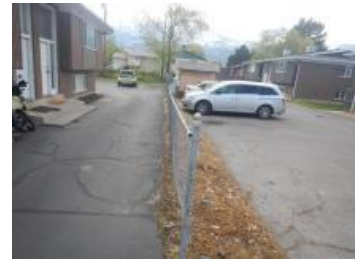
The south fence has been damaged from vehicle impacts.

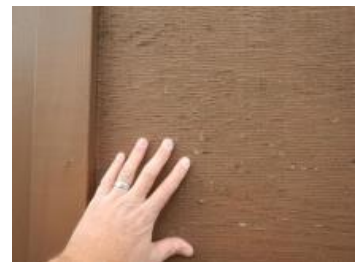
The paint is peeling/flaking.

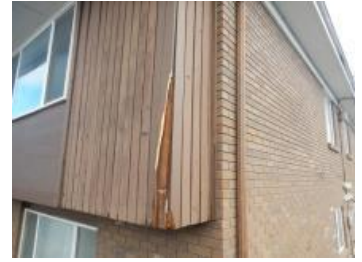
These are installed directly over the plywood. The SE corner has slat damage from vehicle impact.

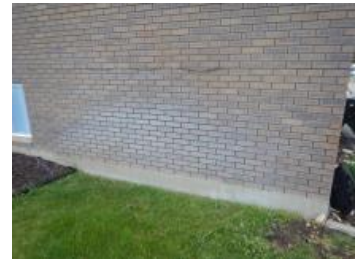
The brick shows no major cracking and/or settlement. The white is from sprinkler overspray.

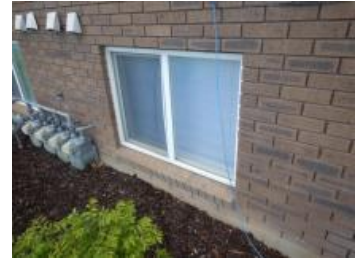
There are hard water spots from sprinkler overspray.

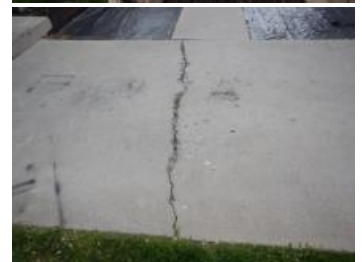
The concrete has cracked and settled.

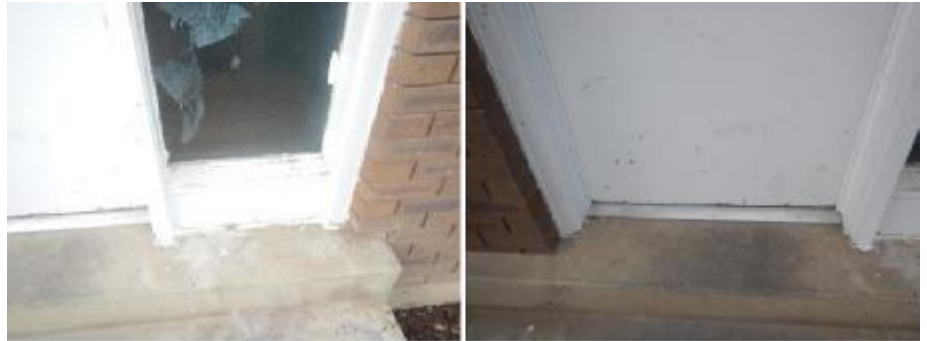
The paint is peeling/flaking. There has been water damage around the single paned windows due to poor caulking maintenance over the years.

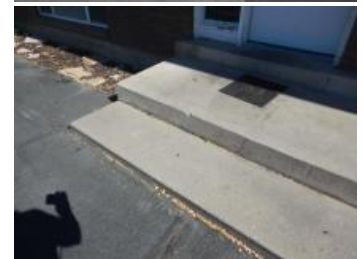
The stairs are different heights and a tripping hazard.

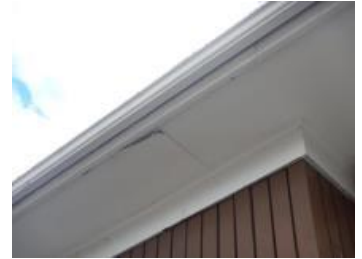
The plywood is sagging = Resecure.

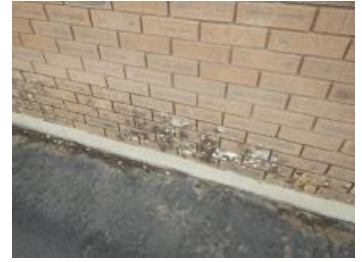
I recommend upgrading the older and leaking gutters. Currently they only cover three sides of the building, yet all four sides would be better. The lower brick on the east parking lot side has moss growth from the roof runoff splash.

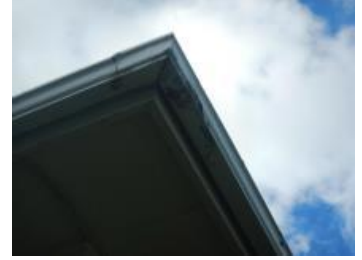
The old gutters leak at the joints.

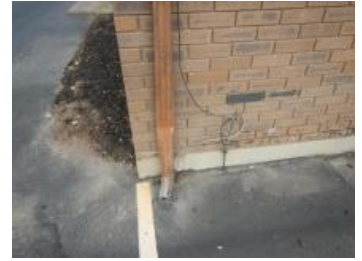
The SE downspout is bent from impact and discharges directly onto the parking area.

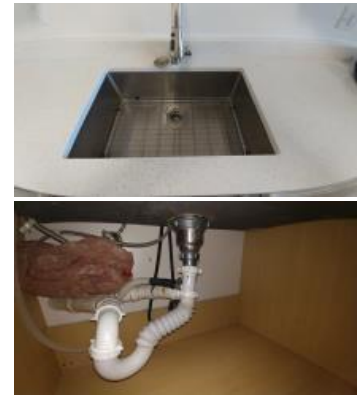
DRAIN CONDITION: They have used an accordion style drain that is prone to clogging since it is not smooth walled.

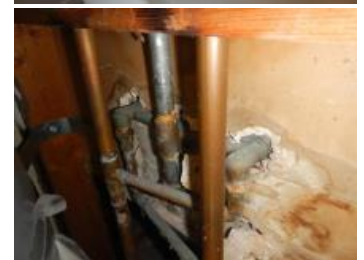
You can see the backside of the water control valve wall from the service room and see the amount of prior leakage.

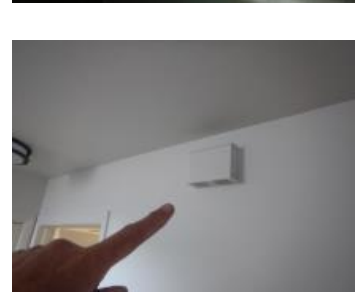
The doorbell chime is faulty in this unit = Replace.

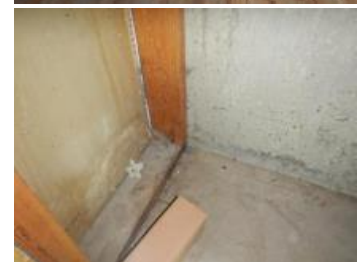
There are signs of prior flooding.

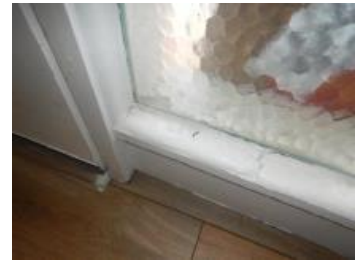
The windows by the front door show water entry damage from long term deferred exterior caulking maintenance.

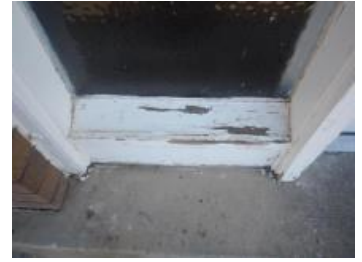
The exterior porch trim paint is in poor condition.

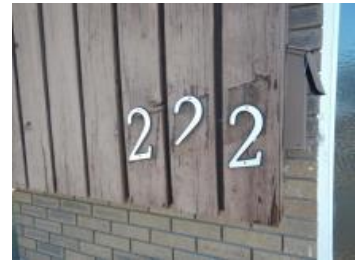
The numbers are damaged.

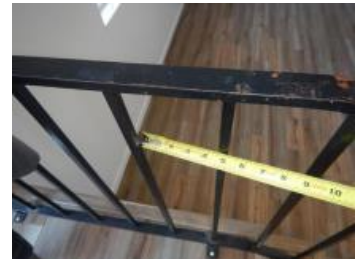
The spacing of the balusters exceeds 4" which may present a hazard to infants.

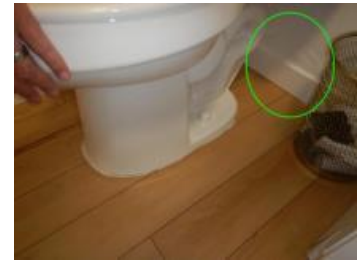
There is water damage on the wall in behind the toilet.

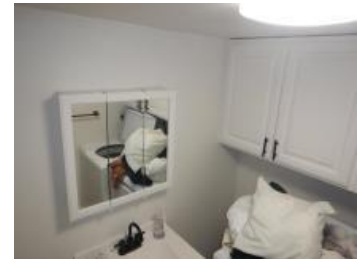
There is no over sink lighting installed.

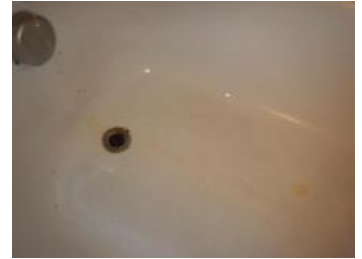
The finish is scarred and marred.

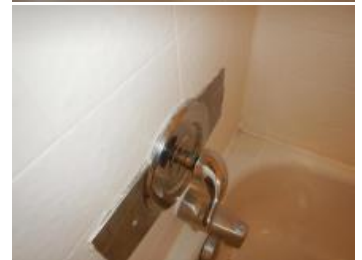
The chrome valve cover is missing and the brass is exposed. This single valve was retrofitted in place of the prior three valve setup.

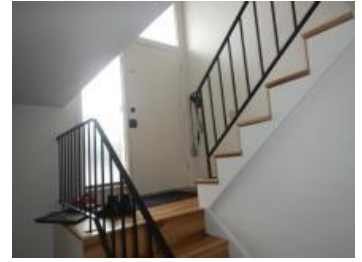
The railing is secure. The spacing of the balusters exceeds the recommended 4" and can be a hazard for infants.

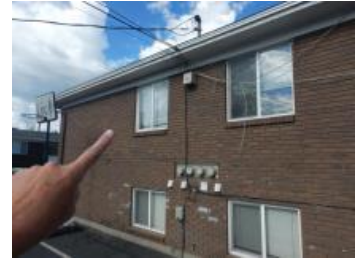
Window screen is not installed (x1).

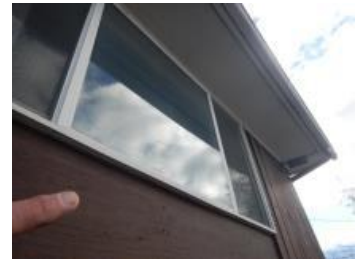
The window pane has lost its dual pane thermo-seal (x1).

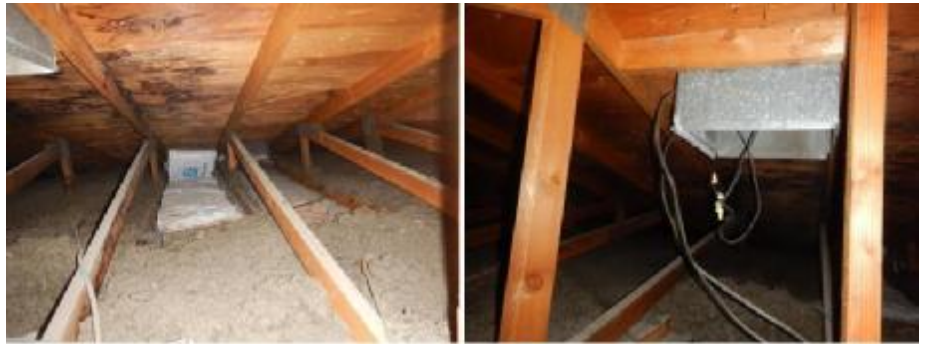
They aborted the ducts. You can see prior staining and the aborted electrical wiring that is still live.

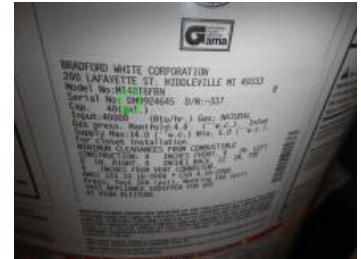
BRADFORD WHITE AGE: Bradford White..... 2007.

LIFESPAN: According to the industry experts, the average water heater life in the U.S. is 8 to 12 years. This unit is still heating water beyond it's projected lifespan. There is no way to tell if the unit will heat for another day, month or decade. When a unit fails it will usually either stop heating, or it will leak water. Funds should be set aside and consideration should be given to upgrading the unit before tank failure occurs and flooding damage results. The condition of the sacrificial anode rod inside the tank is beyond the scope of this evaluation. Replacement of this rod on older units by a licensed Plumber can prolong the overall life of the unit.

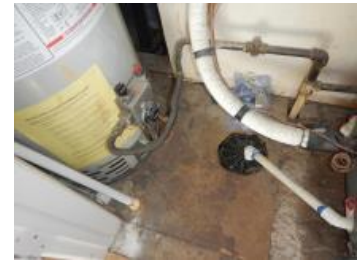
The gas hook-up is equipped with a shut-off valve that requires a wrench to operate. Modern seismic standards recommend the use of a hand shut-off type gas control valve = Consider the upgrade. A flexible gas appliance connector is installed. **POTENTIAL HAZARD** - The flexible appliance connector was not upgraded when the new appliance was installed. The manufacturers prohibit the re-use of flexible appliance connectors due to the risk of cracks, leaks, fires, and explosions.

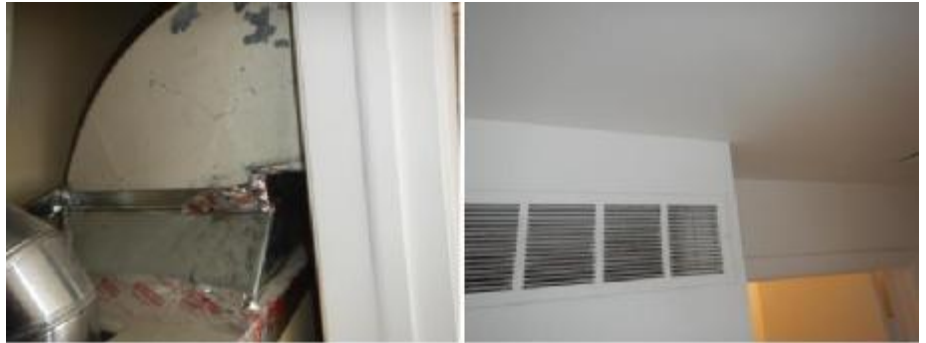
There is no filter installed on this system.

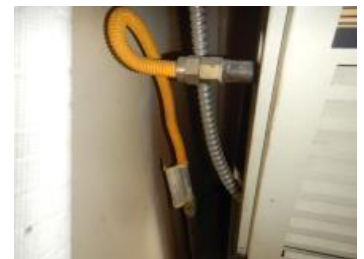
The gas hook-up is equipped with a shut-off valve that requires a wrench to operate. Modern building standards recommend the use of a hand shut-off type gas control valve = Consider the upgrade. A flexible gas line is installed.

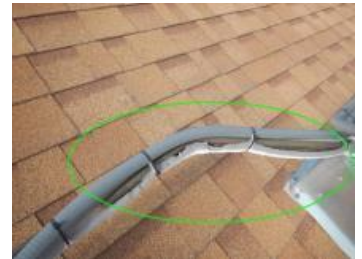
Part of the insulation is missing near the exterior condenser unit and again at the interior evaporator unit = Add the missing insulation to improve efficiency.

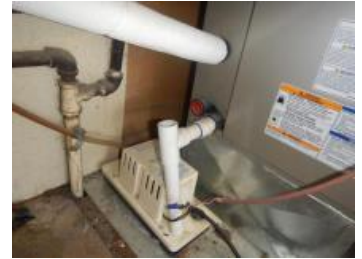
The unit located on second floor does not have the recommended overflow drip pan. This pan protects the home from any condensate leaking or overflowing = Consider either adding the recommended overflow pan and drain line or the A/C emergency condensate cut-off switch. There is a mini-sump for condensate, but this does not prevent any possible leak damages from the AC condensate.

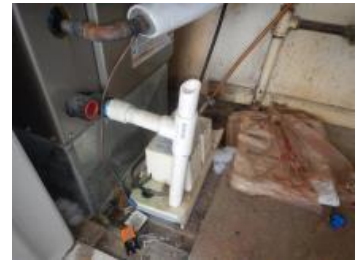
There is a mini sump to transport the condensate. The unit located on second floor does not have the recommended overflow drip pan. This pan protects the home from any condensate leaking or overflowing = Consider either adding the recommended overflow pan and drain line or the A/C emergency condensate cut-off switch.

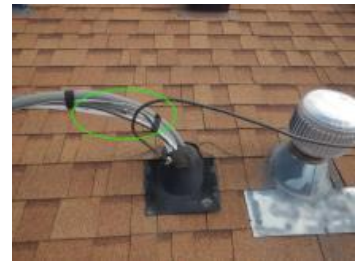
SW Unit #222.
Part of the insulation is missing near the exterior condenser unit and again at the interior evaporator unit = Add the missing insulation to improve efficiency. There is wood subfloor damage from condensation drip.

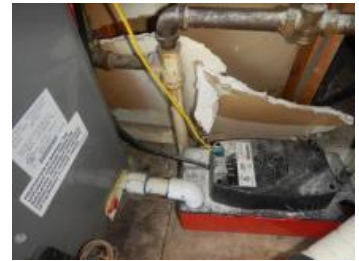
The unit located on second floor does not have the recommended overflow drip pan. This pan protects the home from any condensate leaking or overflowing = Consider either adding the recommended overflow pan and drain line or the A/C emergency condensate cut-off switch. This has nothing to do with the condensate mini-sump installed to help control the AC condensate.

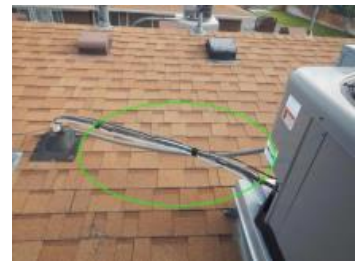
Part of the insulation is missing near the exterior condenser unit and again at the interior evaporator unit = Add the missing insulation to improve efficiency.

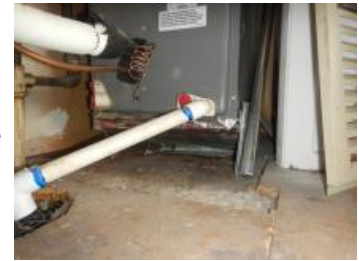
The unit located on second floor does not have the recommended overflow drip pan. This pan protects the home from any condensate leaking or overflowing = Consider either adding the recommended overflow pan and drain line or the A/C emergency condensate cut-off switch.

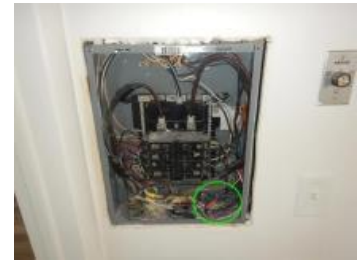
The doorbell transformer is incorrectly installed inside the panel. Low voltage wires are not allowed to be installed inside high voltage panels.

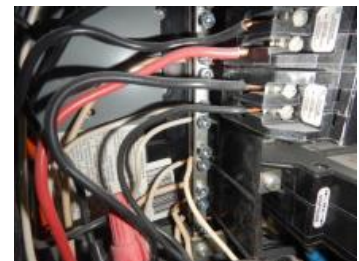
COMBINED NEUTRALS: (x1 lug) Panel manufacturer's recommend that only one neutral wire be secured under each neutral bar lug. This provides extra safety to repair electricians and provides a more secure connection. Consideration should be given to having a licensed electrician reposition the white clad neutral wires so that no more than one neutral is secured under each lug.

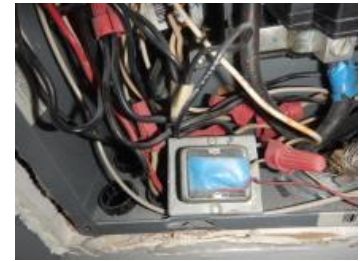
The doorbell transformer is incorrectly installed inside the panel. Low voltage wires are not allowed to be installed inside high voltage panels.
