LEAVITT REPORT

248 West 220 South - Orem, UT.

CLIENT'S NAME:	Tamara Cox.
DATE OF INSPECTION:	06/04/2003.
TIME OF INSPECTION:	01:00 PM.
INSPECTION #:	60403B.
INSPECTOR:	Michael D. Leavitt - Certified Inspector.
CLIENT'S AGENT:	Jerry Loveland - Coldwell Banker West.

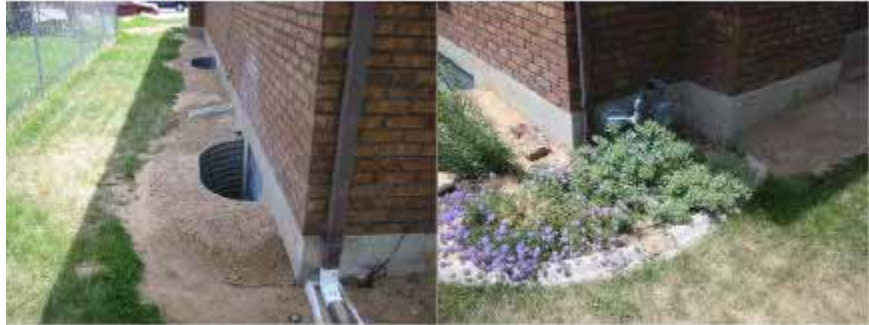
The perimeter grading has just recently been corrected. They have installed a sandy soil around the majority of the foundation. The SE corner still needs corrective action since a downspout discharges into the planter bed and water is trapped near the foundation. The grading should be corrected and a downspout needs to be extended with a drain line.

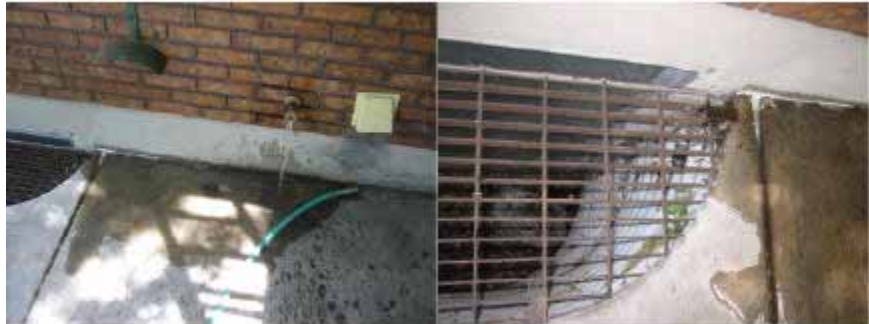
The window well set into the rear patio needs to be re-excavated. The typical installation of the window wells includes the removal of 14-18" of earth below the window sill and then filling the well with gravel. This allows water to collect and soak in to the earth without over filling and flooding the basement.

The slab has settled at this location and when the hose bib was tested the water headed straight for this window well and looks to be one of the main sources of the water damage in the room below. A concrete berm could be added around the window well to help prevent the water flow, but the real long term solution would be to repour the slab with the needed slope to get water to run away from the home.

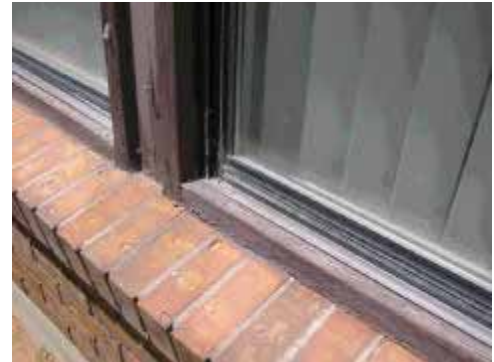
PAINT/STAIN CONDITION: The wood trim needs repainting.

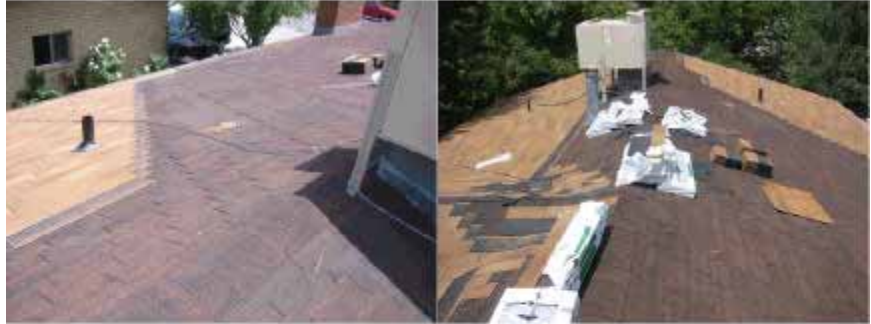
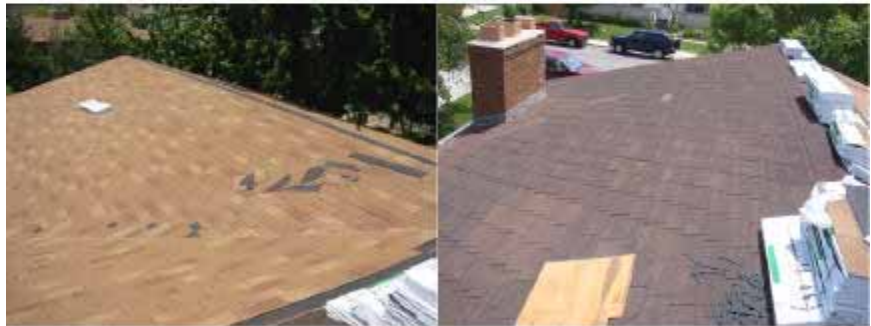
The roof is two thirds complete. The exposed older roof was really deteriorated. The only thing missing with this new installation is increased attic ventilation. The attic was very hot today and you should consider upgrading the attic ventilation. This is usually accomplished with either ridge or roof mounted static vents.

The new ridge cap is not yet installed.

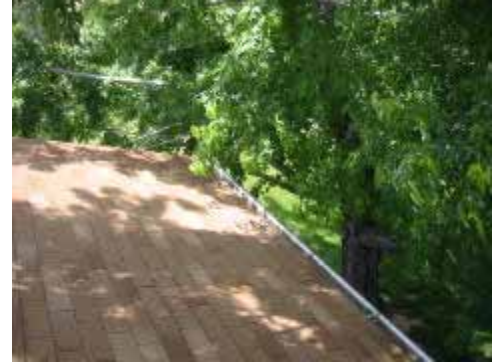
Vegetation overhangs the roof =
 Recommend trimming as needed.

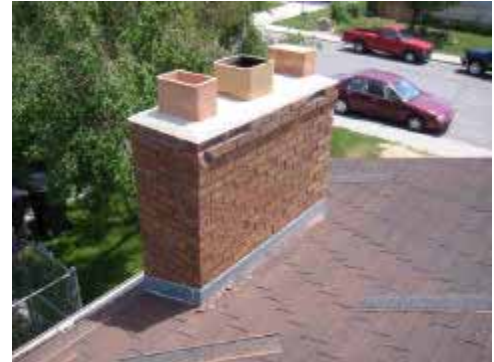
No snow saddles were installed, the
 addition of a snow saddle is
 recommended by the chimney to help
 prevent water penetration.

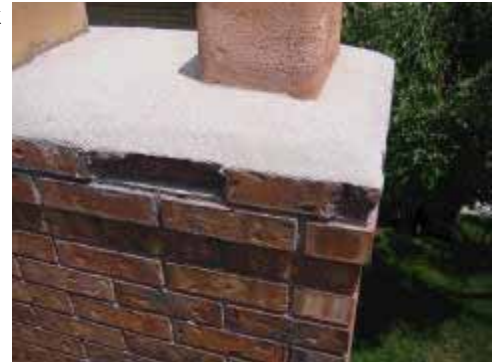
Brick and Mortar. There is some brick
 deterioration on the upper rows.

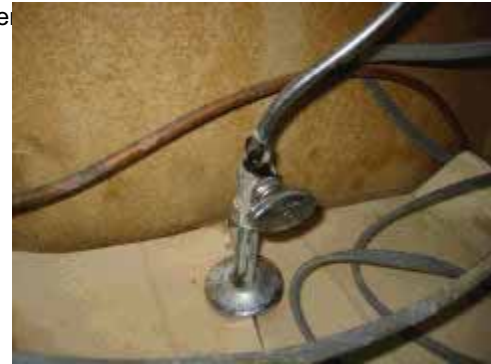
There is a current leak at the cold water shut off valve under the sink = Repair.

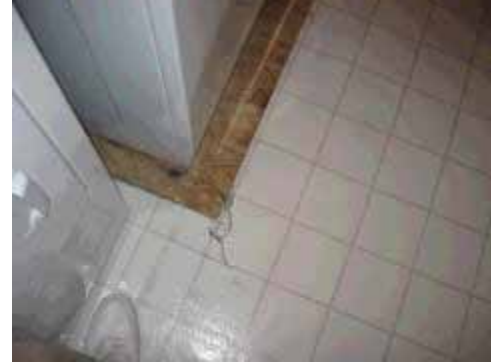
The flooring is damaged under the washer. Currently they have plywood placed down on the vinyl under the unit.

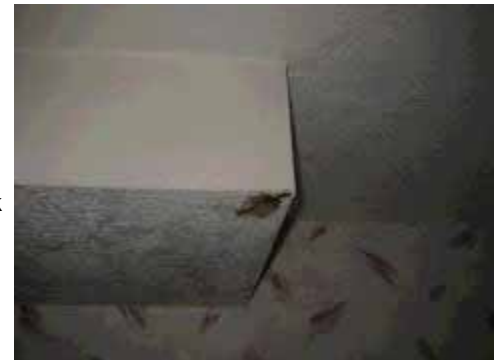
LOCATION:	Basement.
WALL FINISH:	The ceiling shows current water damage from the bathroom above. This is long term damage and the drywall needs to be opened up to identify the full extent of the water damage, rot, and mold. All affected materials should be removed, the leak source repaired, and the finishes restored.

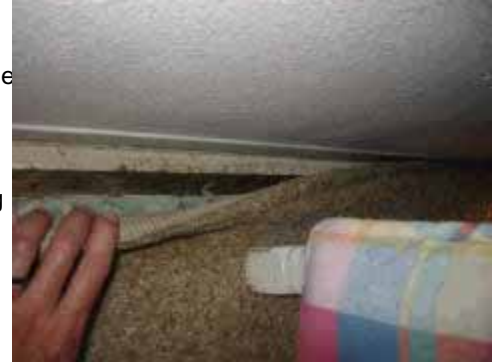
By the signs of the heavily rusted tack strip and the previously pulled up carpet this water entry is a known issue = Ask the seller about the water entry history. The condition inside the wall cavities are unknown and consideration should be given to doing destructive discovery to see if there is mold or rot conditions that need to be resolved = See exterior notes for possible water entry sources.

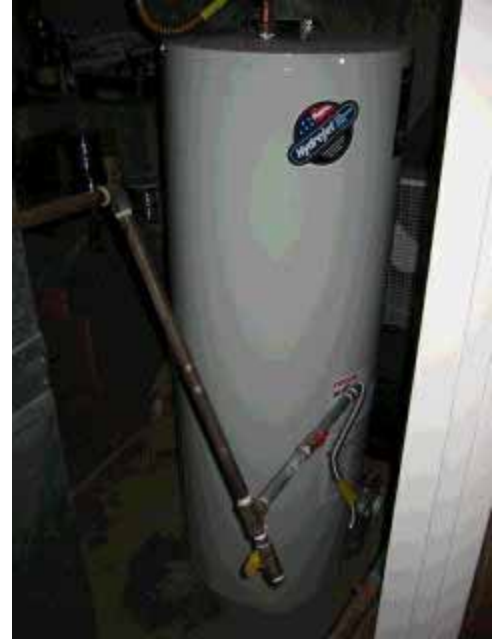
Service area. The access of the burn chamber is now extremely difficult since the wall was added to the laundry room.

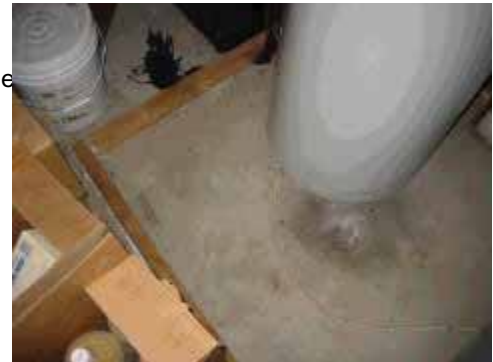
YES. There is a floor drain installed nearby, but it is in the laundry room. The testing of floor drains is beyond the scope of this inspection. They have also created a drain surround with 2x4's and caulking to get any future leaking water to run towards the drain instead of the other rooms.

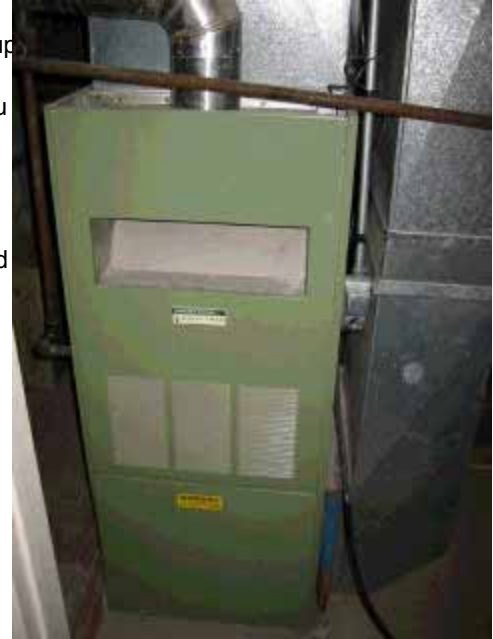
This unit has not been serviced for quite a while. There is a heavy build-up of white encrustations that signifies a poor burn. It is recommended that you have a heating professional further evaluate, tune up, and check the integrity of the combustion chamber. This needs to be done before closing on the home to verify the condition and workability of the unit.

Recommend further evaluation/repair by a licensed Heating Ventilation Air Conditioning technician.

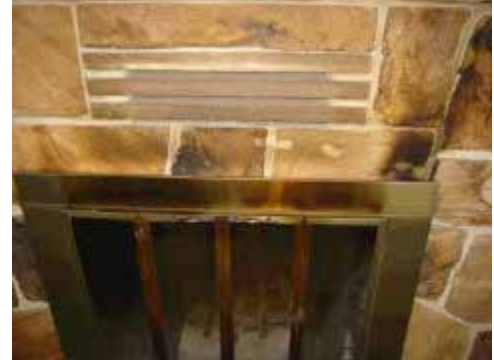
Living Room.
 The unit shows evidence of smoking out the top of the doors and firebox opening = Have a chimney sweep evaluate and correct as needed.
