E.I.F.S. MOISTURE INTRUSION REPORT

1040 N. Elegante Canyon - Somewhere In Utah.

INSPECTION #: EIFS SAMPLE
DATE OF INSPECTION: 06/05/1999
TIME OF INSPECTION: 01:30 PM
CLIENT'S NAME: Mr. Homebuyer

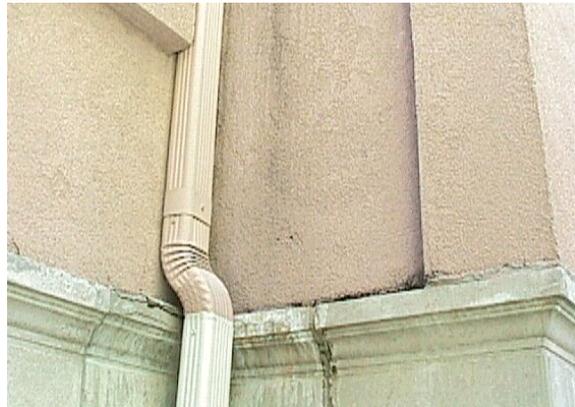
The entire exterior was installed without giving thought as to how any moisture that would get into the walls could effectively get out. You will notice deterioration of the concrete trim blocks at numerous locations. It is presumed that this deterioration at least partially has come from moisture in the walls trying to drain down and get out. The system was not designed with flashing that would allow moisture to run out and over the lower trim blocks.

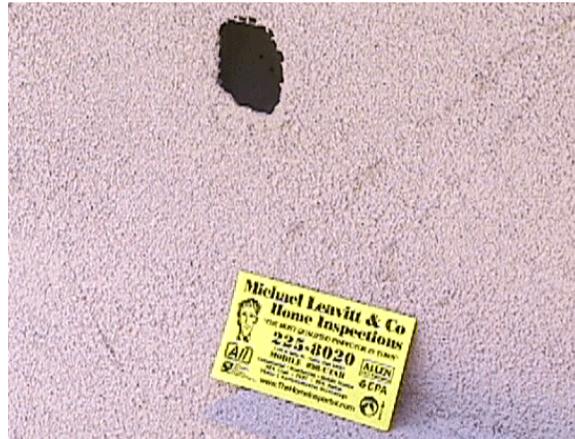
LOCATION 1:

Woodpecker Hole - There is a 2" woodpecker type hole over the north western end doorway. There is a 6" area of missing foam behind the 2" hole. The area tested dry for moisture = Patch.

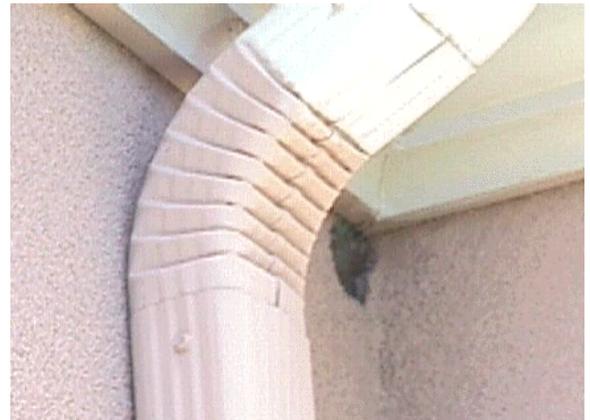
LOCATION 2:

Woodpecker Hole - There is a 2" woodpecker type hole at the south west corner in the corner eave to the east of the master bedroom deck. There is a 8" area of missing foam behind the 2" hole. The area tested dry for moisture = Patch.

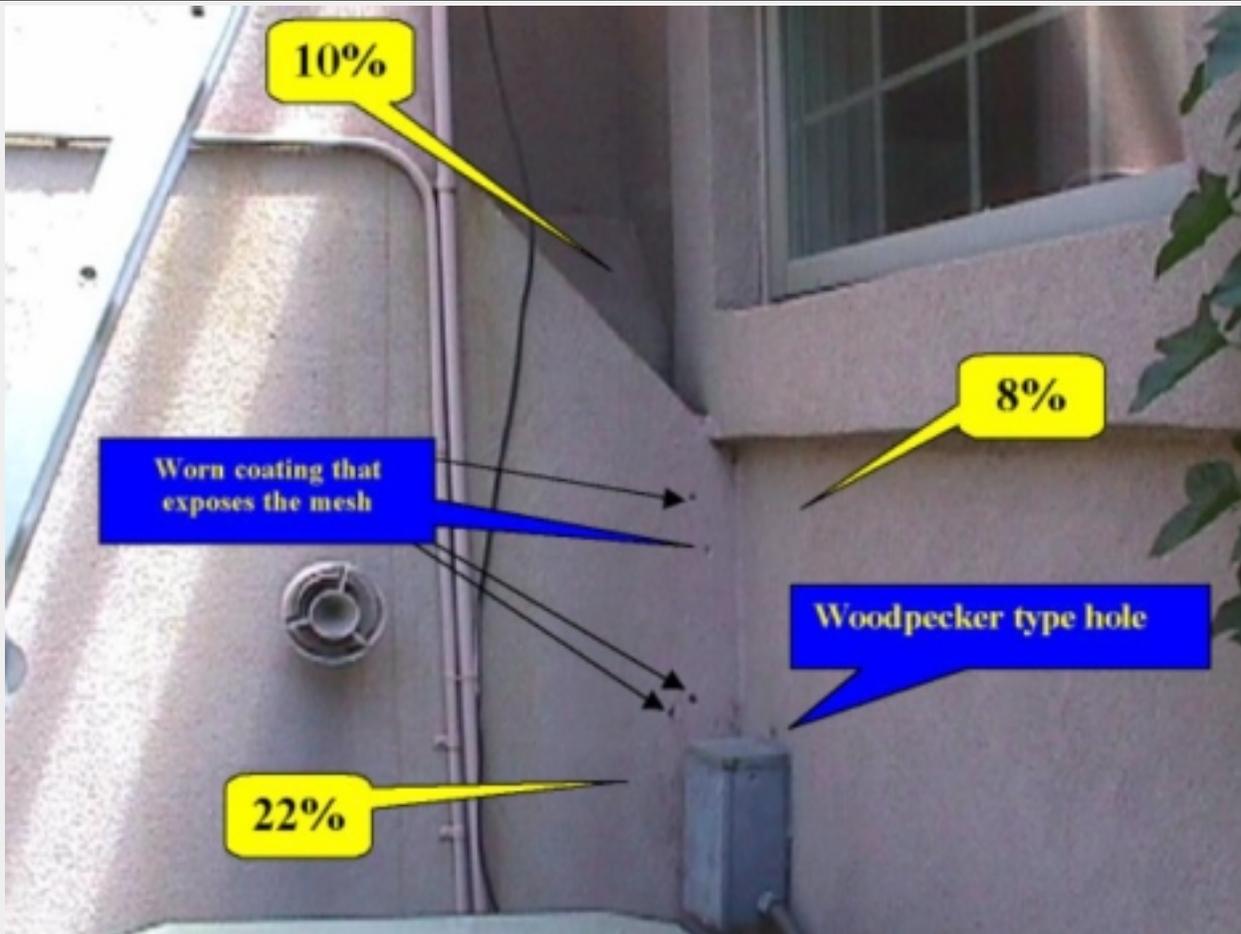
LOCATION #2 PHOTO.

North chimney on the west side from about 4' above the A/C compressor on down the wall. 22% = This moisture looks to be related to the complex valley nook created out of EIFS and the fact that there is deteriorated base and top coats. It is recommended that the area be repaired, monitored, and retested later. The valley tested 10% and near the window 8%

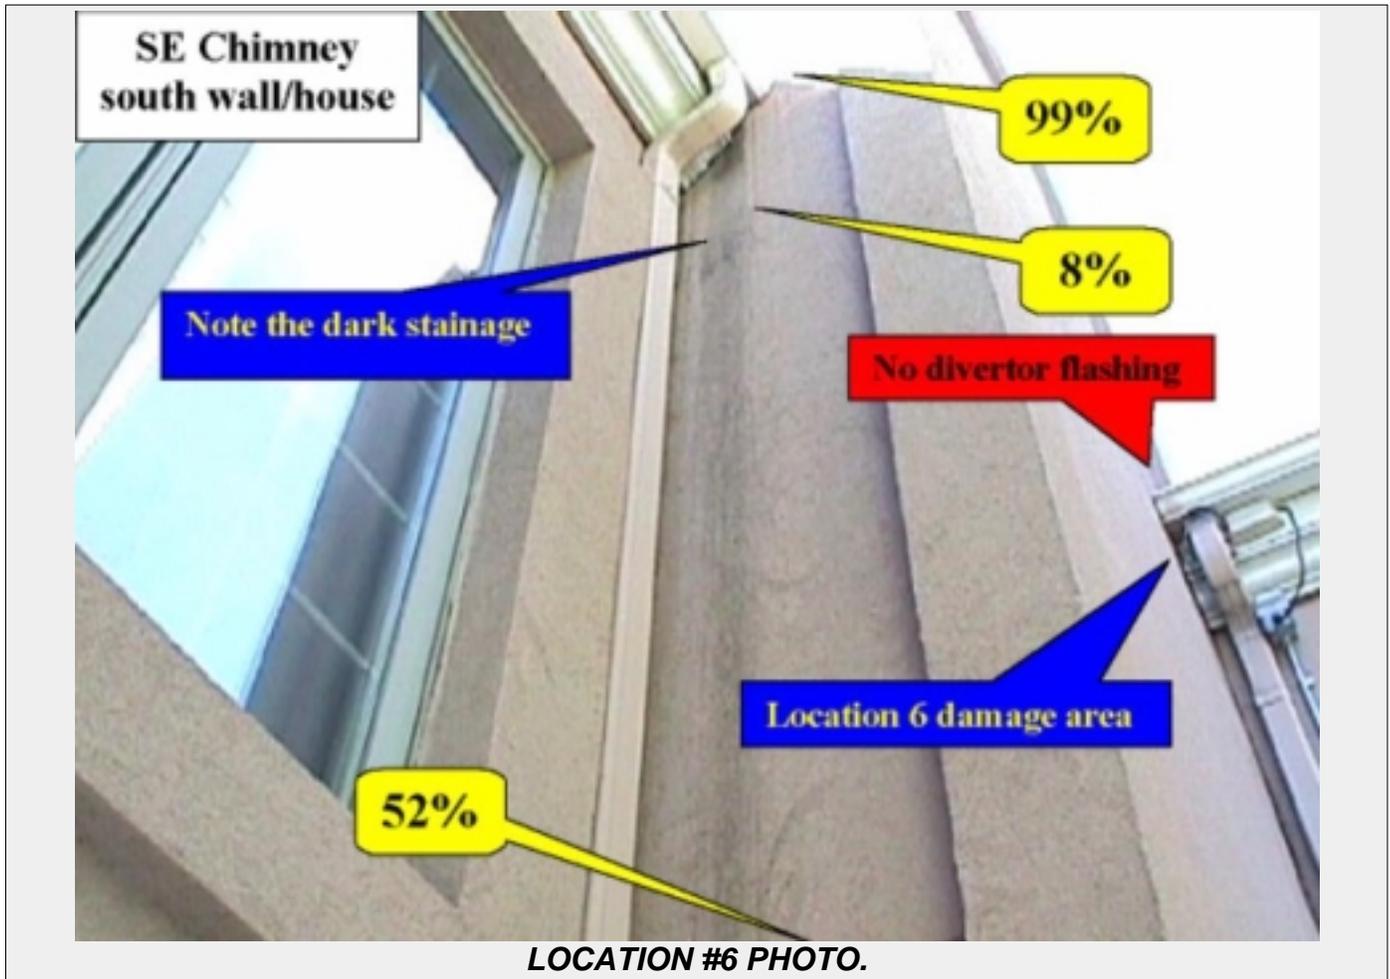
LOCATION 6:

Southeast chimney south wall..... Test reading of 30% or higher = remove siding, and inspect the framing for structural damage, repair as necessary; The point of origin is at the upper appears to be the gutter/EIFS joint. This was determined by probing the surface above the gutter areas to find normal readings. Elevated readings occurred from the gutter on down. It should be noted that there was no diverter flashing installed and no sealant used. Above gutter 9%, At the gutter 99%; Even with the top of the window 99%; Even with the bottom of the window 52%; At the base 99%

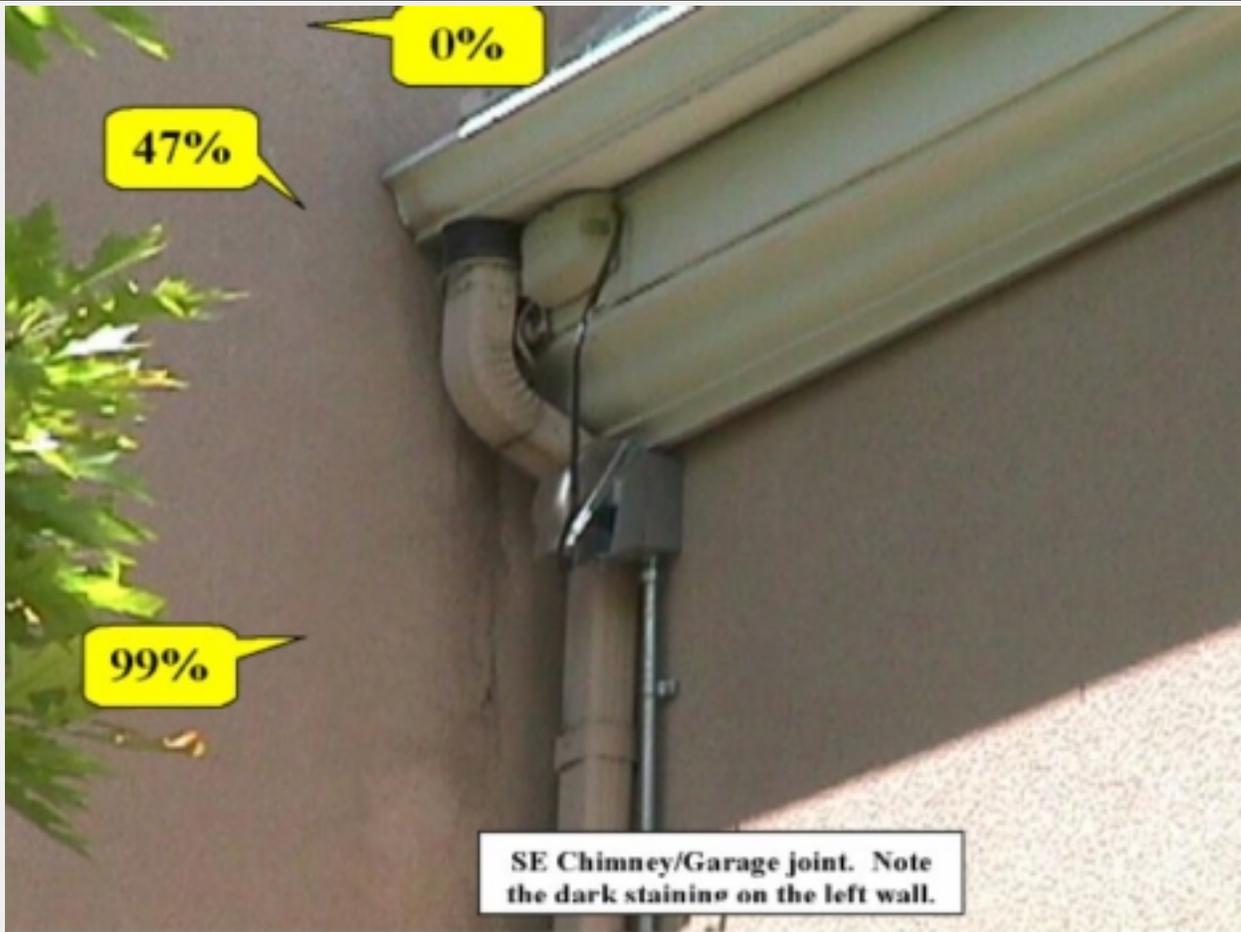
LOCATION #7 PHOTO.

SE Chimney East at the northern end. **Test reading of 30% or higher** - remove siding, and inspect the framing for structural damage, repair as necessary; The point of origin is at the upper gutter EIFS joint. This was determined by probing the surface above the gutter areas to find normal readings. Elevated readings occurred from the gutter on down. It should be noted that there was no diverter flashing installed and no sealant used. Above the gutter 0%; At the gutter 47%; Two feet down from the gutter 99%; Six feet down from the gutter 27%; at the base 26%

SE Chimney East at the northern end. **Test reading of 30% or higher** - remove siding, and inspect the framing for structural damage, repair as necessary; The point of origin is at the upper gutter/EIFS joint. This was determined by probing the surface above the gutter areas to find normal readings. Elevated readings occurred from the gutter on down. It should be noted that there was no diverter flashing installed and no sealant used. Above the gutter 0%; At the gutter 47%; Two feet down from the gutter 99%; Six feet down from the gutter 27%; at the base 26%
