# LEAVITT REPORT

**1387 North 1130 West - Orem, Utah.**

**CLIENT'S NAME:** Kristine & Bill Stewart.  
**DATE OF INSPECTION:** 2-3-2004.  
**TIME OF INSPECTION:** 9 AM.  
**INSPECTION #:** 20304A.  
**INSPECTOR:** Michael Leavitt.

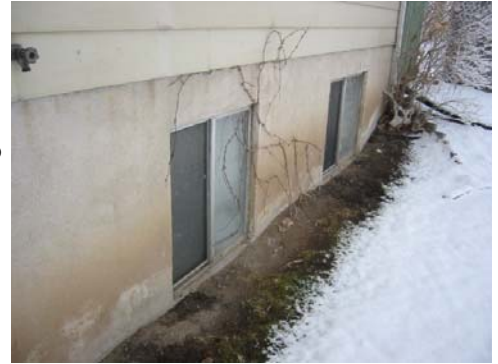
The area around the perimeter of the structure is level at best. Additional measures should be taken to provide the recommended drainage. Correcting the grade will help to avoid erosion and/or standing water along the foundation. The general guideline is for the grading to drop 6" in the first 10' away from the foundation. This promotes water saturation away from the foundation and lessens the chance for water entry in and under the structure.

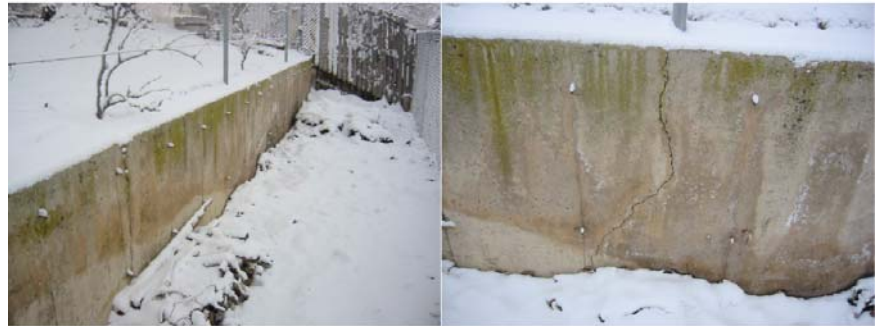
Good.  
 Typical hairline cracks were observed = Monitor.

There is a west lot retaining wall installed. There is a vertical crack but only a little movement.  
 Hose bibs were turned on and off again.

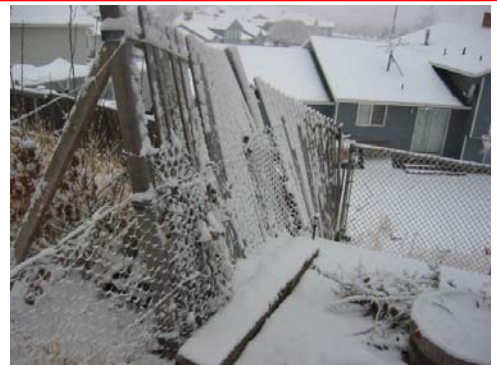
The rear SE corner fence needs to be upgraded.

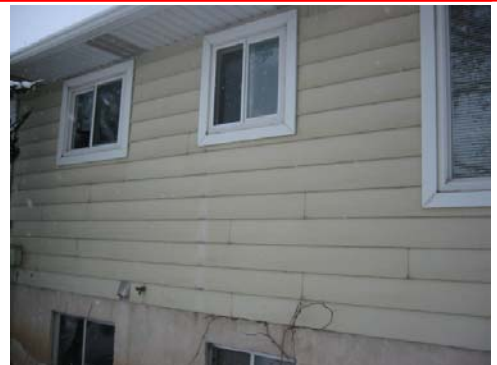
Type: Metal. There are some stains from long term runoff.

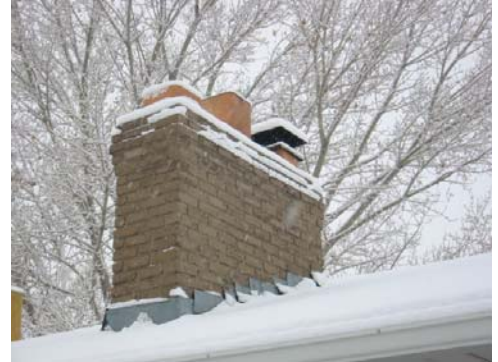
**CONDITION:** I did not view this unit close up.

**MATERIAL:** Brick and Mortar.  
**CHIMNEY COVER:** Did Not View.  
**FLUE LINER:** Did Not View.  
**CHIMNEY CLEAN:** No=Recommend a regular maintenance cleaning by a licensed chimney sweep.  
**REMARKS:** Regular chimney maintenance is highly recommended, yet often overlooked by homeowners. The full evaluation of the structural and internal portions of the chimney is beyond the scope of this visual evaluation. It is recommended that a "Level 2" chimney and flue evaluation be performed by a certified Chimney Sweep to identify any possible hazards. The "Level 2" evaluation is best suited to provide the information needed for the Real Estate transaction.

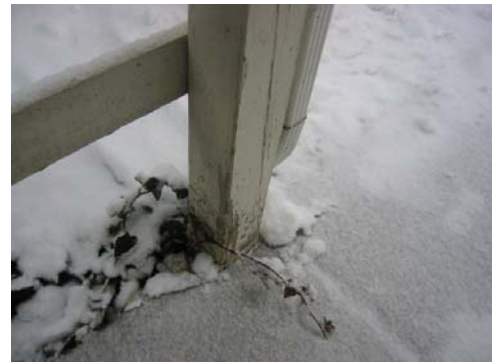
**GENERAL CONDITION:** Fair.  
**TYPE:** Two car.  
**REMARKS:** The support post need to be painted.

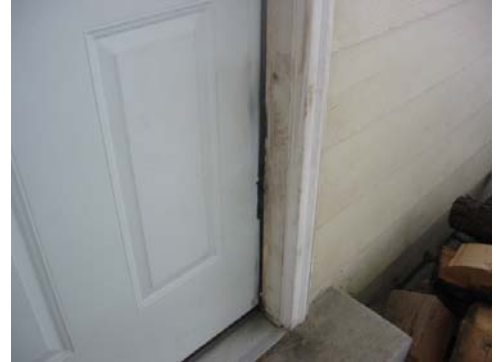
The weatherstripping is damaged.

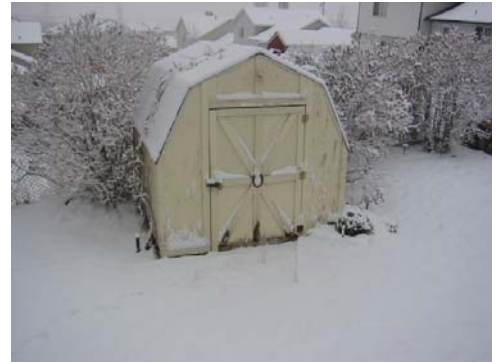
The NW shed is rotted out from old age and neglect.

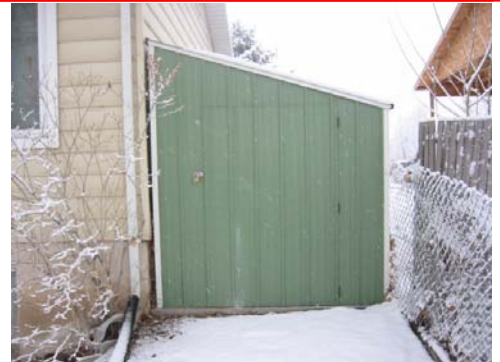
This south side shed was not accessed.

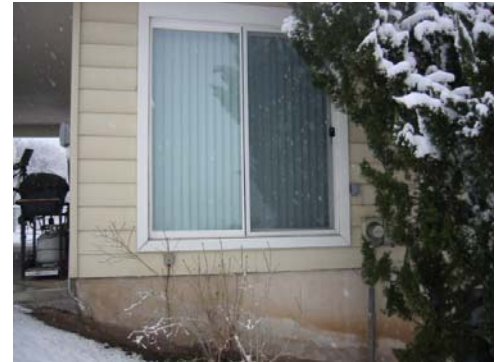
**REFRIGERATOR SPACE:** 71.5" Tall.  
**WALL FINISH:** Good.  
**FLOORING:** Good.  
**WINDOWS:** Good.  
**DOOR:** A sliding glass door has been installed but there is no exterior deck or landing. It is recommended that a permanent lock be installed until the outside landing or deck is built.

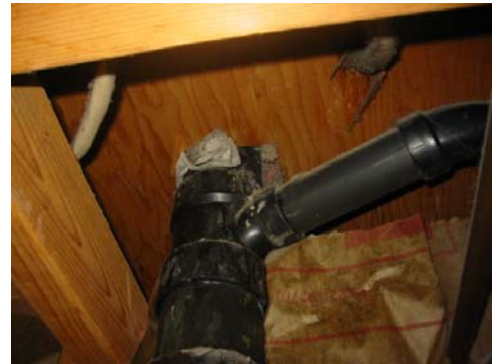
**LOCATION:** Main Floor.  
**WALL FINISH:** Good.  
**FLOORING:** Good.  
**WINDOWS:** The window was upgraded. I did not see a tempered seal = Use with care.  
**DOOR:** Good.  
**LIGHTING:** Good.  
**GFI OUTLETS:** GFCI outlet is installed and appears to be working as designed.  
**BATH VENTILATION:** Ventilation is provided by an open window only.  
**VANITY:** Good.  
**COUNTERTOPS:** Good.  
**SINK:** Good.  
**DRAIN CONDITION:** The drain flowed as designed.  
**FAUCET:** The faucet looks to have a slow drip.  
**TOILET:** **The base is loose at the floor.** The typical repair requires replacement of the inexpensive wax base seal and tightly resealing the base to the flange. From the basement I could see past dry stains but no current leak evidence under this same toilet.

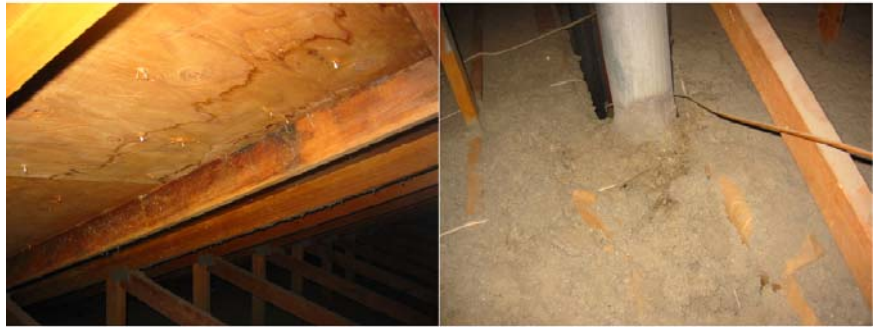
There is past leakage at the vent pipes, flue and swamp cooler. Monitor these for any future leaking.

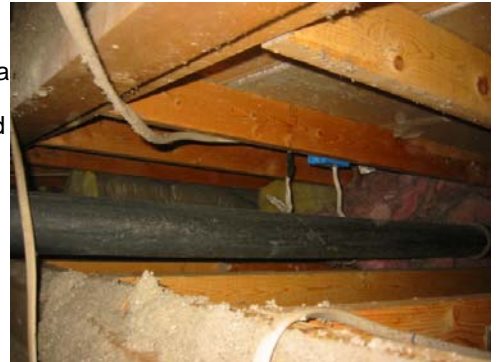
None. There is an open chase down between the kitchen and bathroom walls. There is a wire splice done inside that was made without a junction box and only electrical tape. This splice should be repaired and the chase should be covered with insulation.

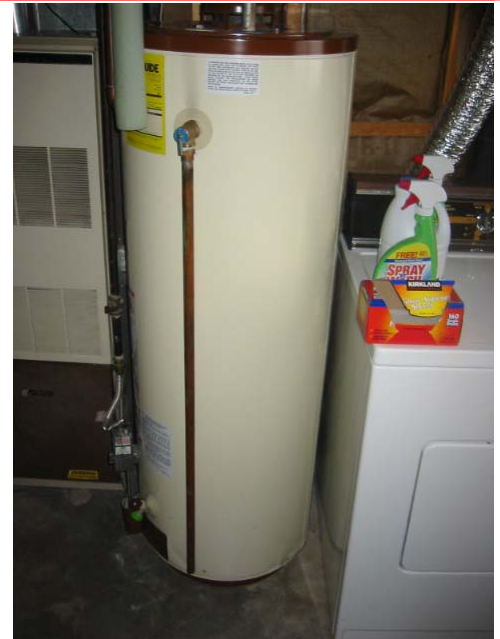
**LOCATION:** Service area.

<b>VISUAL CONDITION:</b>	Fair = Due to age.
<b>BRAND:</b>	A.O. Smith.
<b>APPROXIMATE AGE:</b>	1994.
<b>LIFESPAN:</b>	According to the industry experts, the average water heater life in the U.S. is 8 to 12 years.
<b>TYPE:</b>	Natural Gas.
<b>SIZE:</b>	50 gallons.

No = Potential Hazard.  
 Yes = Did Not Test.  
 Adequate.

The gas hook-up is equipped with a shut-off valve that requires a wrench to operate. Modern building standards recommend the use of a hand shut-off type gas control valve = Consider the upgrade. A flexible gas line is installed.

The combustion air is provided by the home's interior. No exterior or attic ventilation air source is provided. Exhaust venting is Good.

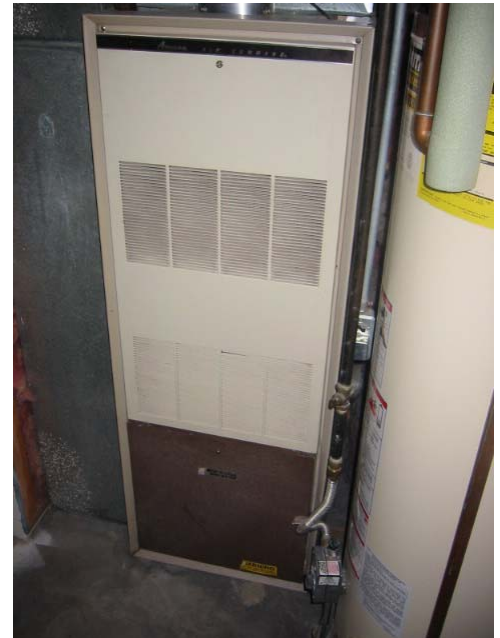
This is an older unit. Due to its age it is recommended that further evaluation by a licensed heating professional to verify the integrity of the combustion chamber.

Amana.  
 Forced Air. This unit uses both gas and electricity.  
 Original.

According to industry experts, the average life of a heat exchanger in the U.S. is 15 to 20 years. Use this estimate as a general guideline. Many factors can affect the operation of this system and it is possible for the system to fail at any time.

**Recommend further evaluation/repair by a licensed Heating Ventilation Air Conditioning technician.** The now famous Questar "Green Sticker" is NOT present on this unit. The "Green Sticker" verifies that this unit has been tuned to operate at this elevation and with the current grade of natural gas. Consideration should be given to

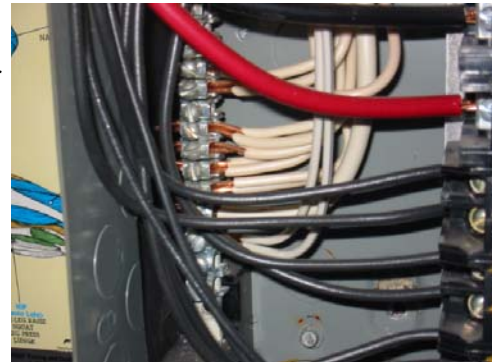
**COMBINED NEUTRALS:** (x6 lugs) Panel manufacturer's recommend that only one neutral wire be secured under each neutral bar lug. This provides extra safety to repair electricians and provides a more secure connection. Consideration should be given to having a licensed electrician reposition the white clad neutral wires so that no more than one neutral is secured under each lug.
