# Wood Destroying Insect Inspection Report

Address of Property Inspected  
1123 East 1200 North.  
Orem, UT.

# TERMITE REPORT - ADDITIONAL COMMENTS

RE: 1123 East 1200 North - Orem, UT

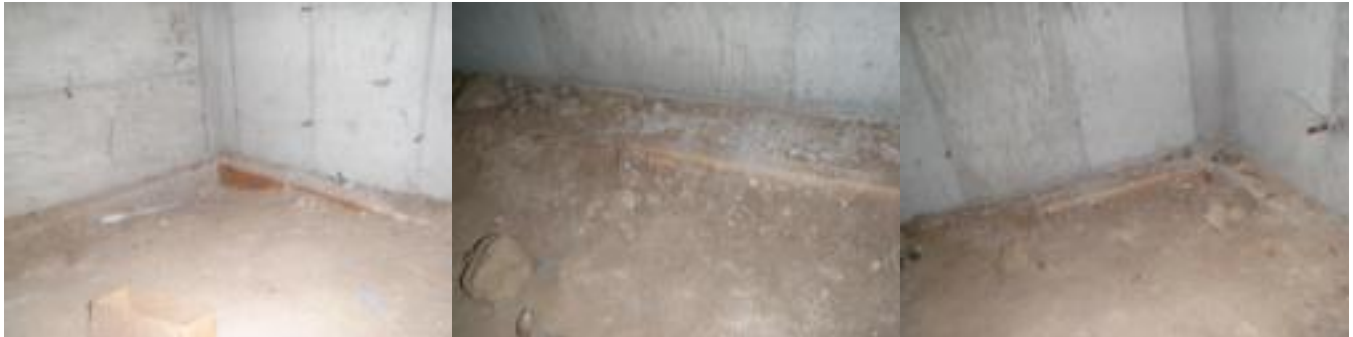
1) **WOOD FOUNDATION FORM** - At the far west side of the crawl space there is a previously infested 2x wood foundation form still installed against the foundation. These forms are supposed to be removed after the foundation sets and keeping it in place is an attractor for termites. Sure enough there is lots of infestation evidence and my probe easily went into several areas of this board. The wood should be removed, and I am left to wonder why the removal was not part of the termite treatment process.

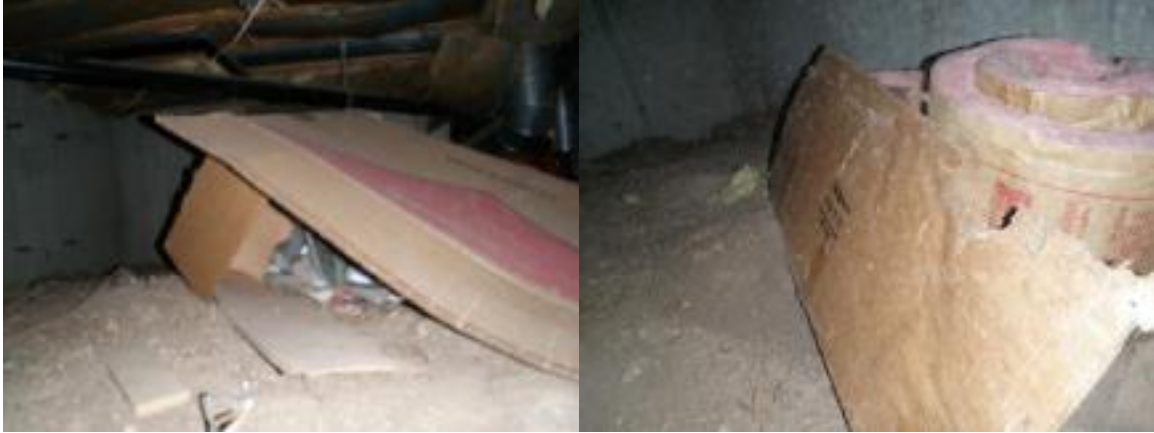
**2) CARDBOARD BOX** - There is a large cardboard box in the crawl space that has wood destroying insect evidence on the bottom portion that is in direct contact with the earth. This cellulose material is an attractor for termites. I am left to wonder why this is still in the crawlspace. Either it was not there when the treatment was performed and we have ongoing termite activity, or it was there before they first treated and nobody bothered to remove it. I would share these supplemental comments with the pest control firm and ask them for feedback. Was the box there all the time and the infestation evidence old, or is it new and the termite activity ongoing?

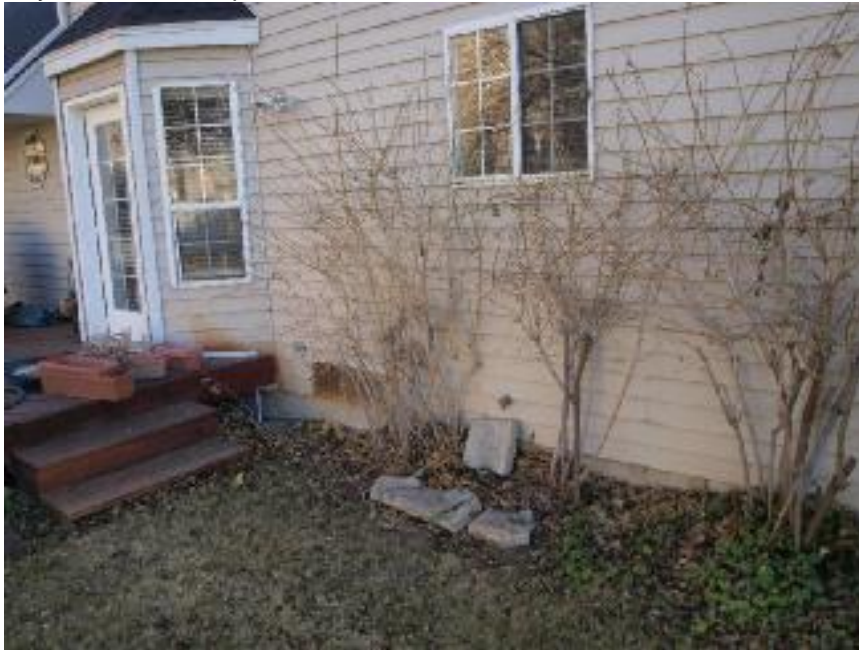
**4) NEGATIVE GRADING** - It is well known that subterranean termites love moist earth verses dry earth. This is why exterior grading is important to consider. You should be able to stand back 10 feet from the home and the earth at the foundation should be 6" higher to promote surface water flow away from the home instead of towards the foundation. The rain gutter discharges have been extended, but the area under and near the deck on the north side draws water towards the foundation. This is easily corrected and preventive in nature.

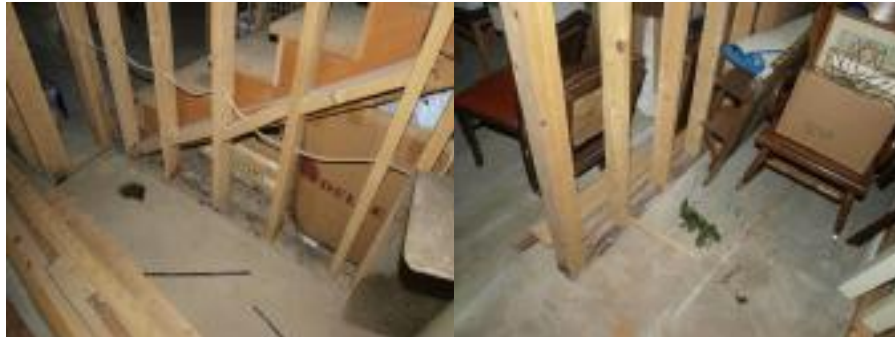
**3) BASEMENT FLOODING** - There are lots of flooding evidences on the basement framing along the center load bearing walls and stairs. There is also water evidence on many of the stored items and mattress. The seller confirmed that they had water entry through the north foundation window well that sits under the deck. This is related to the negative grading that I mentioned earlier. I saw not termite activity as a result. The negative grading condition is correctible and advised.

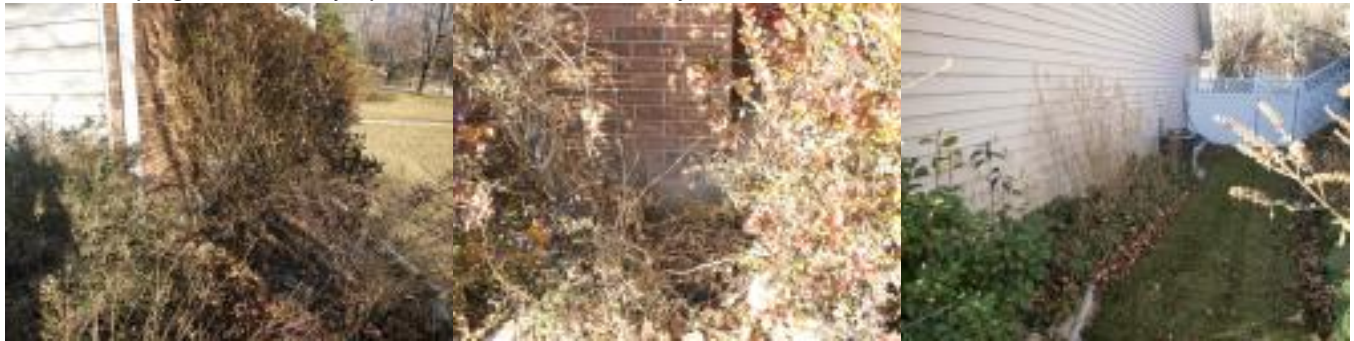
**5) DENSE VEGETATION** - The perimeter landscaping is filled with dense vegetation. This prevent the easy identification of subterranean termite mud tubes. It is recommended that shrubs and bushes be kept away from the home 14-18". The current landscaping is all the way up to the foundation in many areas.
