Michael Leavitt & Co Inspections, Inc.

WATER HEATER

#1 WATER HEATER

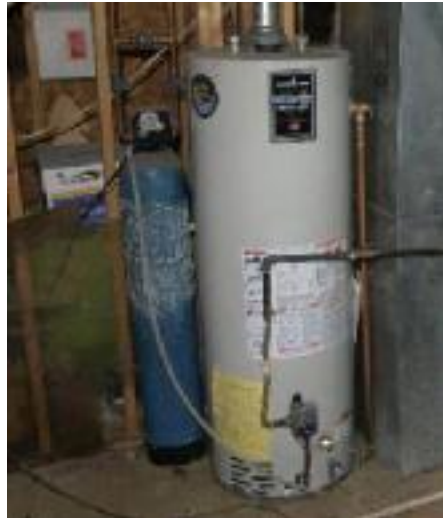
Basement service area.

Bradford White..... 2007.

The water heater is not strapped in conformance with the current seismic safety standards.

No thermal expansion tank or valve was identified = Consider adding. Without the thermal expansion feature you may experience water dripping out of the Safety Release Valve during the warm up cycles as the hot water expands in the system.

An easy operate hand shut-off valve is installed on the gas line. The flex line was not upgraded when the new appliance was installed.

NOT INSTALLED - Sediment traps are installed in the gas line near the unit to catch any debris in the gas lines. See http://www.waterheaterexplosions.com/R_Drip_Leq.html for details.

As mentioned in the Pest Report, there is lots of evidence of basement flooding. The issue is that the slab does not drain towards the drain. It is recommended that a drip pan be installed under the unit with a drain line routed over the floor drain. This upgrade will help prevent flooding in the basement.

No alarm is installed, but is recommended. These units are battery operated and cost less than \$15 and are designed to sound off like a smoke detector when water is detected. Since the basement is unfinished and not regularly accessed a leak alarm would alert you quickly if there is a water leak from the water heater.

It would appear that the latest unit was not installed with the benefit of a building permit that would have required upgrading the installation to the then modern standards.
