SPECIALTY REPORT

Completed July 12, 2023

850 East 820 North
Provo, UT

At the request of Matthew Flinders, I was called upon to visit your apartments and evaluate the exterior grading on the east side and the exterior of the structure at 850 East 820 North, Provo on May 26, 2023.

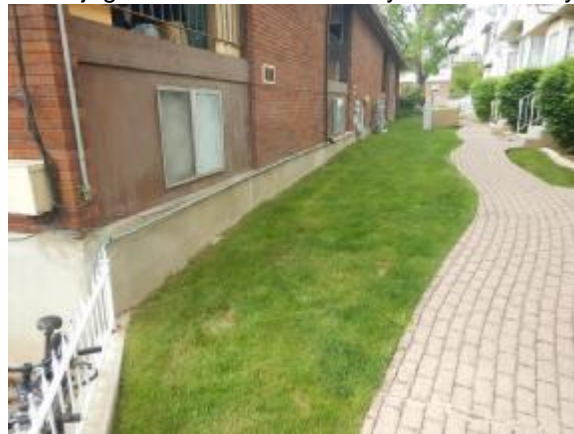
PROPERTY LINE - The east side of the building looks to be on or near the property line. The east neighbor looks to take care of the grass, yet there is the south end jog in the concrete where you see the bicycles at the lower left of the photo.

GRADING - POOR - Corrective action is needed. Currently, the east neighbor is NOT controlling the water on their lot and it flows down the slope directly into your foundation.

RECOMMENDATION - The 6-in-10 rule is the ideal. This means that you step 10 feet back from the foundation and the

grade should be 6" higher than where you are standing. This promotes surface water flow away from the structure. In this case, it is NOT easily possible to do this. The other portion of this rule is that you must stay at least six inches away from your exterior cladding. In your case, it is brick. At the southern end it would be easier, but unattainable at the northern end. So what are your options?

OPTIONS - Looking at this situation, the most straightforward option would be to install a French drain type system. This would include digging a trench along the foundation full length down below the floor slab of the lower units. You could then use black mastic goop to adhere plastic sheeting to the foundation and line the bottom full length. In the trench you would install a perforated black pipe that would run downhill from north to south to get water in the trench to enter the flow downhill safely to the discharge at the lower south end.

NOTE: I would also run a solid black pipe in the same trench and route it to the same south discharge point and run all of my roof downspouts into this solid pipe.

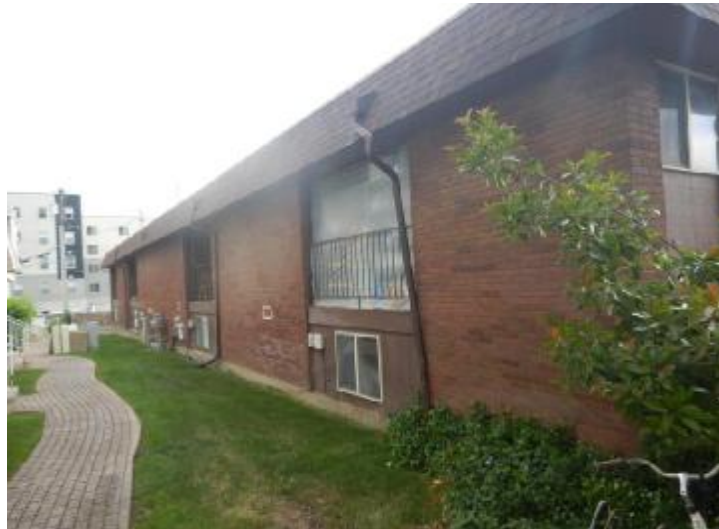
PROPERTY LINE - I refer back to this because I cannot tell where your property starts and stops. What I can tell is that the east neighbor has landscaped all the way up to your foundation. They designed their walkway and then chose a convenient slope down the hill into your building. I see no obvious preventive steps to prevent water collection into your building. Or have they already installed a French drain for you? The only way to tell would be for me to dig, and I did NOT do this during my visit.

WATER CONTROL - I want to stress that property owners are responsible to control the water on their property. They are not allowed to get the water off their property in a way that damages a neighbor's property. Has your property been damaged? Only an interior inspection of your units can confirm or deny if there has been water entry and damage inside your units. It is possible that you have had no water entry at all, but it is also probable that you have had moisture seepage along the east side of your units. Further evaluation is recommended.

WATER ENTRY? - Has there been any water entry along the east walls of your lower level units? I would investigate further to see if this negative grade water flow condition is causing issues inside your building. If so, then you will have mold and rot issues in your carpet, padding, and lower wall drywall framing.

RECOMMENDATION - Lift carpet edges and look closely at the east wall of every lower level unit for water entry signs. It will be very evident in the carpet tack strips along the lower east walls if there has been water entry or not. If so, then you have a major project ahead of you to control the future exterior water flow, waterproofing the foundation, and then addressing any of the interior water entry mold/rot damages. **Due to the owner's choice of lot grading onto your building, even if there has been no water entry, then the French drain system and foundation waterproofing are still recommended.**

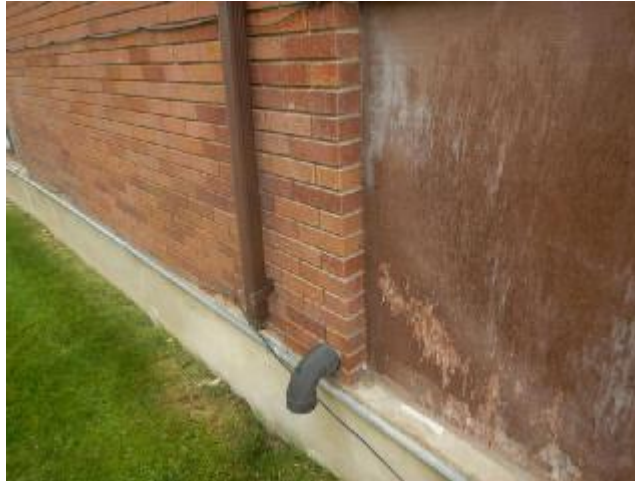
DOWNSPOUTS - The east side roof has several downspouts that discharge directly onto the ground at the foundation. The black elbow looks to be from earlier in the wall roof drain lines. You can see the surface mounted downspout and the way it discharges onto the foundation.

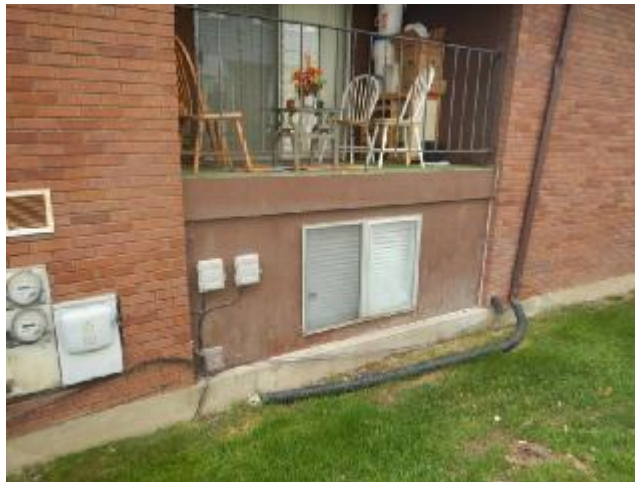
Now look at the others that have black extension pipes added. These really do nothing more than move the water down a few more feet along the foundation. Unless these are joined and routed all the way to the south, then what have you really accomplished?

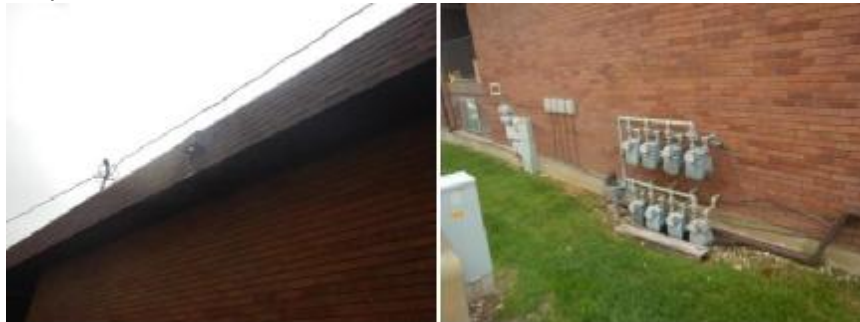
REMOVED - Just above the gas meters is a downspout that is currently removed at the roof and stored behind the meters. Obviously this downspout needs to be restored.

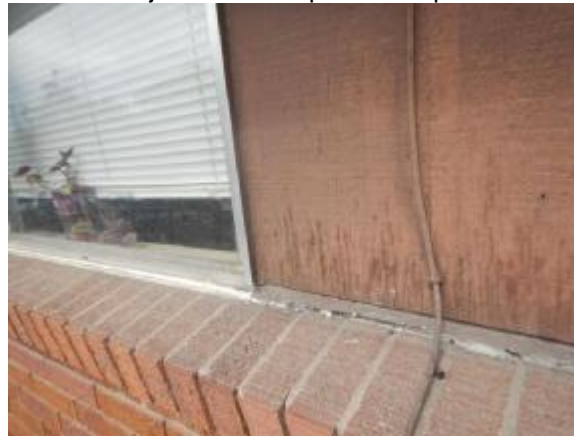
FAILED CAULKING JOINTS - This building was built at a time when you used small overlapping horizontal flashings and lots of caulk to seal up joints and transitions. Many improvements have been implemented over the years that help prolong the life of buildings. You currently have water entering in behind the brick from the siding transitions above. The horizontal brick to wood siding joints and window joints need repair to keep the water out.

FLASHING - Look closely at the photo above and you can see that the through the wall flashing comes out about an inch and barely covers the brick.

RECOMMENDATION - This may sound drastic, but my recommendation is that you do a siding upgrade directly over the current plywood siding. This would include a fresh new drainage plane. This would include much larger through the wall flashings, house wrap or felt paper, and then the new cladding. This would prevent the need for caulk to protect from water entry in behind the brick. It would also allow for a fresh modern look to the building.

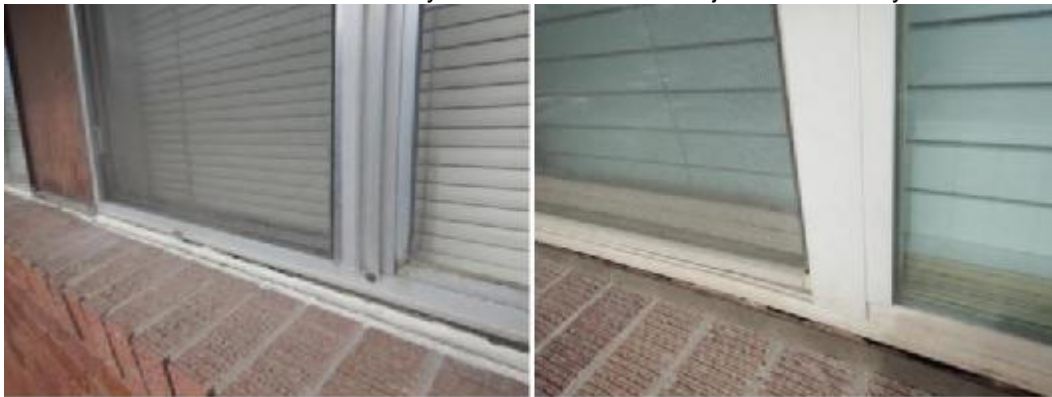
WINDOWS - The current windows have a poor seal along the top edge of the horizontal brick joint. You have both the original aluminum framed windows and a unit with vinyl framed windows. The joints of both styles have failed caulking joints.

RECOMMENDATION - It would have been better if the windows did not terminate immediately on top of the brick so that an overlapping through the wall flashing could be used. But since it was done this way, then this caulking joint is critical. Obviously, the current joints have long been deferred. These must be touched up at least annually.

WINDOW UPGRADE - You should consider upgrading the upper level west windows to new dual paned vinyl framed units. Talk with the window supplier/installer about their recommendation for flashing upgrades to deal with this brick joint. I can envision a window unit with no flange being set into place. The waterproofing details would be installed prior to the window by use of perimeter opening flashing and lower edge pan flashing that safely gets any water to flow out and over the sloped brick window sill. If your installer has no idea what I am referring to and just wants to rely on caulk, then you have the wrong installer for the job. Caulk on the sheltered lower level windows may work just fine, but these upper row units are directly exposed to wind driven rain and snow, and require extra precautions to prevent water entry. I will share a couple of details to

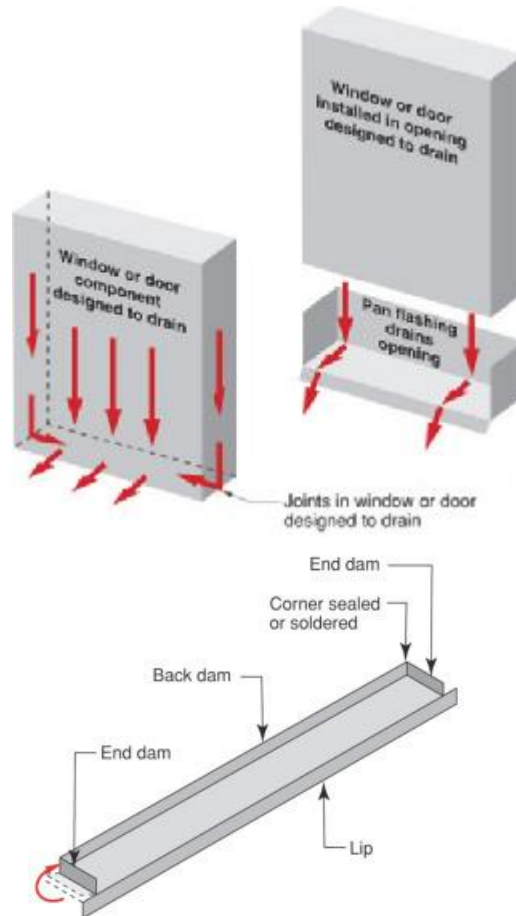
Obviously, the lower lip on the pan flashing would be angled out and over your angled brick and not vertical like the drawing above.

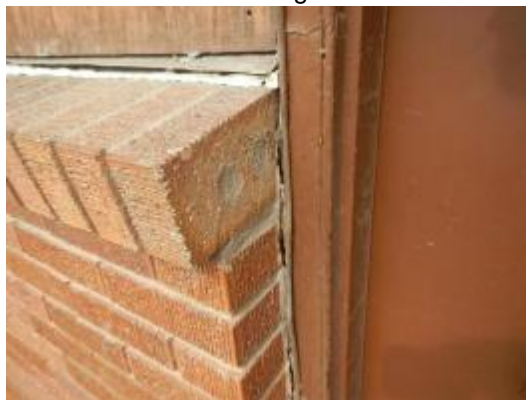
DOORS - The door to brick joints suffer from the same caulking failures that allow water into the walls.

RECOMMENDATION - The door frame to brick and siding joints need to be recaulked.

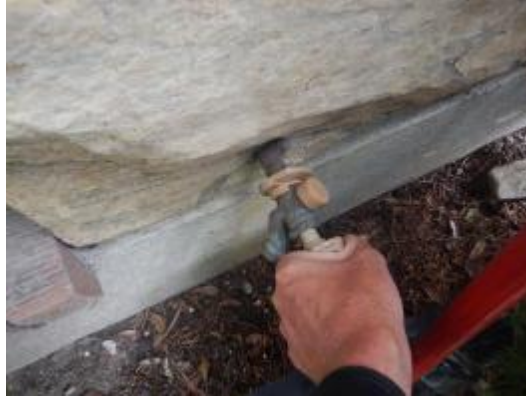
HOSE BIB - The hose bib set into the stone is not secured and twists.

RECOMMENDATION - Secure the mounting flanges of the hose bib to prevent twisting.

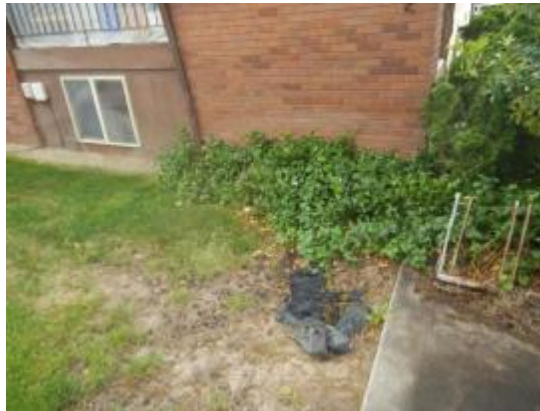
FOLIAGE - The foliage is overgrown.

RECOMMENDATION - Trim the foliage back from the structure.

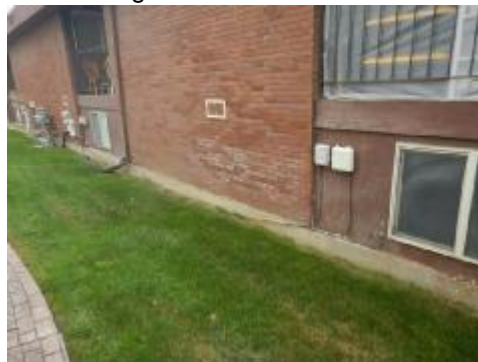
BRICK EFFLORESCENCE - The white staining on the brick shows that it is being excessively sprayed with water.

RECOMMENDATION - Check the sprinkler spray from the neighbor first. I suspect you have stray sprinkler spray directly onto your building. Scrub the white powder off and then monitor to see if it returns. This may have been from decades ago. If it returns, then it is an ongoing issue.

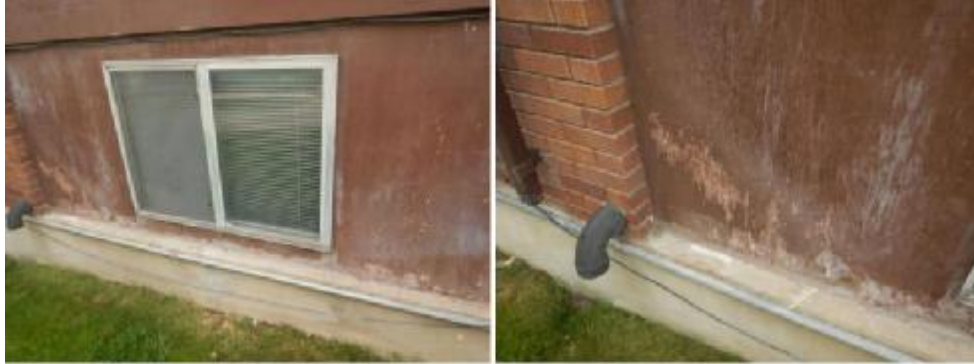
REAR SIDING - The siding has been poorly maintained and there is ongoing damage.

RECOMMENDATION - Consider residing the building. At the very least you need to prep, paint, and caulk to attempt to stretch more life out of the siding.

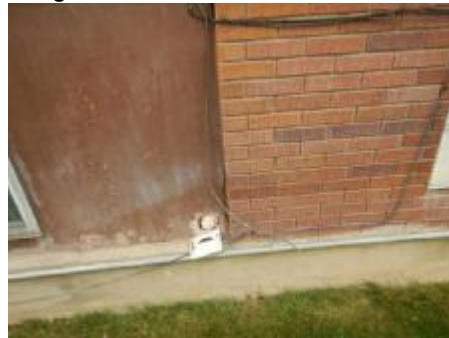
DRYER VENT - The louver vent is protruding and not secure.

RECOMMENDATION - Consider residing the building. At the very least you need to prep, paint, and caulk to attempt to stretch more life out of the siding.

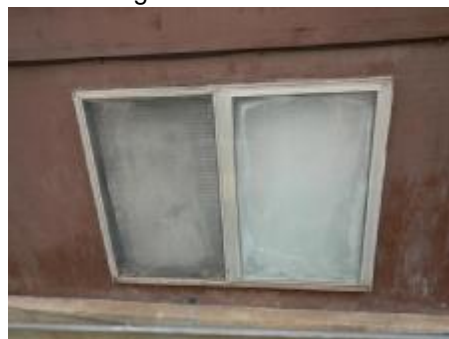
HARD WATER SPOTS - The windows are damaged and covered with hard water spots.

RECOMMENDATION - Replace the window. As for the source, it is probably the neighbor's sprinklers spraying the building.
