## CONCRETE REPORT

### INSPECTION PROPERTY ADDRESS

850 East 820 North  
Provo, UT

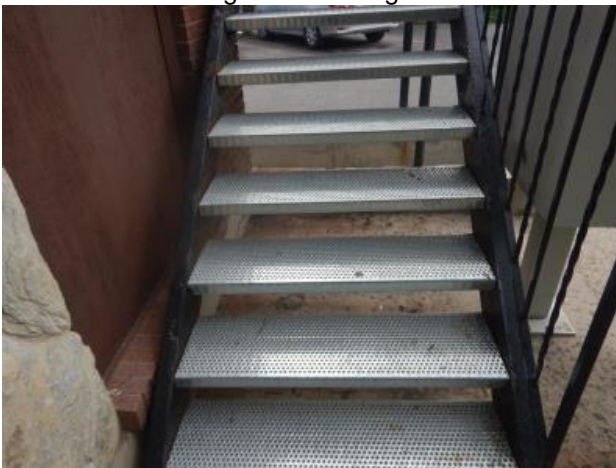
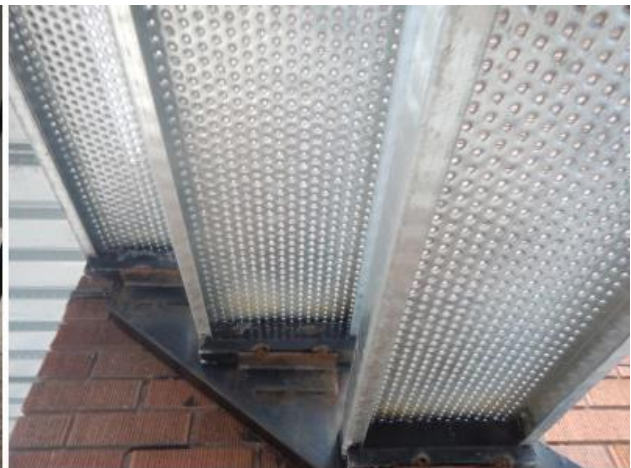
**STAIR TREADS** - The old stair tread mounts rusted out and the stairs had to be replaced. I can see the old mounting points. I can see the rust and damage to the stringers.

The new treads are a great upgrade, but the stringers and mounting point were not completed during the major tread repairs. The connecting points were all left unpainted and the rusting continues. I see no evidence of any painting after the tread installs.

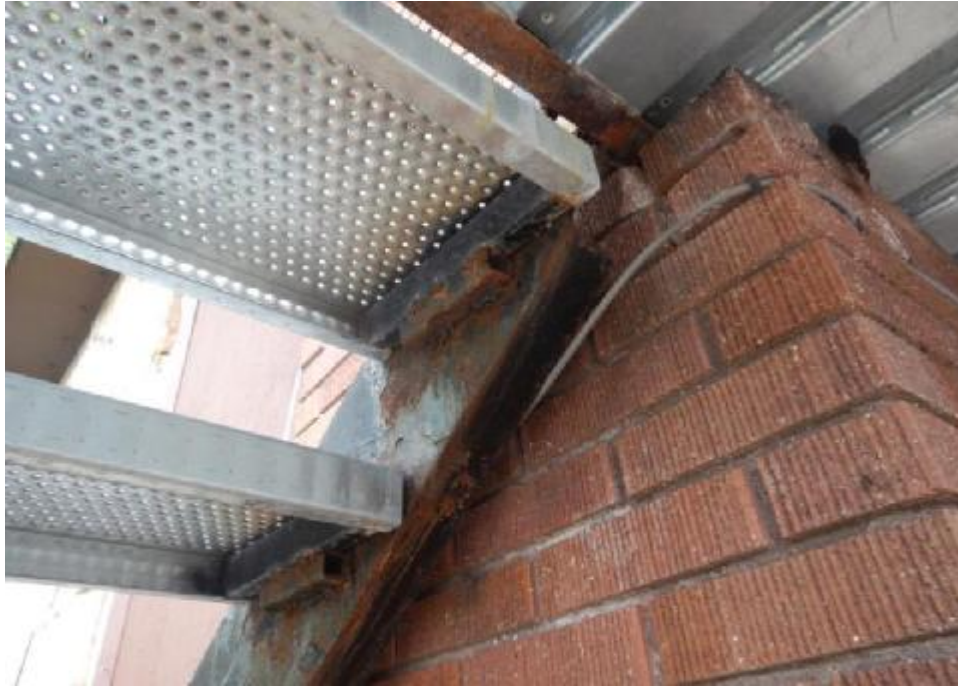
**RUST** - Look closely at the image below and you can see the ongoing rust in the stringer and at the mounting point of the tread. This rust does not stop unless it is either removed or treated, and then protected. This means that the stair tread replacement solution will be short lived unless corrective action is taken. This would have been so much easier to do prior to the installation of the new treads. Why? Because there is rust in the stringers behind the edge of the new tread that you can't get to with the tread in place.

**STRINGERS** - With grinding, rust treatment, and protection you will greatly extend the life of these stairs. Doing nothing and the rusting will continue.

**RECOMMENDATION** - I have seen stairs like these treated and coated with Por15 (por15.com) and it seems to work well. You need to get the rusting stopped and then get these stringers protected to endure the rain, snow, and rock salt used in the wintertime to promote snow melt.

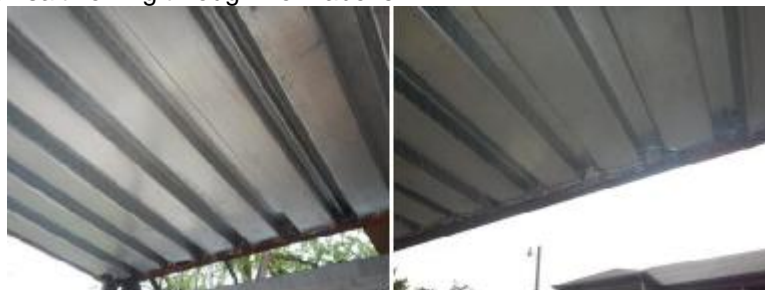
**WALKWAY FRAME** - The previous concrete and pouring supports were removed leaving just the steel framework. Unfortunately, they did nothing to stop the rust prior to the new concrete installation. This rusting will be difficult to stop with continued snow, rain, and rock salt flowing through from above.

**RECOMMENDATION** - This also needs to be prepped, treated, and protected to prolong its life. Another primary concern will be to stop the water flow between the concrete and the steel. This might best be achieved by coating the concrete walk above. But lets take a look at the concrete work condition...

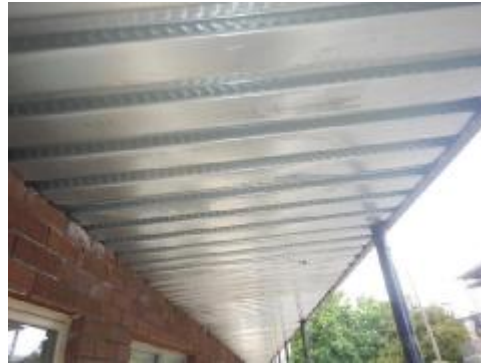
**UNDERSIDE** - You can see the fresh metal pan used to support the concrete from below. On one side is the brick shelf and the other is the steel angle iron.

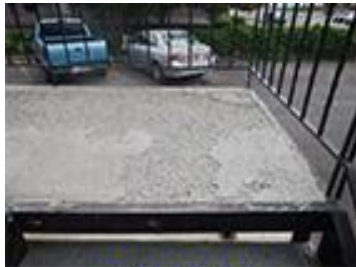
**PHOTO #1**

Photo 1 shows near total surface deterioration. As you look on to 3 and 4 you see that there is a rainfall deterioration from the middle to the outer edge. Keep in mind that there is a partial roof covering and the deterioration is from the protected area outward. Why is this important? If one is trying to blame the application of salt to the walks, then there would be surface deterioration all the way across.

**RECOMMENDATION** - With the severe finish deterioration, if you want to preserve the current concrete work, is to have it overlaid with a modern deck coating. Here are three websites to check out. Realize that they focus on residential elite decks, but the concept of coating may be your solution...

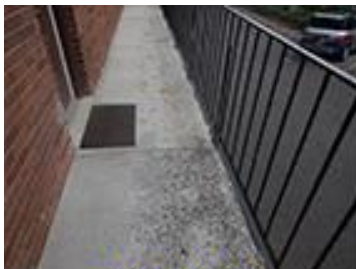
**PHOTO #5**

Notice how the deterioration is from the mid point outward. Also notice the transition in photo 5 from one pouring to the next. The failure is much harsher in the lower portion of photo 5 than in the upper portion of 5. Photos 6 and 7 show much lighter damage. Photo 8 shows much more damage in the immediate entryway to the apartment.

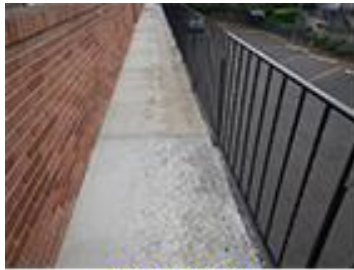
PHOTO #9

Once again look at the pouring transition in photo 9. The outer portion of 9 in the lower portion of 9 is total finish damage, where the upper portion is much more intact, yet discolored. The discoloration continued through 10 and much of 11. Photo 12 shows another pour transition and the discoloration pattern and deterioration changes again.

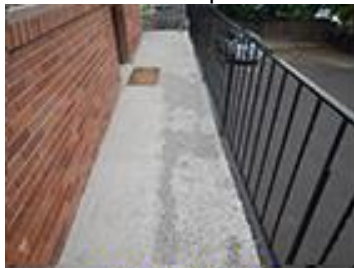
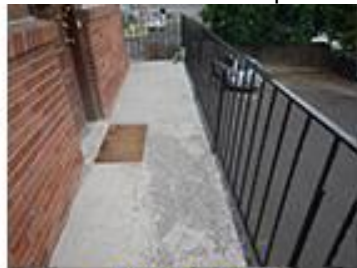
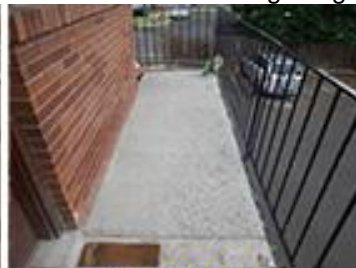
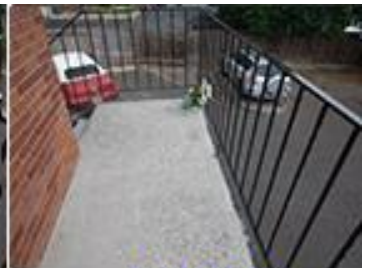
Photos 13 to 16 show the same deterioration pattern and no staining.
