# STUCCO REPORT

**6167 W Teton Park Dr - Herriman, UT**

CLIENT'S NAME:	Bill Miller.
DATE OF INSPECTION:	07/03/2023
START TIME:	8:00 AM
INSPECTION #:	70323A
INSPECTOR:	Michael D. Leavitt - Master Inspector
CLIENT'S AGENT:	None - Owner Occupied

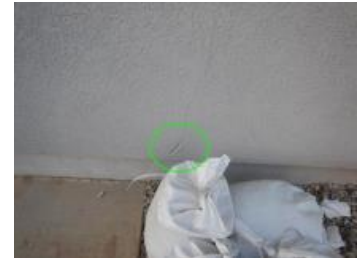
I found one two inch gouge on the right side near the trash cans.

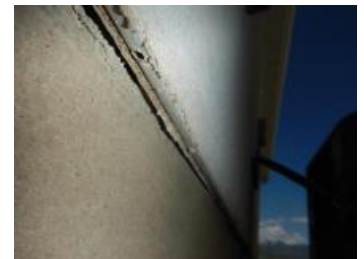
INCORRECT - Appears to be acceptable at this time.

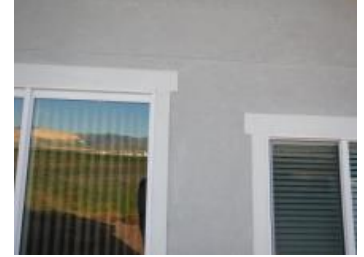
I found no sealant at the differential material joints.

The ASTM standards for the application of Portland Cement-Based Plaster requires sealant at the exposed ends and edges of the system. This includes penetrations and joints with dissimilar materials such as doors and windows. Please refer to ASTM C 926 A2.1.3.

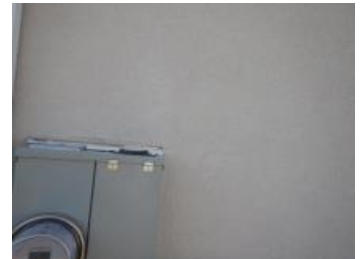
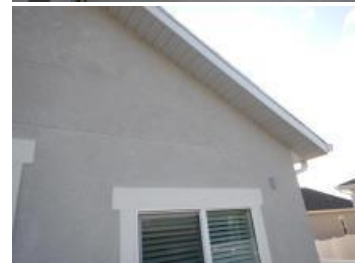
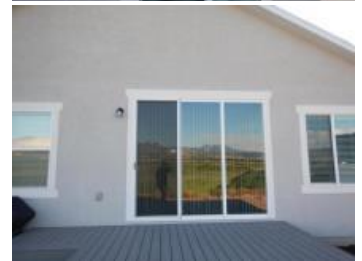
Fair. Penetrations need sealant to help finish the detail.

All flashings are concealed. There are no through the wall visible cap or pan flashings.

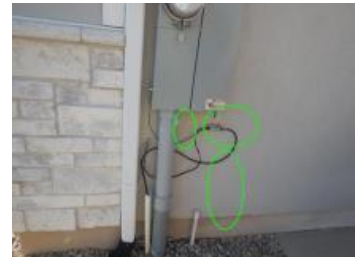
**CRACKS 02:**

From the upper right of the panel.

**EXCESSIVE** = The amount of hairline cracking is deemed excessive.

I recommend a crack patching and refinishing of the stucco to address the documented cracks.

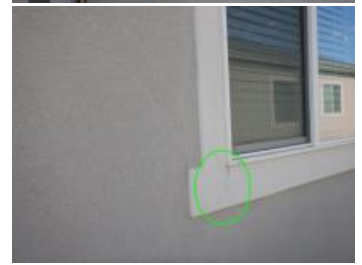
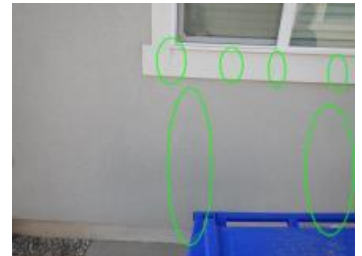
**CRACKS 04:**

Vertical below the window.

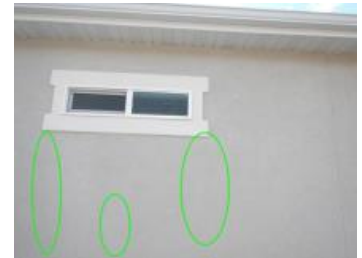
CRACKS 01:

14' linear feet of cracking.

**EXCESSIVE** = The amount of hairline cracking is deemed excessive.

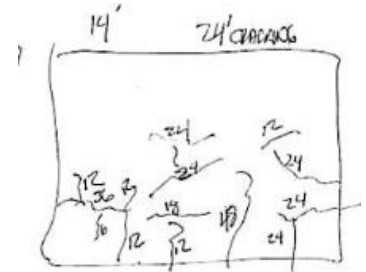
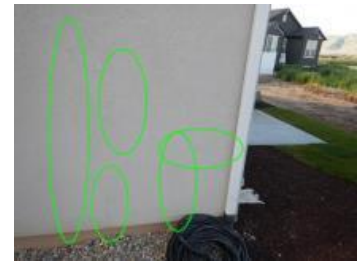
Right side, final section ending at the rear corner of the home.

24' of cracking. It was surprising to see this amount of hairline cracking. The photos do not do it justice. Seeing it first hand and it becomes very obvious.

**EXCESSIVE** = The amount of hairline cracking is deemed excessive.

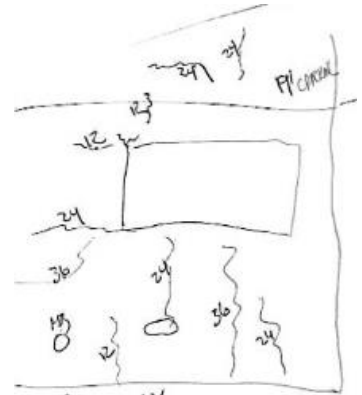
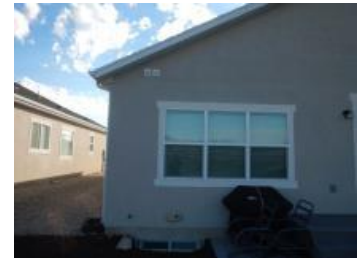
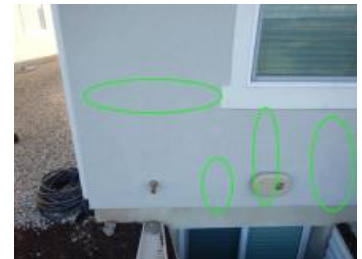
Rear West.

13' wide. This exposure is taller with the gable.

19' of linear cracking.

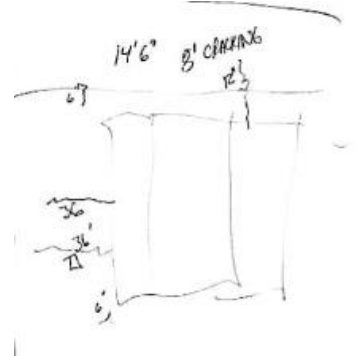
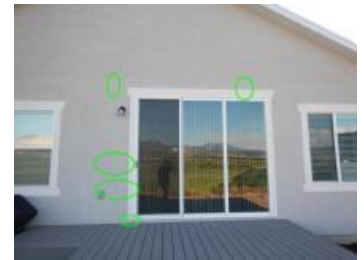
Rear middle.

8' of linear cracking. Keep in mind that the large 3-panel door occupies most of this main floor section.

**EXCESSIVE** = The amount of hairline cracking is deemed excessive.

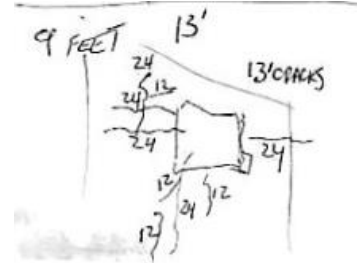
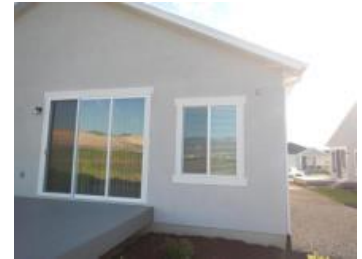
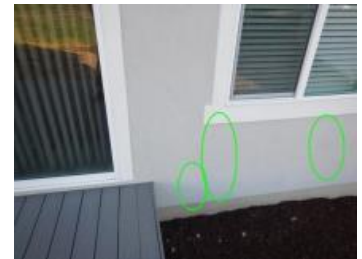
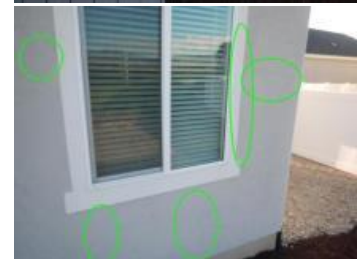
Rear east side.

13' linear feet of cracking.

**EXCESSIVE** = The amount of hairline cracking is deemed excessive.

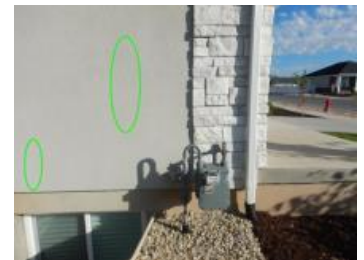
Left side closest to the street.

5' linear feet of cracking.

This section has lesser amount of visible cracking. It could be that there are more, but the sun had already expanded them to make them less visible.

All damaged areas should be further evaluated and repaired by a reputable stucco contractor.
