HEATING SYSTEMS

#1 FURNACE

COOLING SYSTEMS

#1 AIR CONDITIONING

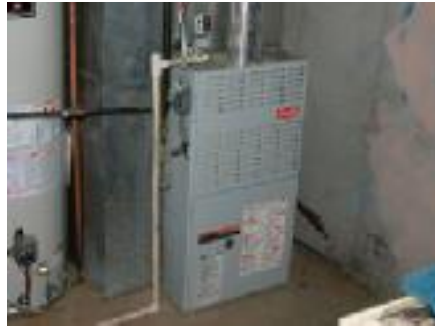
Whole house.

Bryant.

Forced Air. This unit uses both gas and electricity. 80+ efficiency unit.

The clip that secures the filter is laying in the bottom of the lower chamber and needs to be re-installed to secure the filter. Right now the filter moves inward and the air bypasses it completely.

The lower fresh air duct near the crawlspace opening is stuffed with fiberglass insulation. This large 10" duct should be open and free flowing to bring fresh air to the furnace and water heater. NOTE: This is not really a big deal until the basement is finished off and the gas fired appliances are contained in their own small room.

The now famous Mountain Fuel "Green Sticker" is NOT present on this unit. The "Green Sticker" verifies that this unit has been tuned to operate at this elevation and with the current grade of natural gas. Consideration should be given to having this unit serviced and tuned up to perform at its most efficient level.

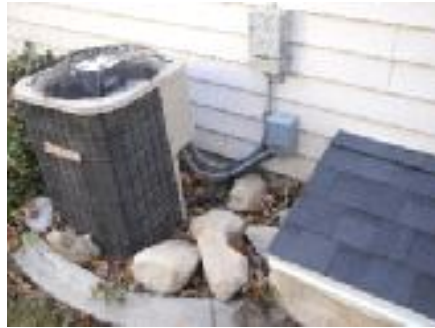
CONDENSER UNIT:

The compressor unit sits unlevel. It is recommended that the unit be re-leveled to help prolong the units lifespan.
