LEAVITT REPORT

248 West 220 South - Orem, UT.

CLIENT'S NAME:	Tamara Cox.
DATE OF INSPECTION:	06/04/2003.
TIME OF INSPECTION:	01:00 PM.
INSPECTION #:	60403B.
INSPECTOR:	Michael D. Leavitt - Certified Inspector.
CLIENT'S AGENT:	Jerry Loveland - Coldwell Banker West.

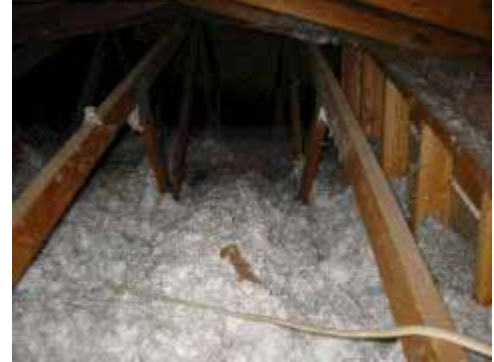
ATTIC COMPONENTS:

ATTIC INSULATION:	Type: Blown-in Fiberglass. Total Thickness: 10"-12".
--------------------------	--

ATTIC VENTILATION:	Adequate.
ATTIC ELECTRICAL:	The attic insulation prevented the viewing of the attic electrical = Did Not Evaluate.

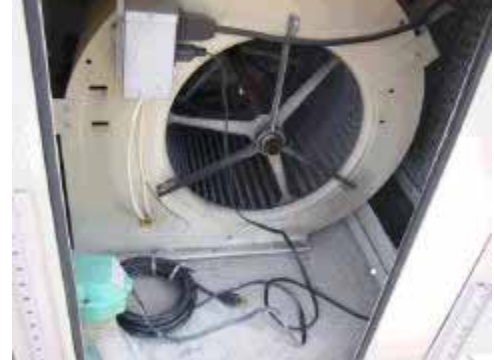
VISUAL CONDITION:

Units are not evaluated when they are shut down for the winter = Ask the owner for details about the unit's condition.

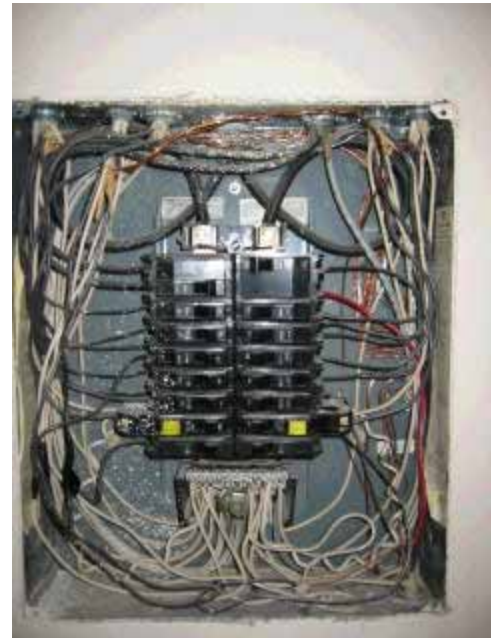
#1 SUBPANEL:

SUB-PANEL LOCATION:	Basement.
----------------------------	-----------

PANEL LABELING:	Partial. Determining whether the labeling of the breakers is accurate is beyond the scope of this evaluation.
110/120V BREAKERS:	14.
220/240V BREAKERS:	2
GFCI BREAKERS	Two GFCI breakers were identified.
