# LEAVITT REPORT

**1387 North 1130 West - Orem, Utah.**

**CLIENT'S NAME:** Kristine & Bill Stewart.  
**DATE OF INSPECTION:** 2-3-2004.  
**TIME OF INSPECTION:** 9 AM.  
**INSPECTION #:** 20304A.  
**INSPECTOR:** Michael Leavitt.

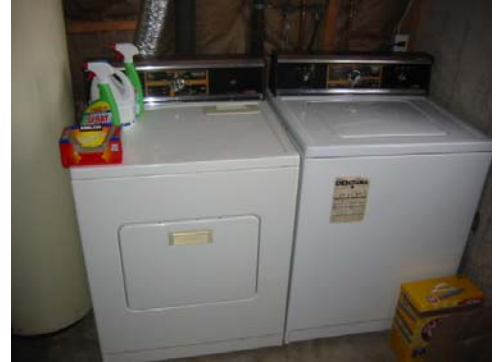
**LOCATION:** Basement.

- WASHER HOOK-UPS:** Did Not Test. It is recommended that you use the more expensive braided steel water hook-up lines for this installation. The cheaper rubber lines are prone to rupturing and flooding of the home.

- WASHER DRAIN:** Did Not Test. The testing of the washing machine drain is beyond the scope of this inspection.
- FLOOR DRAIN:** There is an emergency floor drain for plumbing leaks.

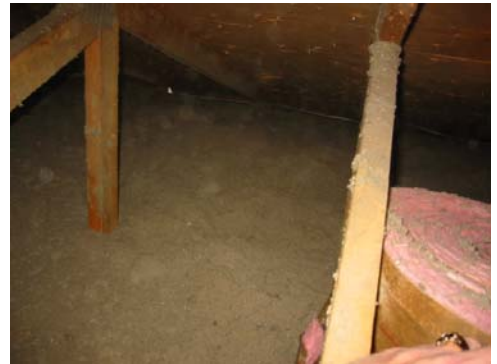
**ATTIC INSULATION:**

Type: Blown-in Cellulose. Total Thickness: 4"-6".

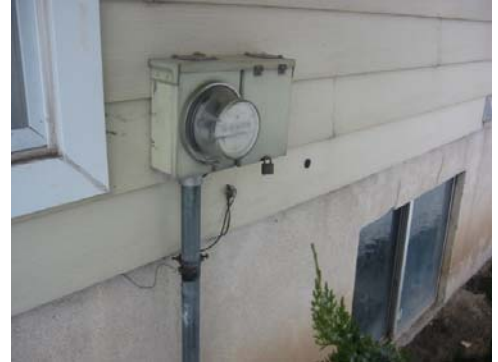
**MAIN PANEL LOCATION:** West exterior.

**MAIN DISCONNECT SIZE:** 100 amps.  
**SERVICE ENTRY CABLES:** Unable to view the service entry cables due to the panel configuration.

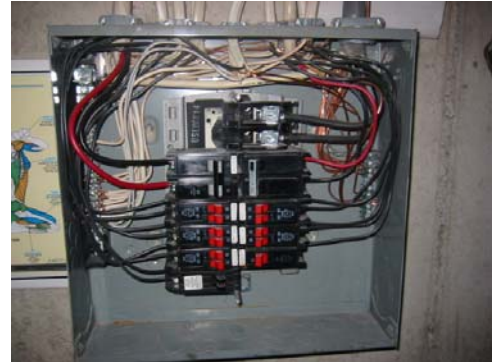
**SUB-PANEL LOCATION:** Basement.

**GENERAL CONDITION:** Working as designed.  
**PANEL LABELING:** Yes. Determining whether the labeling of the breakers is accurate is beyond the scope of this evaluation.
