## CONCRETE REPORT

### INSPECTION PROPERTY ADDRESS

850 East 820 North  
Provo, UT

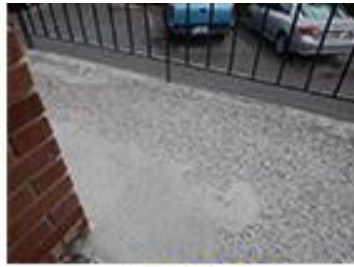
**PHOTO #2**

Photo 1 shows near total surface deterioration. As you look on to 3 and 4 you see that there is a rainfall deterioration from the middle to the outer edge. Keep in mind that there is a partial roof covering and the deterioration is from the protected area outward. Why is this important? If one is trying to blame the application of salt to the walks, then there would be surface deterioration all the way across.
