# STUCCO REPORT

**6167 W Teton Park Dr - Herriman, UT**

CLIENT'S NAME:	Bill Miller.
DATE OF INSPECTION:	07/03/2023
START TIME:	8:00 AM
INSPECTION #:	70323A
INSPECTOR:	Michael D. Leavitt - Master Inspector
CLIENT'S AGENT:	None - Owner Occupied

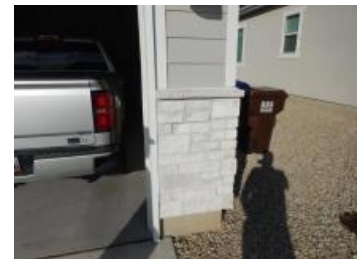
STUCCO TYPE: There is a traditional hardcoat stucco installed and not the synthetic EIFS type product.  
STUCCO LOCATIONS: Stucco is installed on the right, rear, and left sides of the home. The front of the home has a faux stone that is set onto a stucco base coat.

SHEATHING: Oriented Strand Board.  
UNDERLAYMENT: Did Not View.  
WIRE LATH: Yes.  
SEALANT APPLIED: None.  
TEST EQUIPMENT: No probing was performed.  
TEST PERSONNEL: Michael D. Leavitt.
