RADON REPORT

1665 West 700 South - Lehi, UT

CLIENT'S NAME: Jordan Lee DATE OF INSPECTION: 11/01/2023 **START TIME:** 1:00 PM INSPECTION #: 110123B

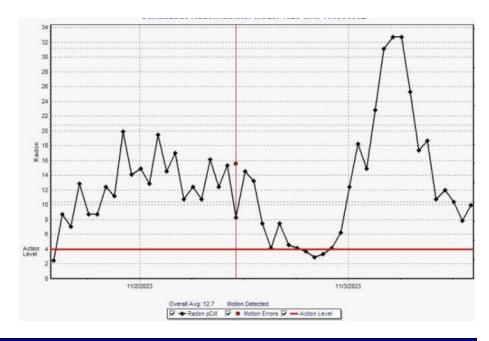
GRAPH:

RESULTS: The action level established by the US EPA and Surgeon General is 4 pCi/l. Results under the action level of 4 pCi/l are still considered a risk. Final test results averaging over 4 pCi/l are considered a risk that should be mitigated. Excessive radon levels is an indoor air quality issue related to cancer that can be improved with the addition of a radon mitigation system.

12.7 pCi/l. OVERALL AVERAGE pCi/I: EPA AVERAGE pCi/I: 13.2 pCi/l.

OVER 4 pCi/I - The USEPA states that for "EPA AVERAGE" test results 4pCi/I and higher, remedial actions should be performed to lower the home's Radon level. It is recommended that you contact a Radon Mitigation specialist for more details and have a mitigation system installed.
