# <section-header>

# 187 S Inlet Spring Dr #115 - Saratoga Springs, UT

# **CLIENT & INSPECTION INFORMATION**

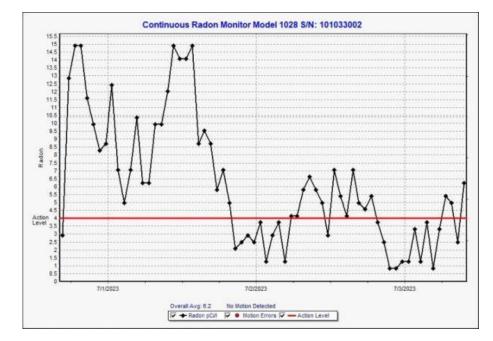
**GRAPH**:

OVERALL AVERAGE pCi/I: EPA AVERAGE pCi/I: HOURLY READINGS:

6.2 pCi/l.	
5.9 pCi/l.	
Date:	06/30/2023
Time	<b>Counts Flags</b>
	pCi/l
16:36	2.9
17:36	12.8
18:36	14.9
19:36	14.9
20:36	11.6
21:36	9.9
22:36	8.3
23:36	8.7
	07/01/2023
Time	<b>Counts Flags</b>
	pCi/l
00:36	12.4
01:36	7.0
02:36	5.0
03:36	7.0
04:36	
05:36	6.2
06:36	6.2
07:36	9.9
08:36	9.9
	12.0
10:36	14.9

14.1
14.1
14.9
8.7
9.5
8.7
5.8
7.0
5.0
2.1
2.5
2.9
2.5
07/02/2023
Counts Flags
pCi/l
3.7
1.2
2.9
3.7
1.2
4.1
4.1 5.8
5.8 6.6
5.8
5.0
2.9
7.0
5.4
4.1
7.0
5.0
4.6
5.4
3.7
2.5
0.8
0.8
1.2
07/03/2023
Counts Flags
pCi/l
1.2
3.3
1.2
3.7
0.8
3.3
5.4
5.0 2.5
2.5 6.2.
0.2.

**OVER 4 pCi/l** - The USEPA states that for "EPA AVERAGE" test results 4pCi/l and higher, remedial actions should be performed to lower the home's Radon level. It is recommended that you contact a Radon Mitigation specialist for more details and have a mitigation system installed.
