LISTING INSPECTION REPORT

892 East 350 South - Kamas, UT

CLIENT'S NAME:	Ray & Patricia Dufour
DATE OF INSPECTION:	03/18/2024
START TIME:	9:00 AM
INSPECTION #:	31824A
INSPECTOR:	Michael D. Leavitt - Certified Inspector
CLIENT'S AGENT:	Drew Armstrong & Matthew Flinders - Armstrong Flinders & Associates

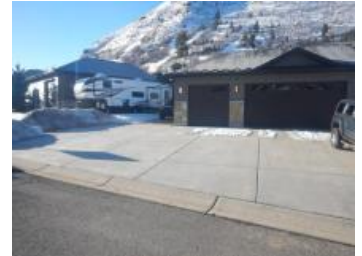
ADDITIONAL PARKING:

They added a gravel parking strip on the east side of the home.

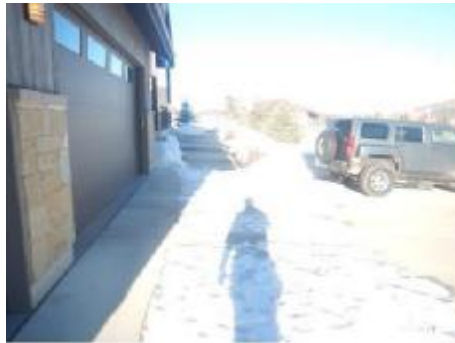
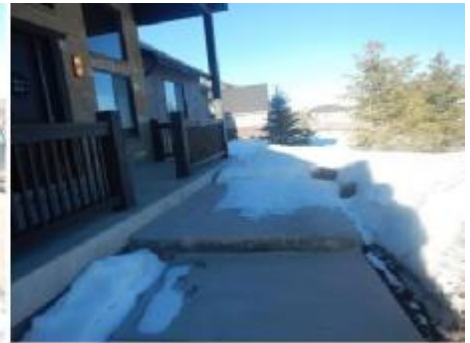
WALKWAYS:

The front walkway was partially covered with snow.

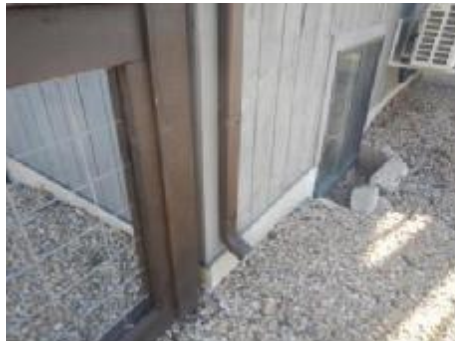
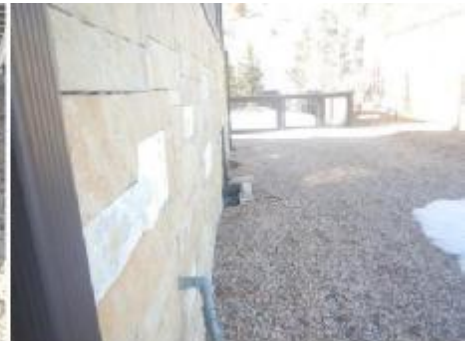
FOUNDATION DRAINAGE:

I found good drainage around the home. The porous nature of the near foundation areas prevents ponding of water.

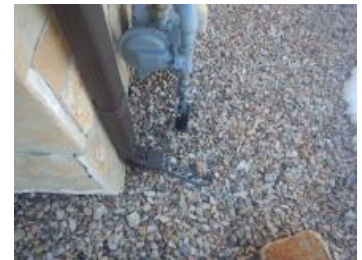
ROOF DRAINAGE:

Good. The electric heat strip tape helps during the winter freezes.

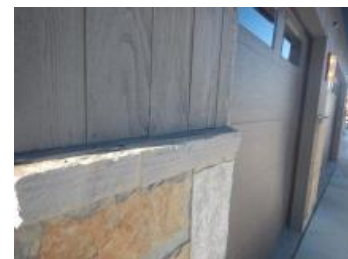
FLASHINGS:

The needed horizontal through the wall flashings are used along the horizontal stone lines.

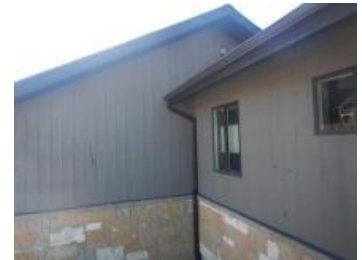
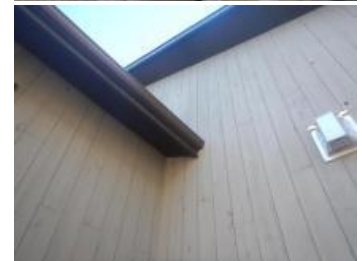
ROOF TO WALL:

I looked closely at the roof to wall connections and found no failure stains.

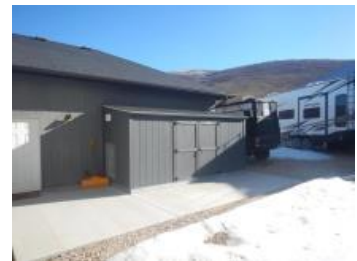
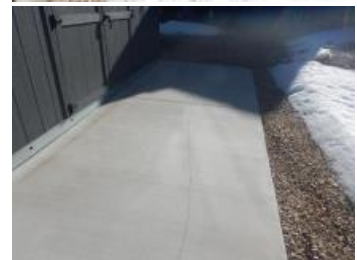
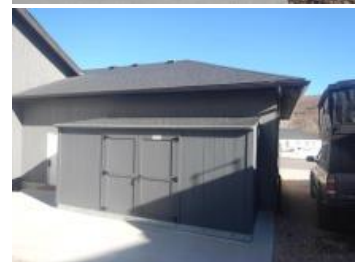
STORAGE:

This added Tuff Shed storage area is a great addition.

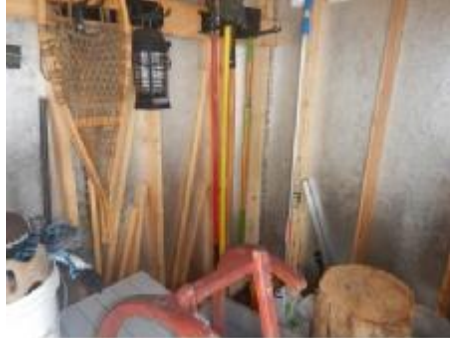
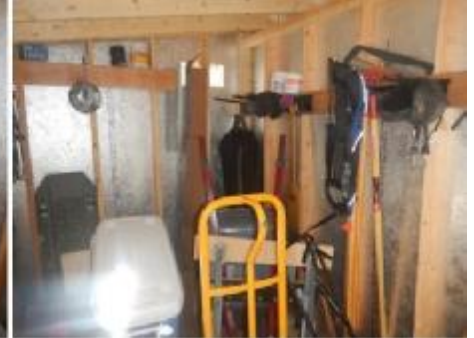
WATER ENTRY:

I found no signs of water entry into the shed.

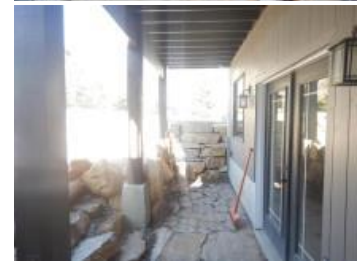
WATER COLLECTION:

I do not see signs of ponding water. The porous nature of the stonework allows water to soak into the earth.

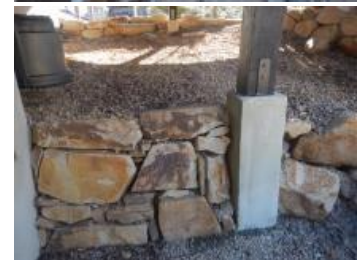
RETAINING WALL:

The stone retaining walls and deck columns are in good condition.

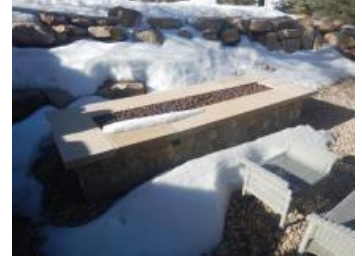
GAS HEATER:

I did not test this large natural gas flame area.

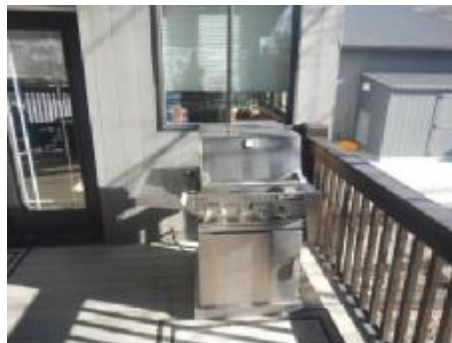
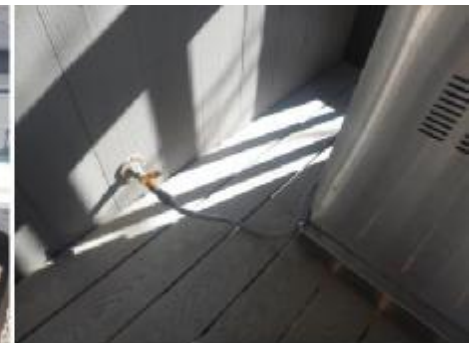
GAS BBQ:

Yes. There is a gas BBQ hook-up.

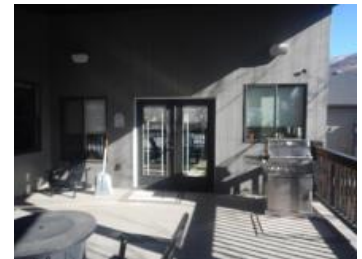
DOOR:

Good.

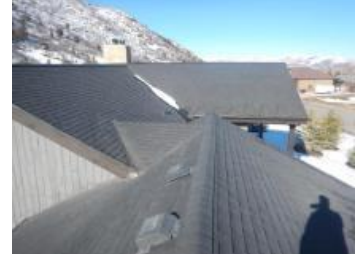
ROOFING CONDITION:

Good. I was able to view about 85% of the roof.
The rest was snow covered.

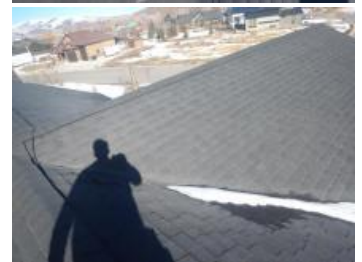
RIDGES:

Good.

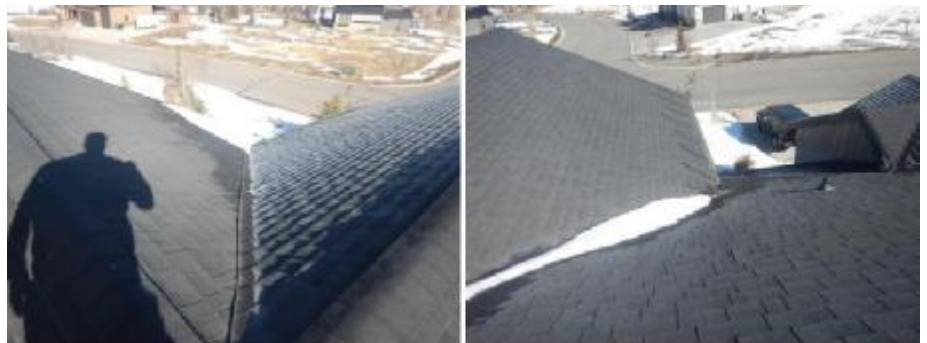
VALLEYS:

Good. Some were still snow filled.

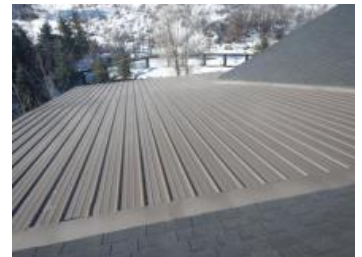
DECK ROOF:

Good.

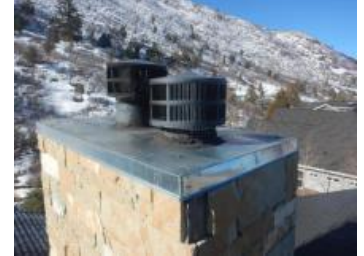
SPARK ARRESTOR:

A spark arrestor is installed.

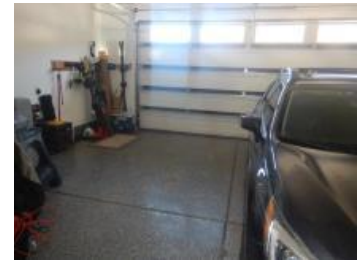
GENERAL CONDITION:

Good.

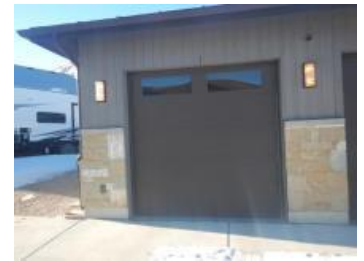
MAIN GARAGE DOOR(S):

Good.

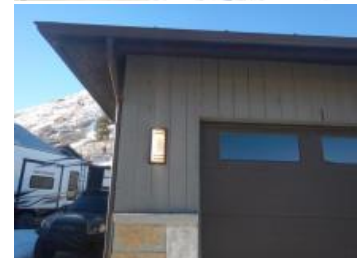
SETTLEMENT:

I found no evidence of movement at the large garage door openings.

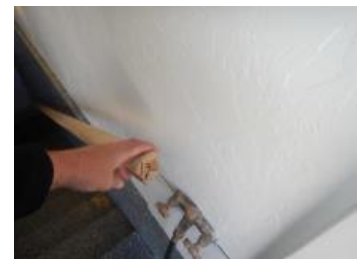
HANDRAIL:

The installed handrail is secured. There are no turnbacks at the top and bottom of the handrail.

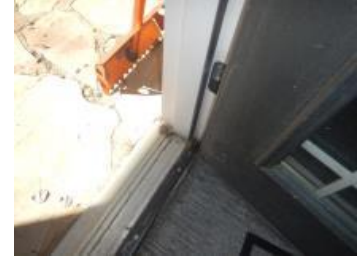
DOOR:

Looking closely at the threshold, this exterior door has had some water seepage. Caulk the threshold and keep the weatherstrippings and door seal fresh.

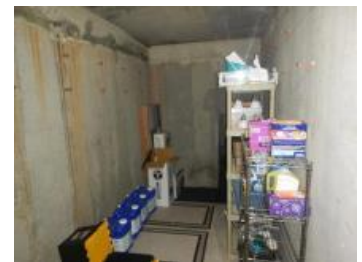
Under the front porch.

On my first visit I identified ceiling cracking and water entry signs. Since that time, the front porch was recapped and the side walls sealed. I found no fresh water entry signs during my visit.

I have recommended that the owner provide the work invoice so that if there are future issues, then you know who to contact.

I also recommend that the interior water stains be washed/scrubbed off so that it will be easier to identify any future water seepage stains.

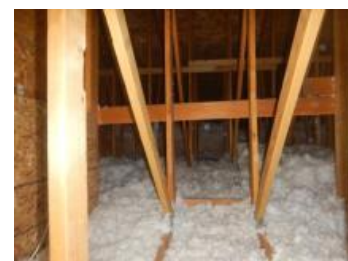
LAUNDRY ATTIC:

The laundry attic accesses the eastern half of the home. The truss structure is in good condition.

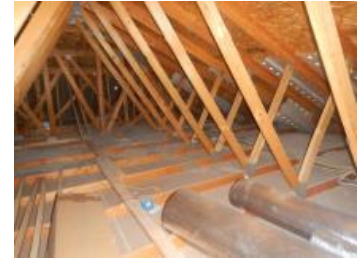
GARAGE ATTIC:

This area is only partially insulated. Some items are stored there. Consider removing the stored items and fully insulating this garage attic area.

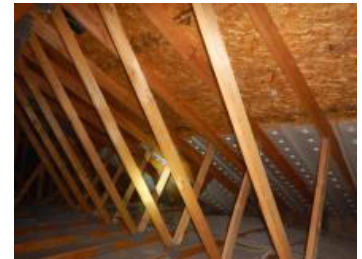
GARAGE STRUCTURE:

Good. This is a full truss system.

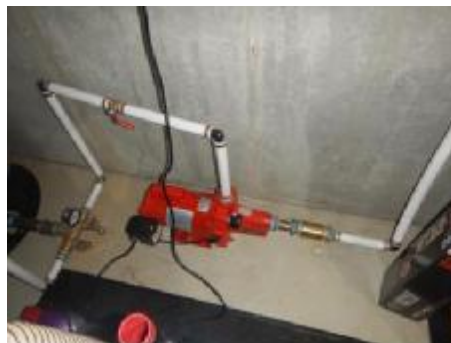
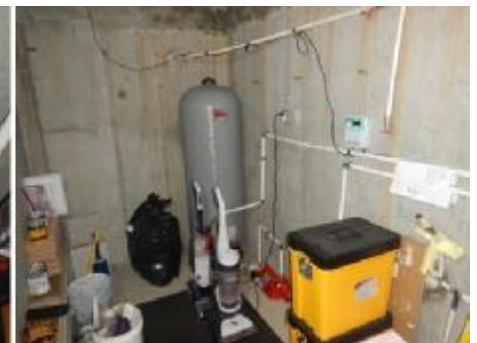
BOOSTER PUMP:

Due to lower water pressure up in this canyon, the owner installed a booster pump and expansion tank. This is an excellent solution to raise the water pressure inside the home.

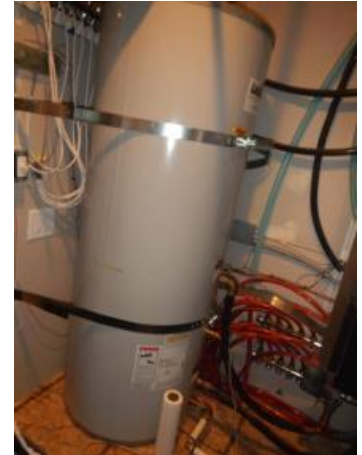
LOCATION: Basement service area.

VISUAL CONDITION: This tall tank is heated by water from the on-demand boiler. This is unique in that the water heating is provided by a coiled pipe within the tank that allows one of the boiler zones to flow water through and keeps the boiler water/glycol separate from the drinking/bathing water.

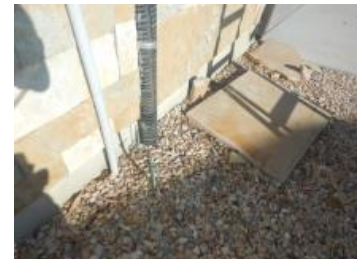
HOUSE GROUND CONNECTION:

Rod.

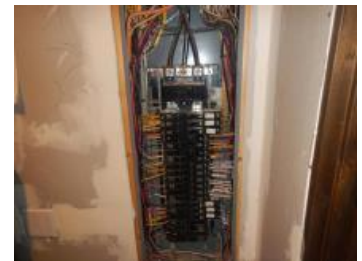
SUB-PANEL LOCATION:

Basement.

The wiring methods inside the panel are professional and working as designed.

The recommended 4 wire feed for a subpanel is installed.
