4-PLEX INSPECTION REPORT

222, 224, 226, & 228 North 250 East - Orem, UT

CLIENT'S NAME:	Eduardo Silva
DATE OF INSPECTION:	05/08/2024
START TIME:	9:00 AM
INSPECTION #:	50824A
INSPECTOR:	Michael D. Leavitt - Master Inspector
CLIENT'S AGENT:	Kim Brown - Bill Brown Realty, Inc

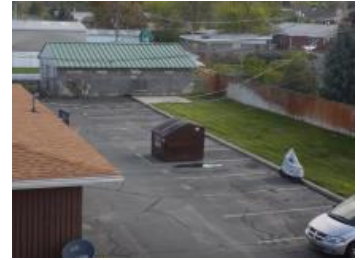
TRASH:

The dumpster is NOT located on this property. It is two buildings to the north.

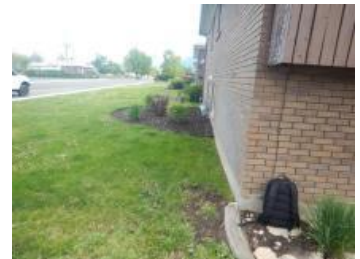
SLOPE WITHIN 10 FEET OF HOUSE:

The area around the perimeter of the structure is level at best. Additional measures should be taken to provide the recommended drainage. Correcting the grade will help to avoid erosion and/or standing water along the foundation.

The general guideline is for the grading to drop 6" in the first 10' away from the foundation. This means that you should stand 10 feet away from the structure and the earth at the foundation should be at least 6" higher than where you are standing. This promotes water saturation away from the foundation and lessens the chance for water entry in and under the structure.

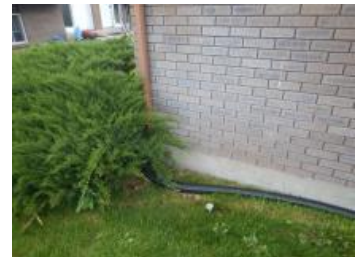
ROOF DRAINAGE:

The NW downspout has an added discharge line still discharges right onto the foundation.

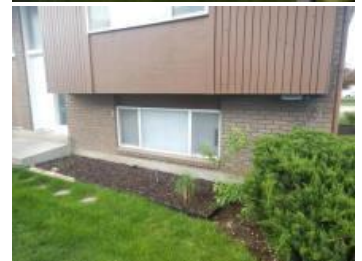
PLANTERS:

The planters are too low and collect water. Add fill and raise them so that water flows away from the structure.

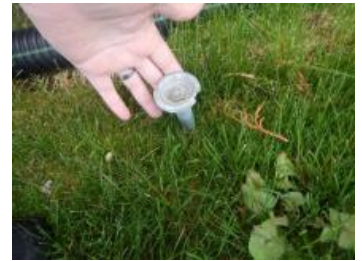
SPRINKLERS:

Currently the old galvanized pipe system is joined with the unit to the north. You will need to install a complete new system for your property only. Keep in mind that you also have the rear east yard.

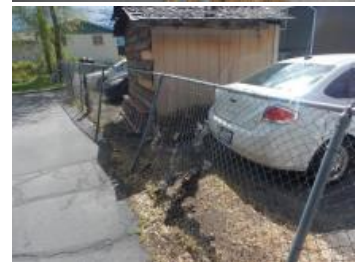
MORE DAMAGE:

The south fence has been damaged from vehicle impacts.

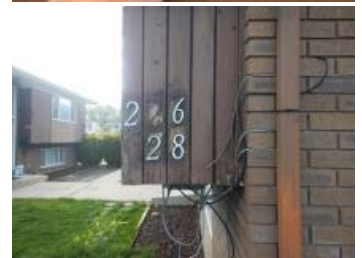
NUMBERS:

The numbers are damaged.

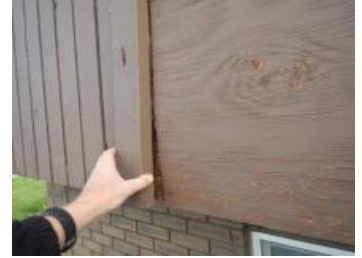
LOOSE:

Some of the slats are loose and warped.

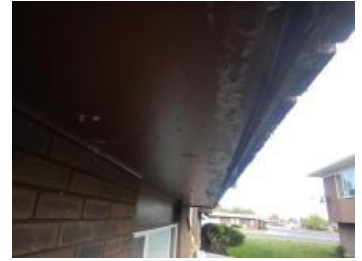
OVERHANGS:

The underside paint is peeling/flaking.

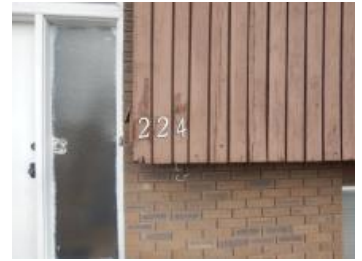
CONSIDER:

You should consider a siding overlay that would lessen the needed exterior painting maintenance in the coming years and decades.

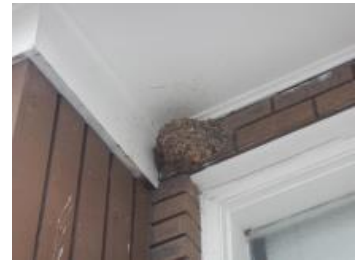
INSECTS:

There is a nest high on the soffit.

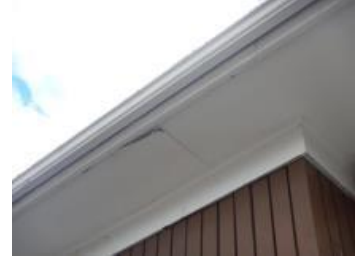
SOFFIT:

The plywood is sagging = Resecure.

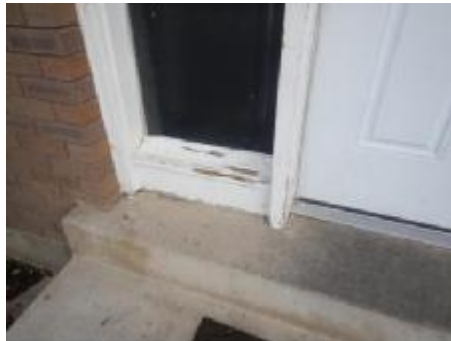
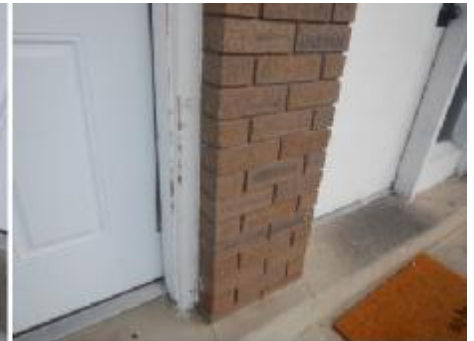
DOOR:
PAINT:

The weatherstripping is damaged.

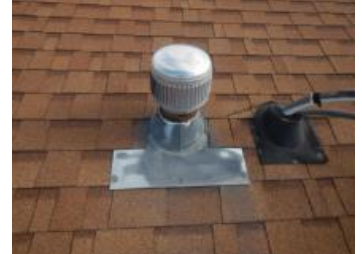
FLUES:

FURTHER EVALUATE = The furnace flues terminate really low to the roof. Typically, they need to terminate at least a foot above the roof. As you have the furnaces serviced, have the HVAC verify whether or not the flue termination heights need to be increased. When you upgrade the furnaces (of which all are on your short list) the flue heights should be raised.

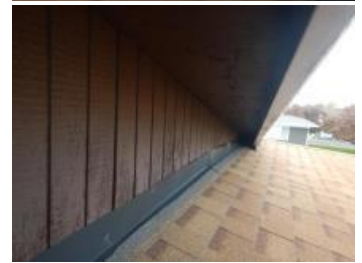
ROOF TO SIDING:

The flashing to siding joints were not caulked = Add caulk.

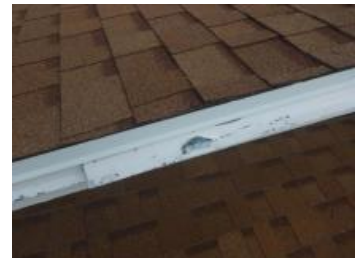
ROOF METAL:

The earlier roof drip edge flashing paint is peeling/flaking.

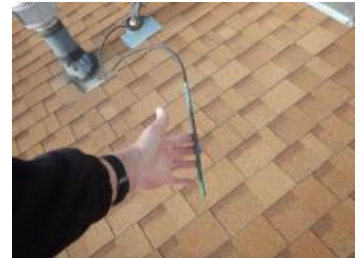
EVAPORATIVE COOLER:

The old swamp cooler water lines are still on the roof.

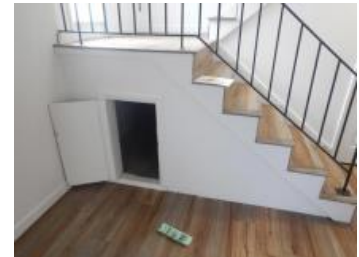
Living room under the stairs.

There are signs of prior flooding.

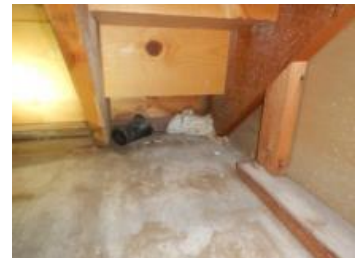
REMARKS:

The underside of the stairs does not have the
recommended fire rated drywall.

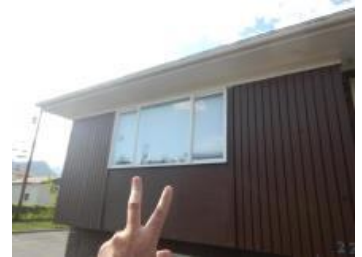
SCREENS:

Window screen is not installed (x2).

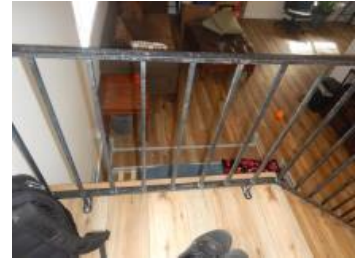
BALUSTRADE SPACING:

The spacing of the balusters exceeds 4" which may present a hazard to infants.

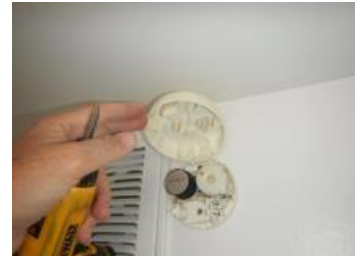
SMOKE ALARMS:

UPGRADES ARE RECOMMENDED = These are needed on each floor and inside the sleeping rooms.

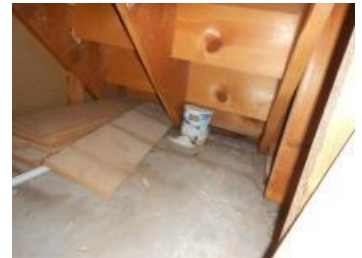
REMARKS:

The underside of the stairs does not have the recommended fire rated drywall.

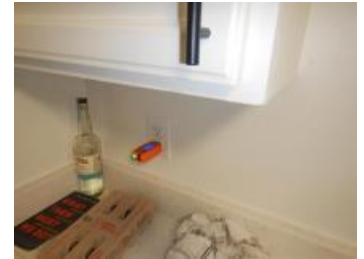
LIGHTING: There is no over sink lighting installed.

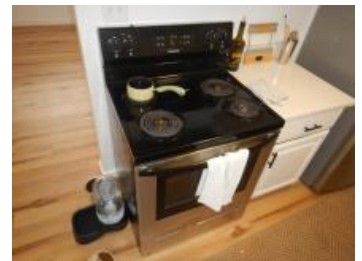
OVEN:

Electric: Functioning. The temperature settings and timer were not tested. The safety anti-tip bracket is **NOT** installed on this unit. This safety bracket helps to prevent toppling of the unit if a child were to open the door and climb up on it = Consider adding for safety.

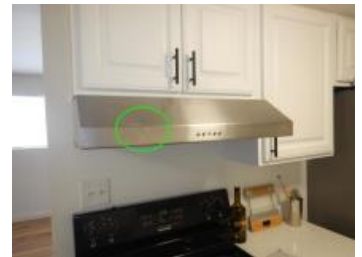
EXHAUST FAN:

Recirculating style - Functioning: Yes. The fan was turned on, tested, and then turned back off. There is a dent in the fan housing.

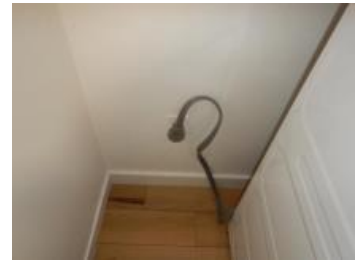
DRYER HOOK-UPS: There is a 220 electric dryer hook-up. The dryer receptacle is a 3 prong type for older installations. If your unit needs a 4 prong receptacle, then it is recommended that you contact a licensed Electrician for the pigtail conversion.

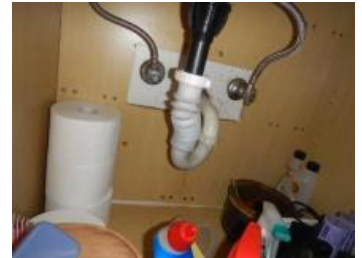
DRAIN CONDITION:

There is an accordion style drain pipe which promotes clogs. Consider upgrading to all smooth wall drain piping.

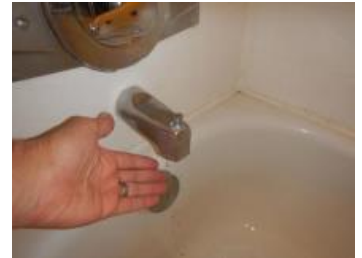
TUB/SHOWER PLUMBING:

The water control valve cartridge leaks and there is steady dripping from the spout 24/7 = **REPAIR.**

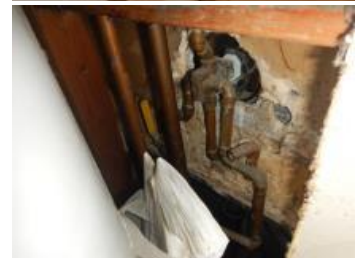
LEAKS:

Here is the backside of the wall that shows water staining, damage, and mold.

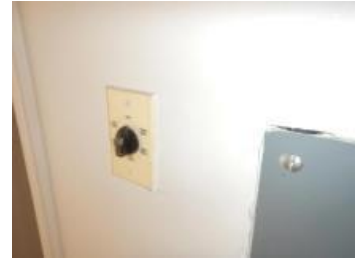
WALL FINISH:

The swamp cooler switch is still installed.

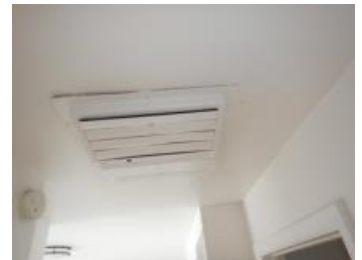
CEILING:

The swamp cooler vent is still installed, although it is aborted in the attic.

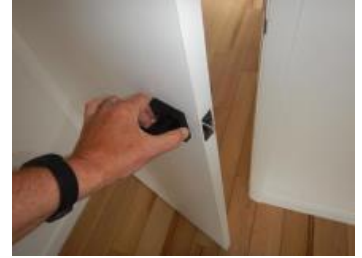
DOOR:

The door handle is loosely mounted.

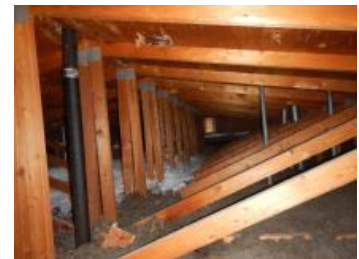
INSULATION:

The NE unit must have had a major swamp cooler leak/flood. The insulation in that area has all been upgraded to modern depths. I do not see rot and damage to the framing and the typical culprit is a swamp cooler water hook-up line that fails and floods.

The NE unit has modern R-38 depths. The other three units have their original 6" of insulation instead of the modern 12-15" = Consider adding a fresh layer to all the attic and hit the R-38 depths.

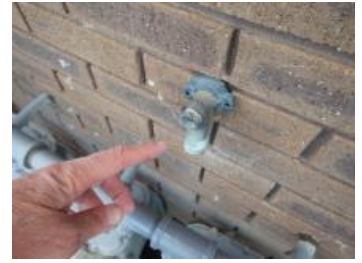
HOSE BIBS:

Neither exterior hose bib was tested. Both have had their handles removed.

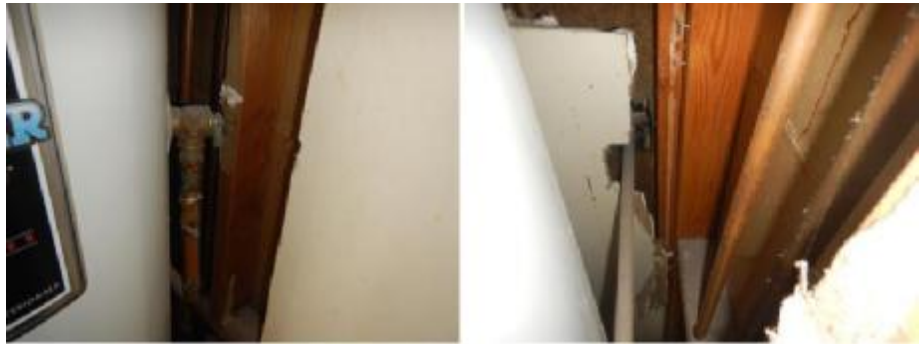
TPR VALVE:

Yes = Did Not Test. They routed the discharge into a drain pipe inside the wall cavity.

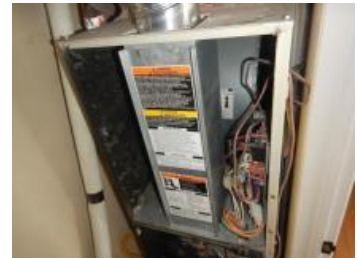
SE Unit #224.

REPAIRS ARE NEEDED to the system = Recommend further evaluation/repair by a licensed Heating Ventilation Air Conditioning HVAC specialist. When I arrived the unit had the blower solid cover over the burner area and the louvered cover over the blower chamber. This meant that the return area was the entire service closet instead of the interior of the unit. Not only was this an error, I found no filter for the system. The other units had either a filter change just above the furnace or retrofitted hallway return air grills that open for a filter. This unit has long been run without a filter. And since the tenants have dogs, this means that pet hair has been recirculated throughout the system. I recommend a good furnace and ductwork cleaning and tune-up. Keep in mind the advanced age of the system. It should be on your short list for replacement.

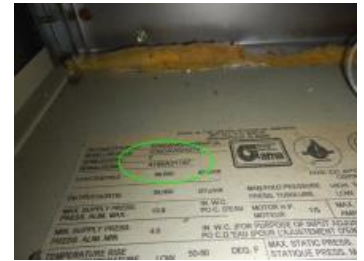
APPROXIMATE AGE:

1995.

According to industry experts, the average life of a heat exchanger in the U.S. is 15 to 20 years. Use this estimate as a general guideline. Many factors can affect the operation of this system and it is possible for the system to fail at any time.

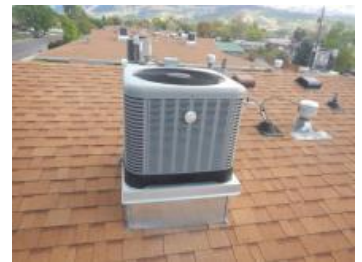
**COOLING ZONE:
SUCTION LINE INSULATION:**

SW Unit #222.
Part of the insulation is missing near the exterior condenser unit and again at the interior evaporator unit = Add the missing insulation to improve efficiency. There is wood subfloor damage from condensation drip.

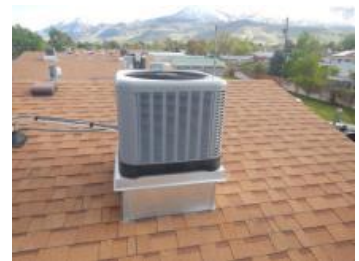
SE Unit #224.

Part of the insulation is missing near the exterior condenser unit and again at the interior evaporator unit = Add the missing insulation to improve efficiency.

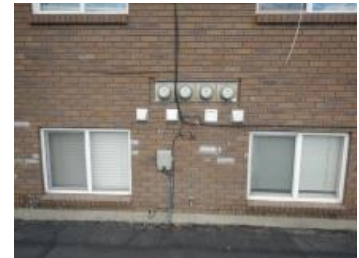
EXTERIOR SHUT-OFFS:

The exterior has four meter bases only. There are no exterior shut-offs.

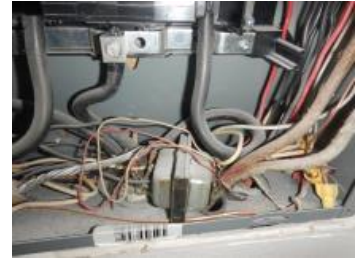
LOW VOLTAGE:

The doorbell transformer is incorrectly installed inside the panel. Low voltage wires are not allowed to be installed inside high voltage panels.

RECOMMEND REPAIR: It is recommended that a licensed Electrician be consulted to repair/resolve the noted conditions.

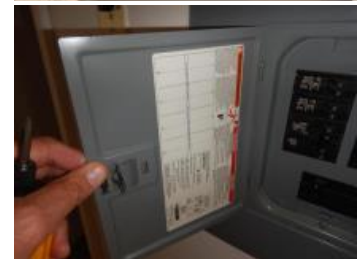
PANEL LABELING:

The electrical distribution panel is not adequately labeled. The circuits should be labeled according to use.
